**CONDITION ASSESSMENT REPORT
OF
HADLEIGH GUILDHALL
HADLEIGH
SUFFOLK**

Client: Hadleigh Town Council
The Guildhall
Hadleigh
Suffolk IP7 5DN

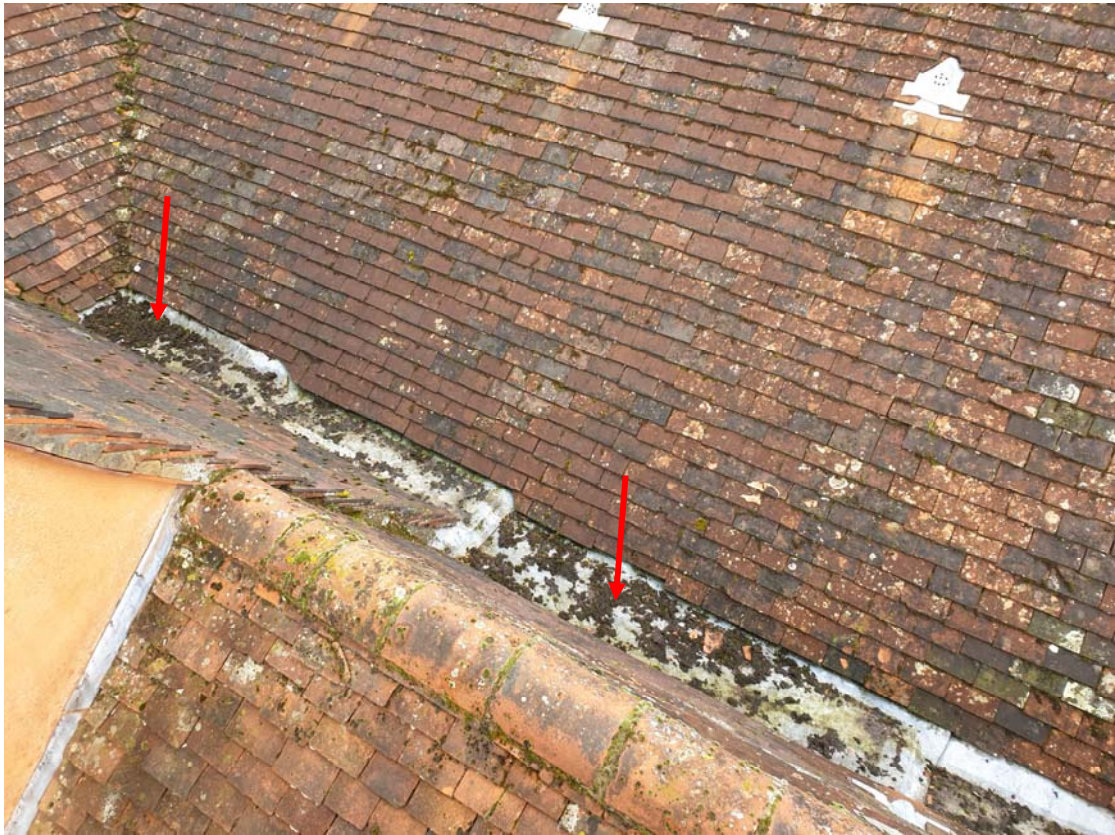
Photograph 04 – Moss and debris build-up noted to the valley gutters

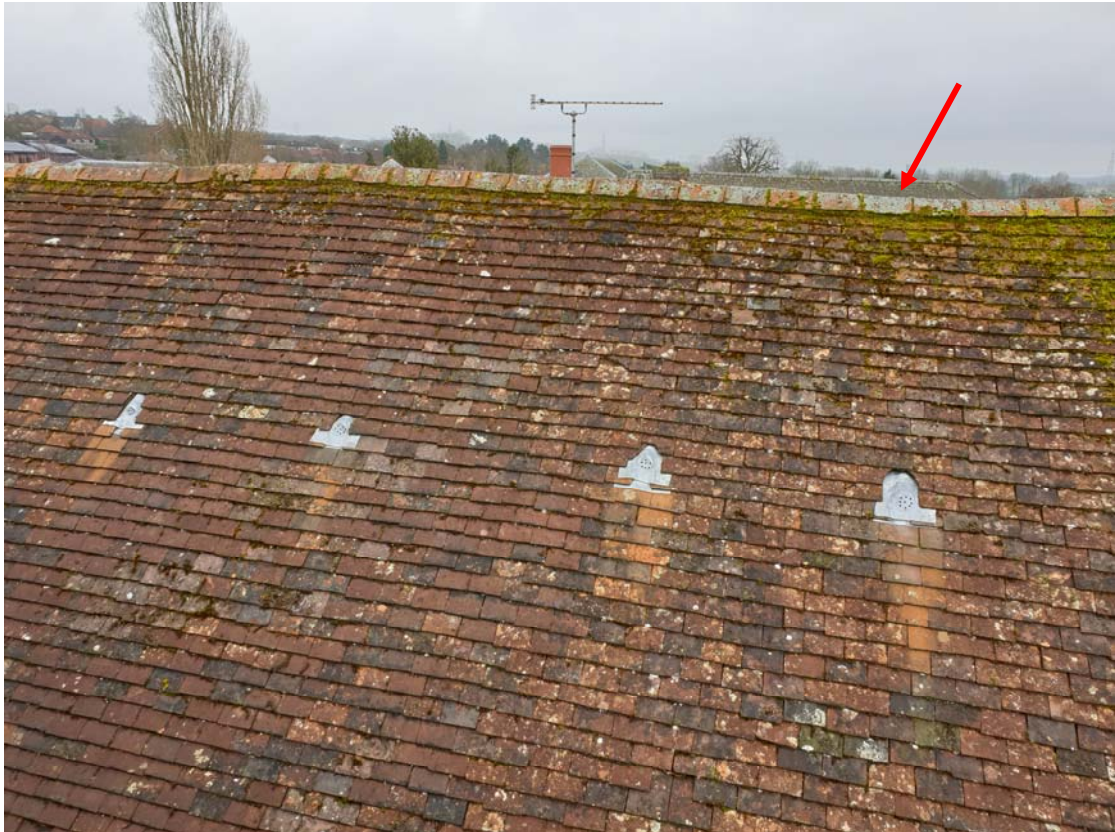
Photograph 05 – Undulations noted to the ridgeline of the roof over the south range of the Market Hall

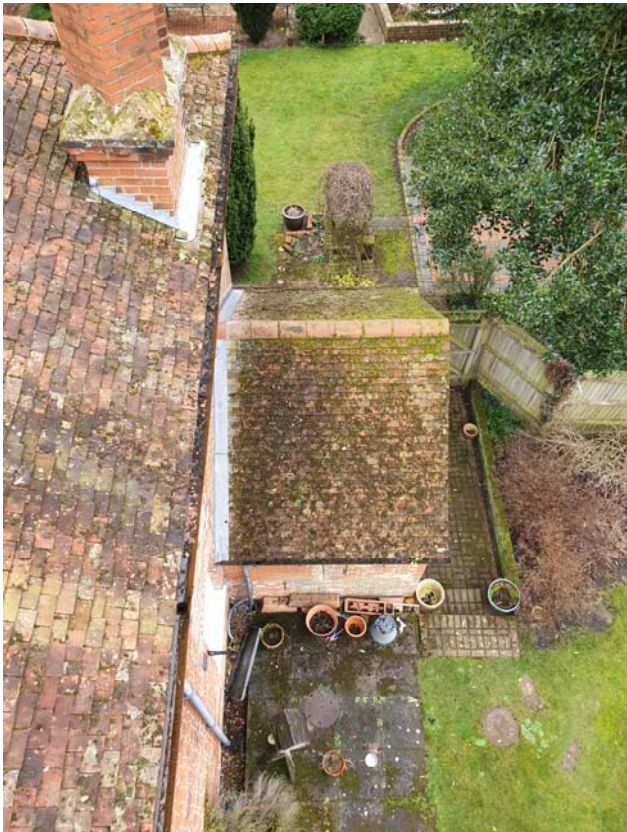
Photograph 06 – Far west roof over porch, as seen from the cherry picker

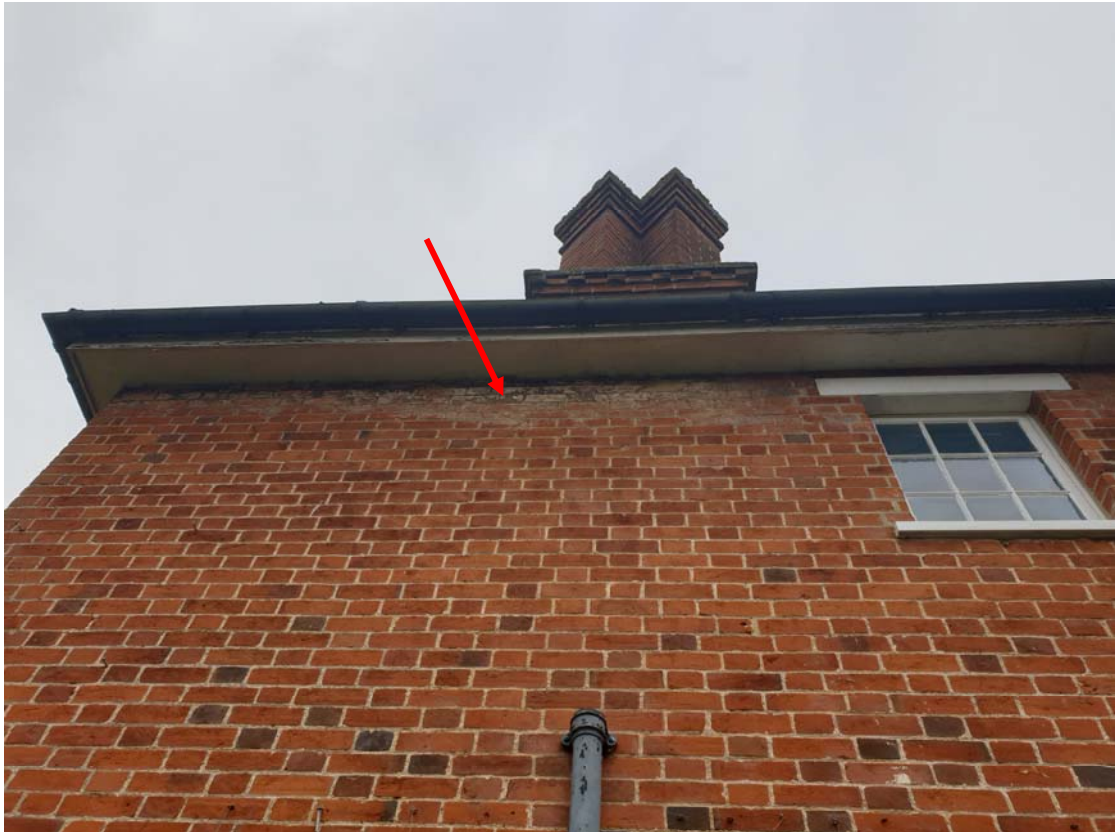
Photograph 15 – White stains at high-level – West elevation of Market Hall's west range

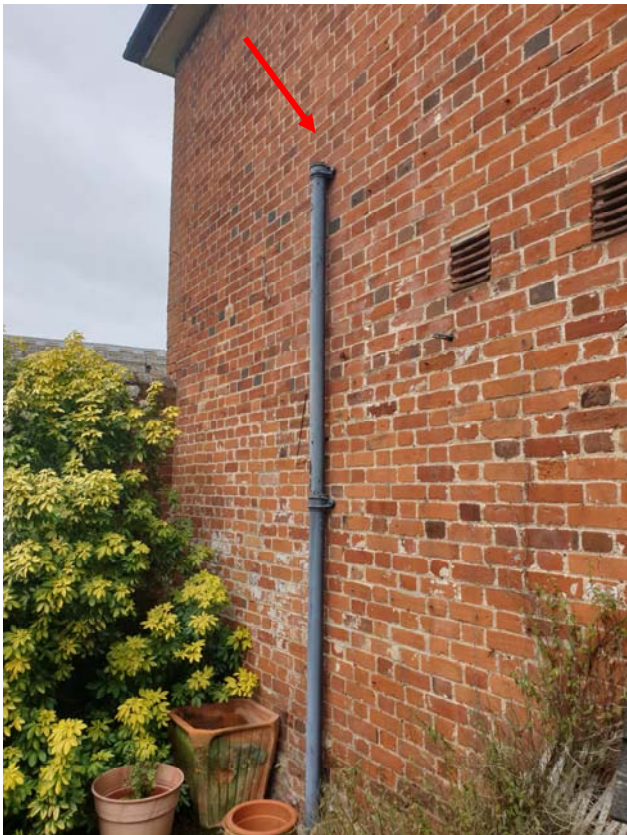
Photograph 16 – Missing section of downpipe to the west elevation of the Caretaker's range

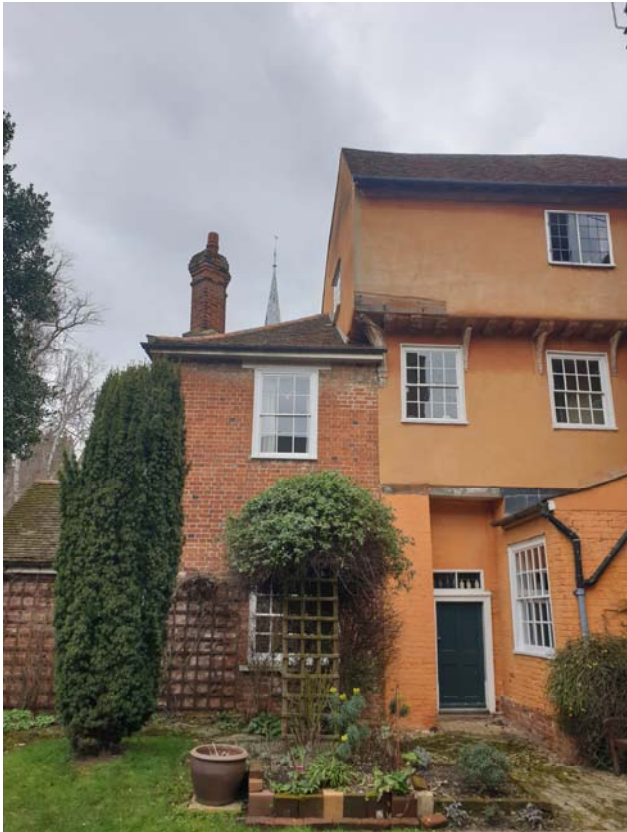
Photograph 17 – South elevation of Caretaker's range

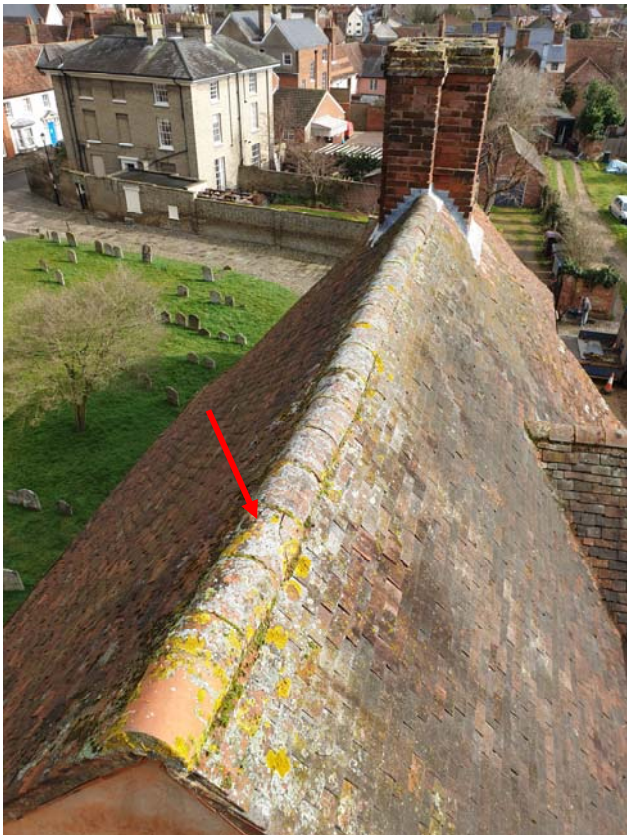
Photograph 18 – Fractured ridge tile to the Market Hall's middle range

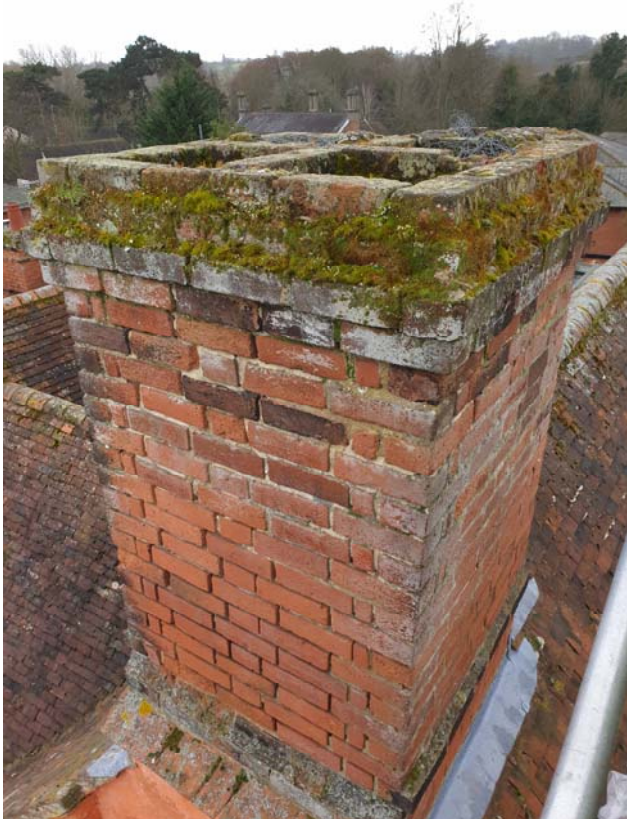
Photograph 19 – Chimney stack to the Market Hall’s middle range

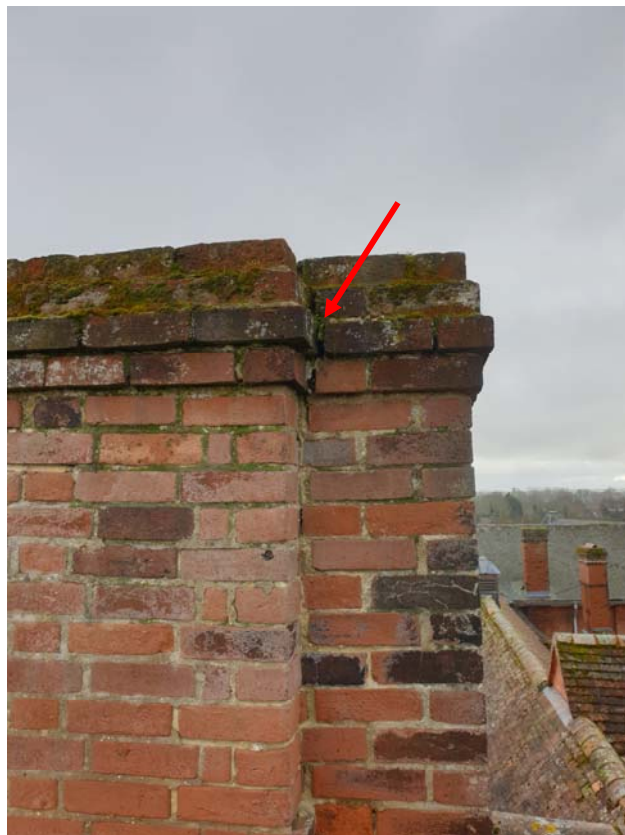
Photograph 22 – Minor separation crack to the middle range's chimney

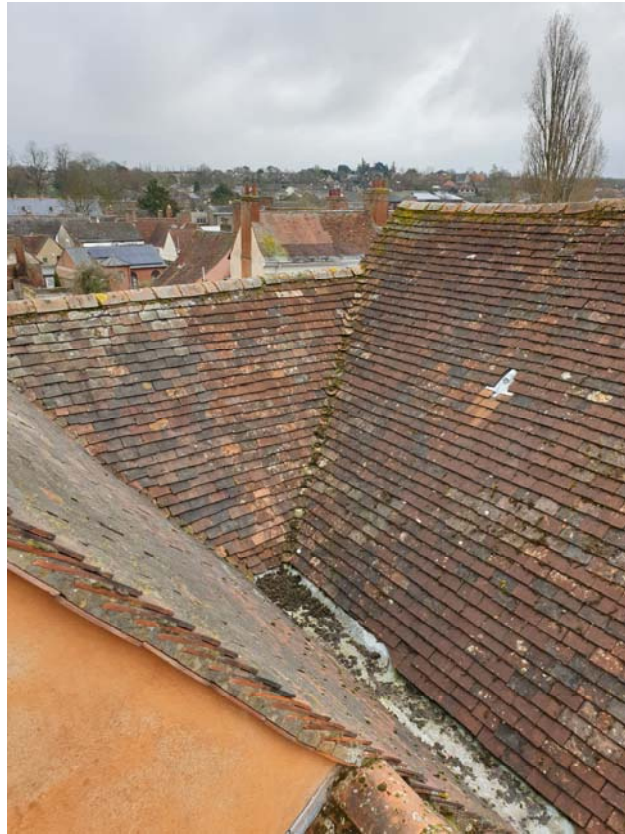
Photograph 23 – Roof arrangement over the Market Hall's middle range

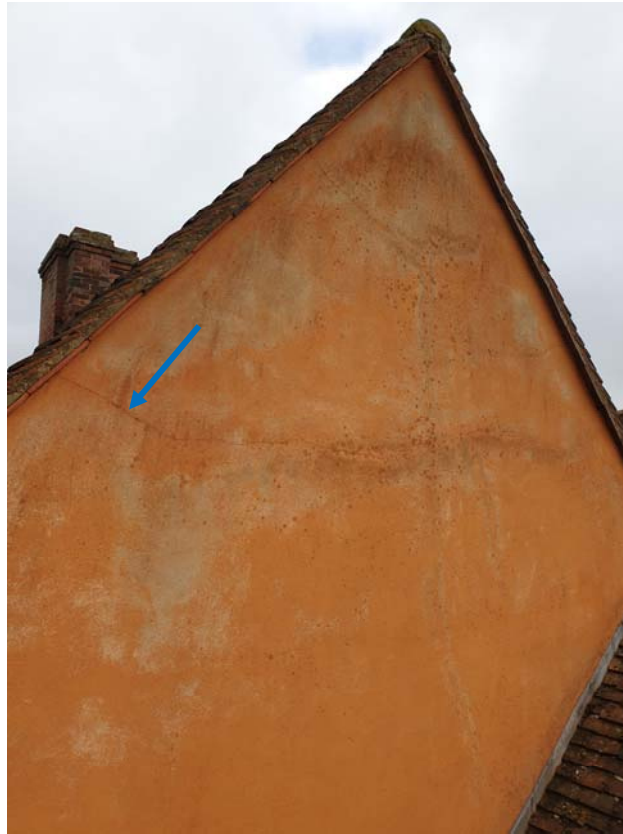
Photograph 25 – Minor cracking in the render to the west gable of the middle range

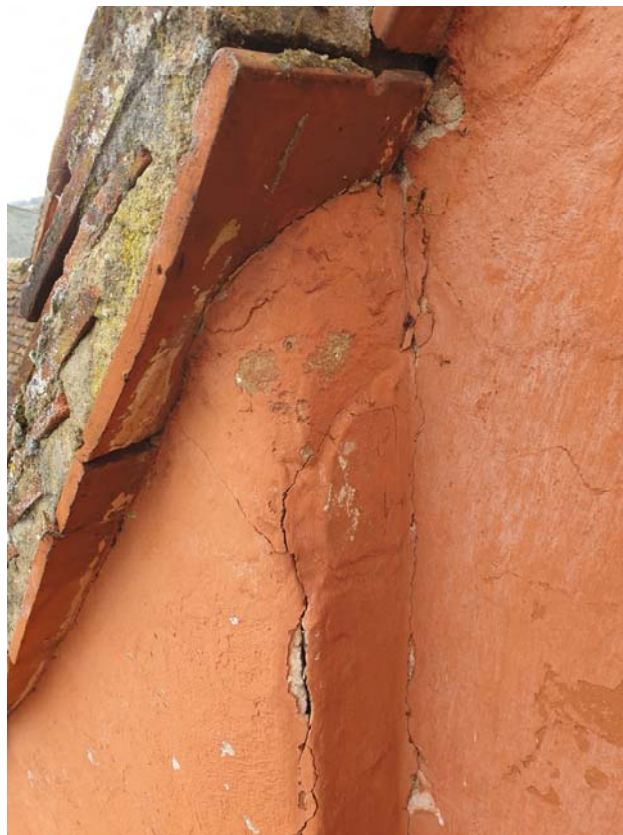
Photograph 26 – Cracking and live render to the east gable of the middle range

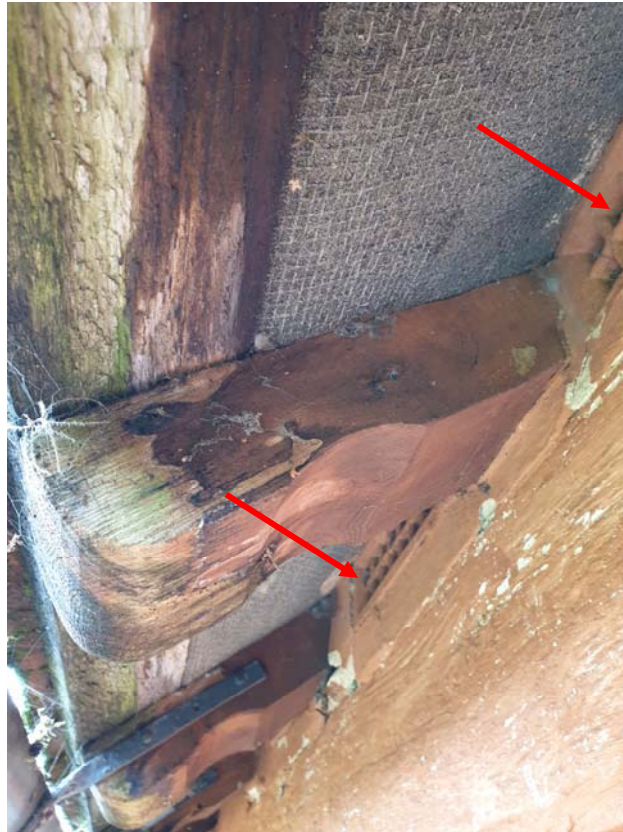
Photograph 27 – Air bricks noted to the eaves level of the middle range

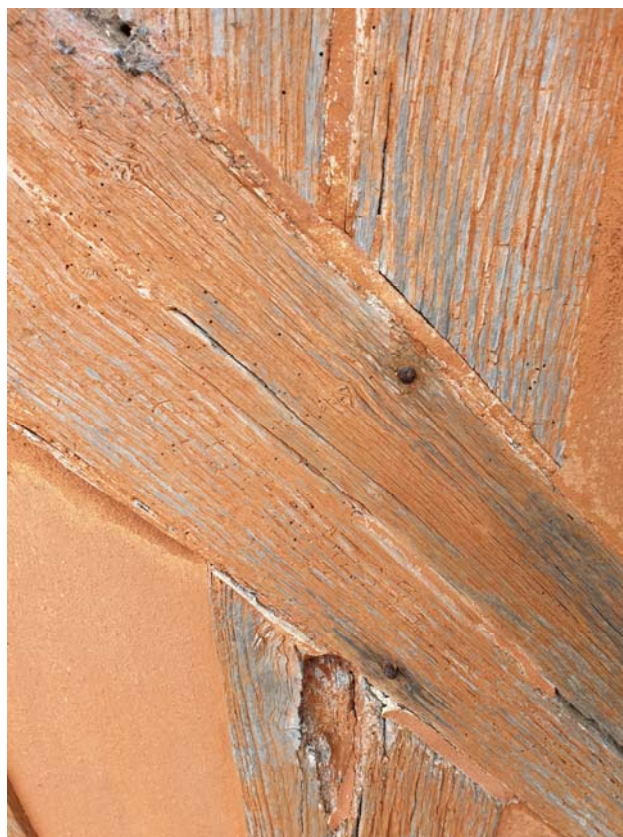
Photograph 28 – Wood-boring insect attack noted to the north elevation of the middle range

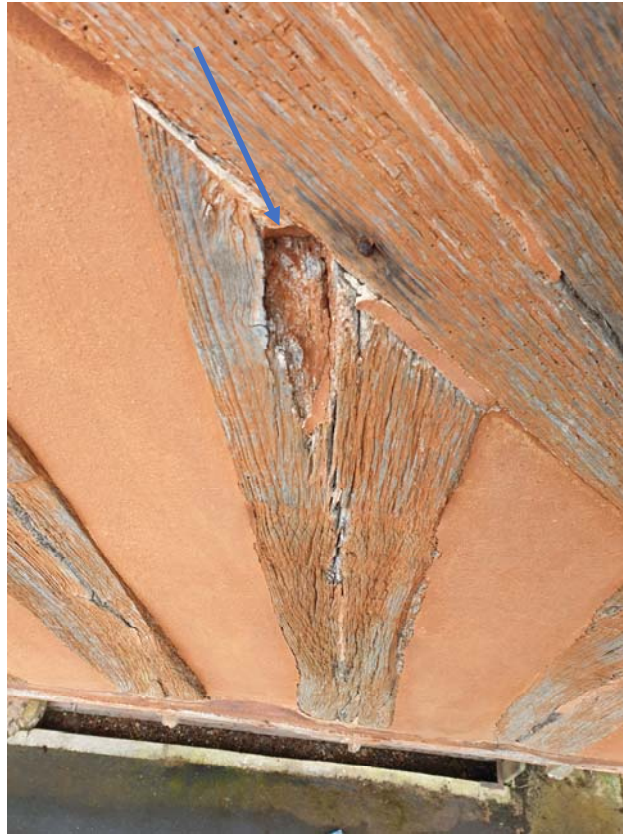
Photograph 29 – Decay noted to the exposed timber of the middle range

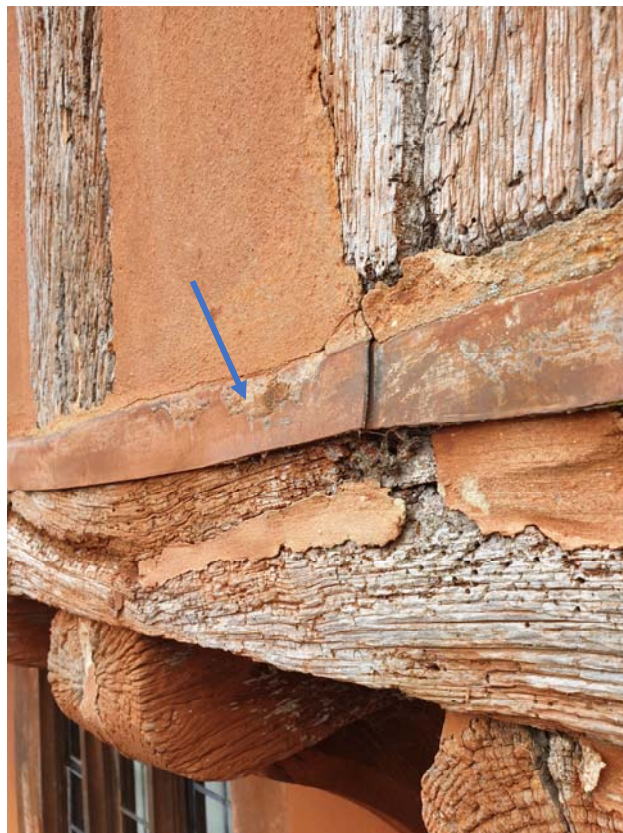
Photograph 30 – Lead flashings noted to the soleplates of the middle range

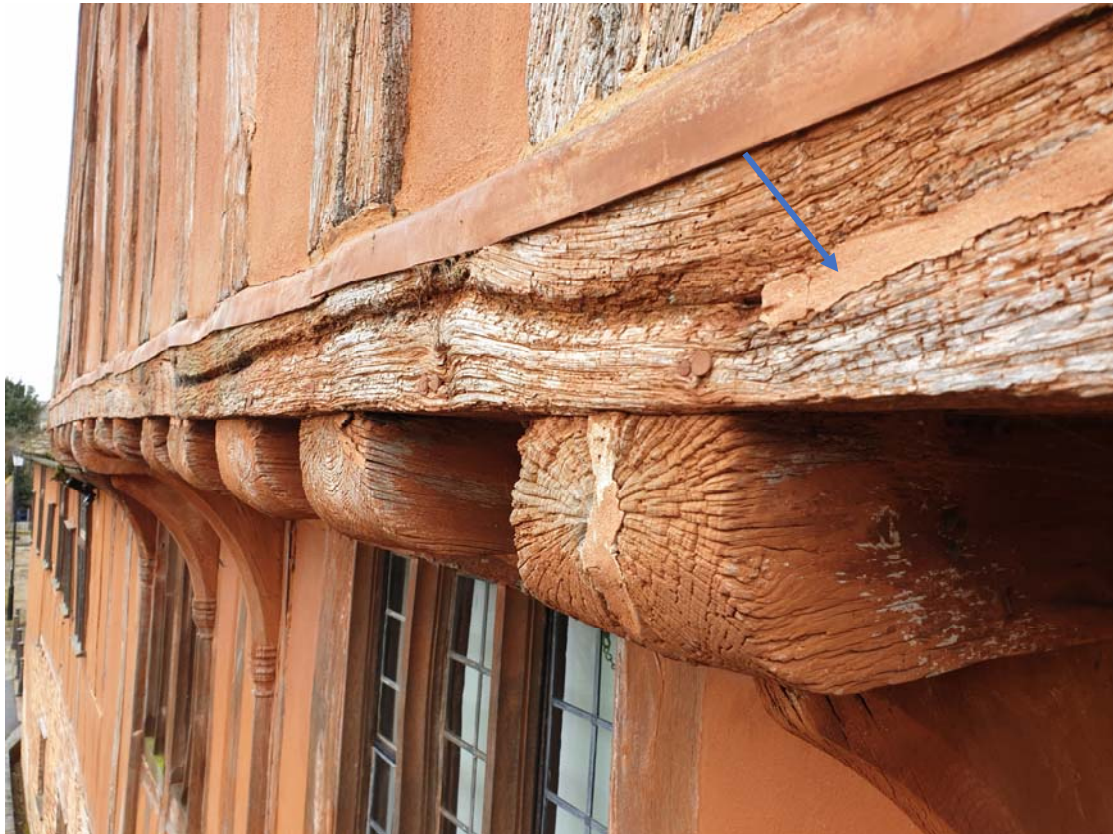
Photograph 31 – Plastic repairs to decayed soleplate of the middle range

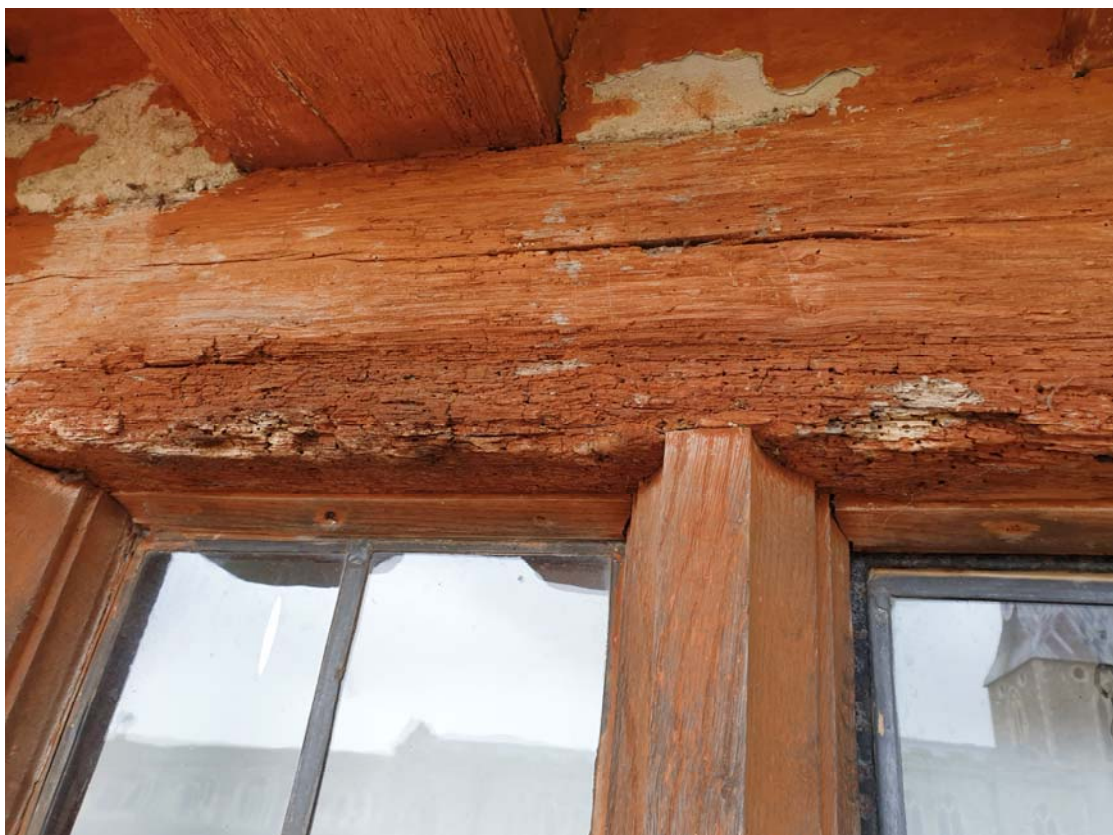
Photograph 32 – Rot noted to the 1st-floor central window of the middle range

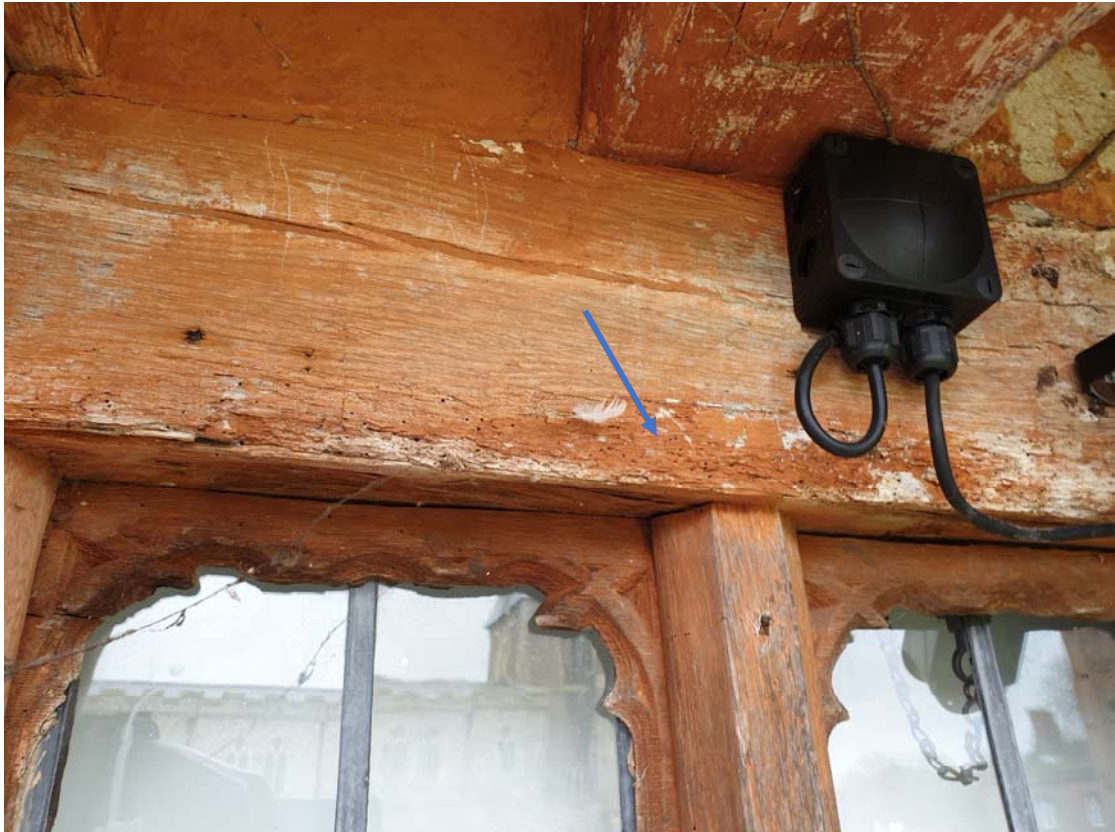
Photograph 33 – Local decay noted to the 1st floor west window of the middle range

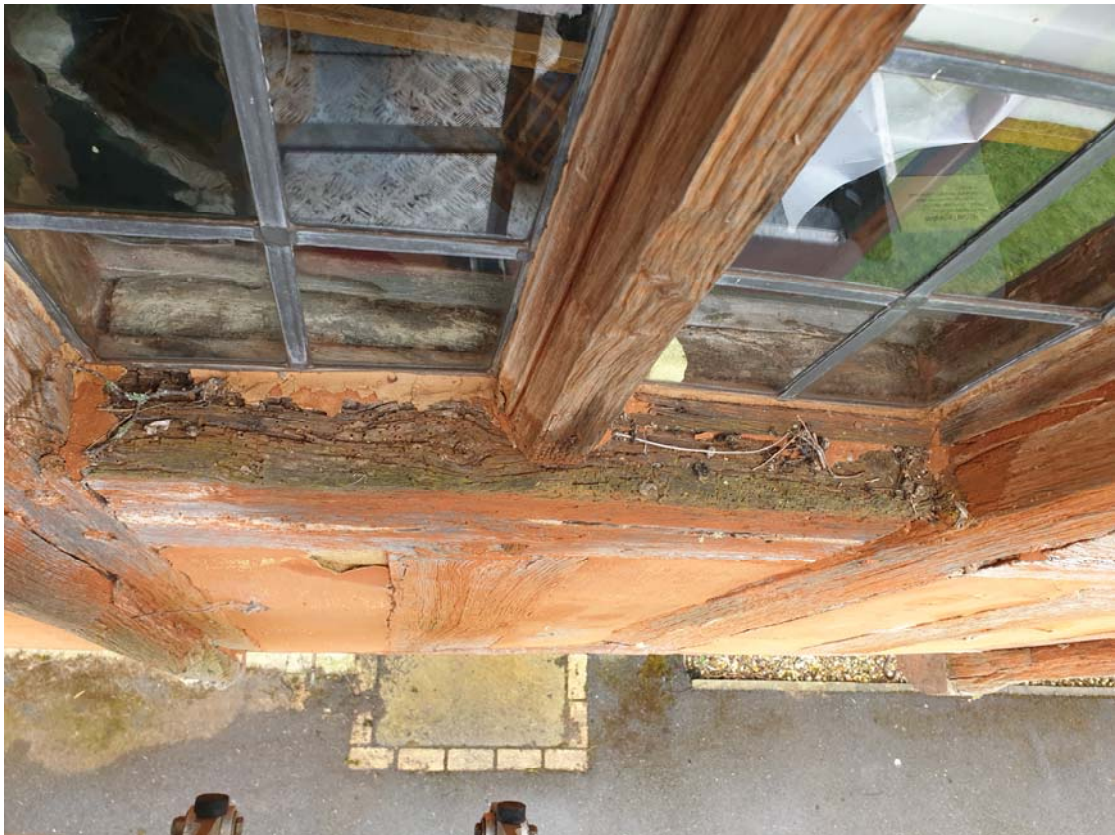
Photograph 34 – Decay noted to the sill of the 1st floor west window (middle range)

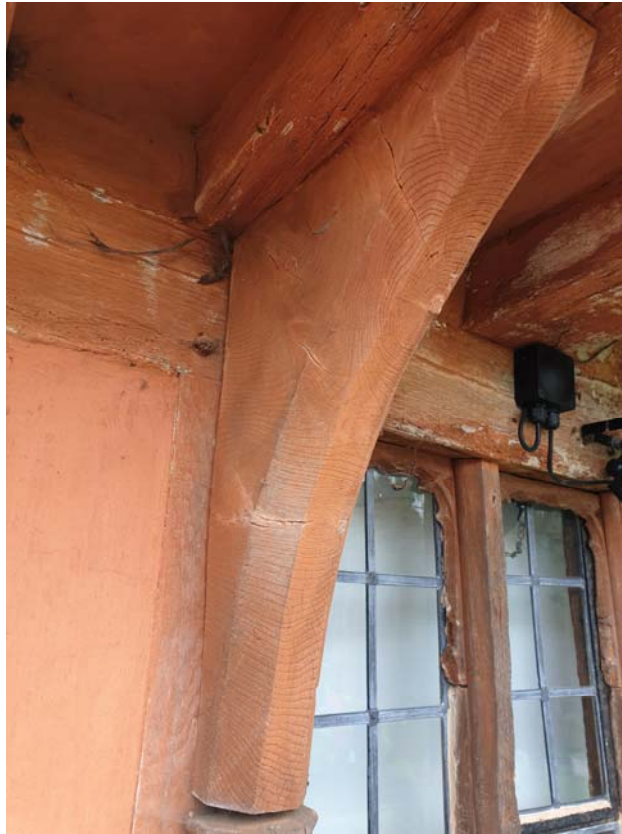
Photograph 35 – Jetty brackets generally found in good condition

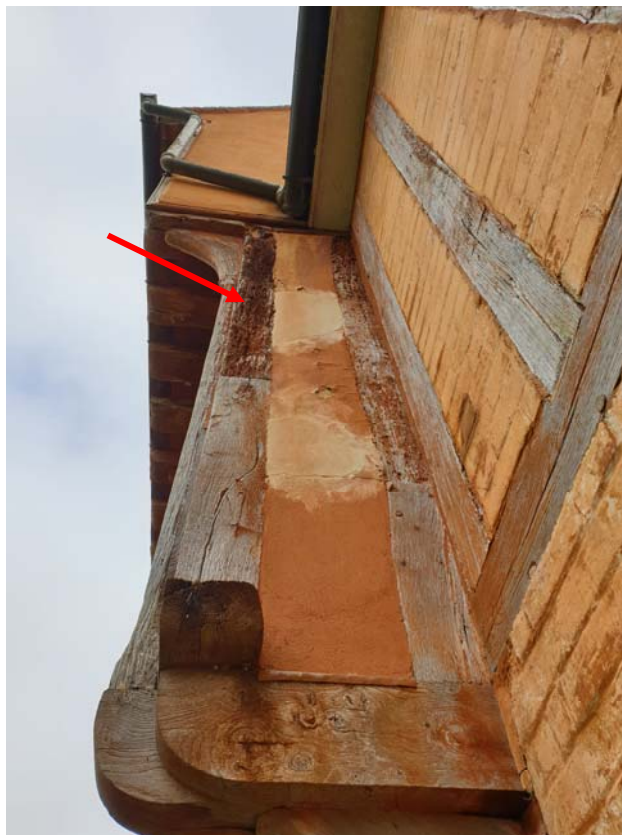
Photograph 36 – Decay noted to the north-west corner post of the middle range

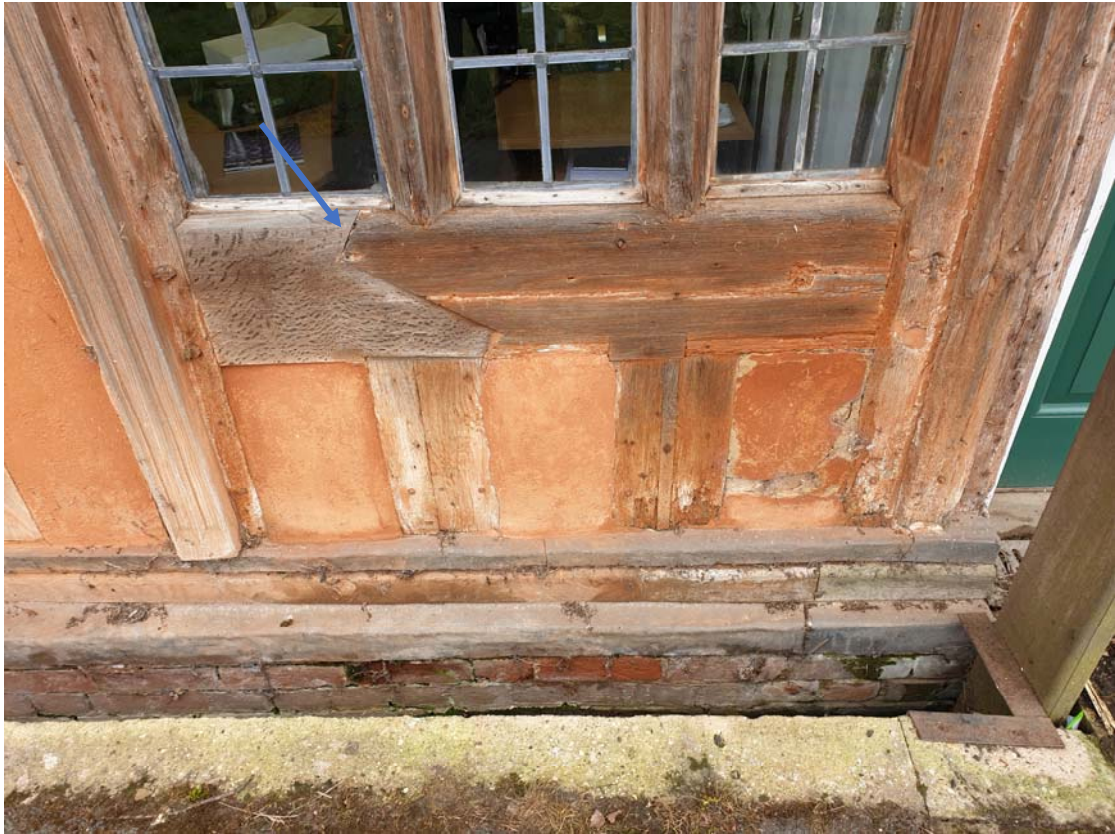
Photograph 37 – Scarf repair noted to the GF west window of the middle range

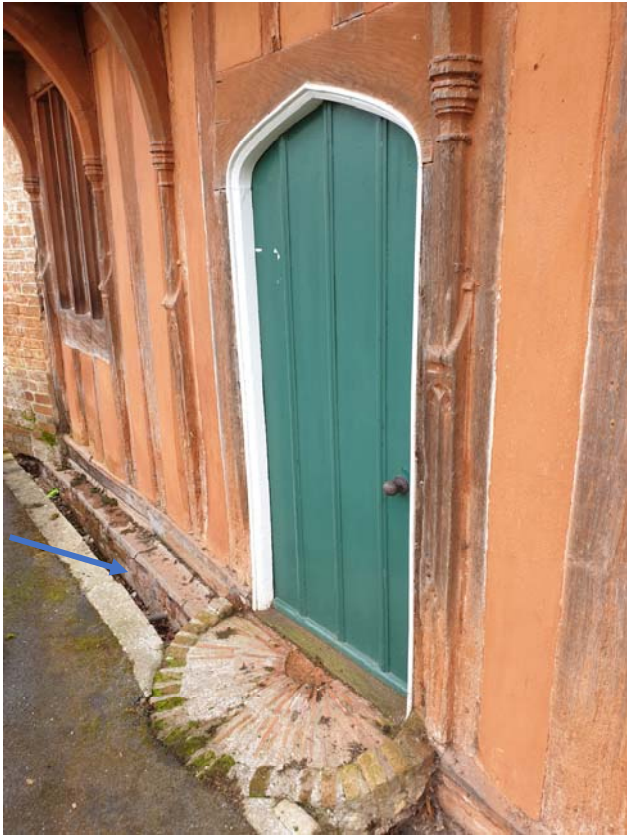
Photograph 38 – Existing ditch along the perimeter of the North elevation (middle range)

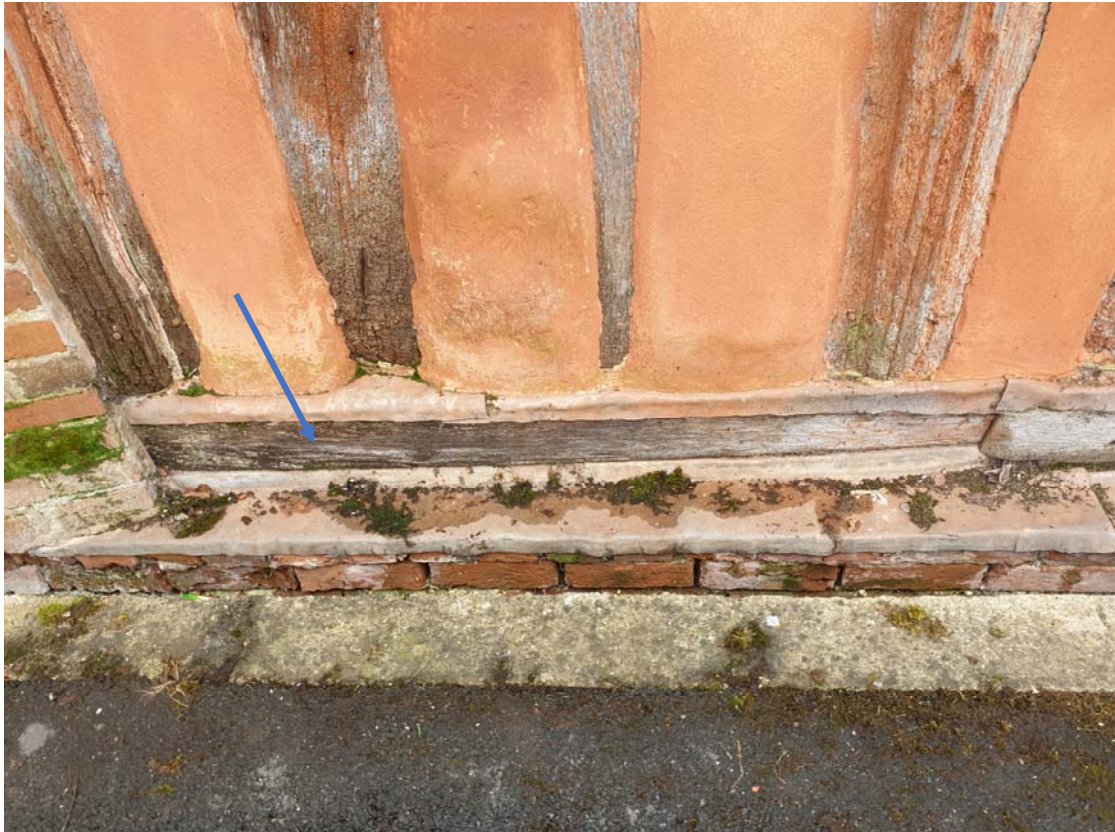
Photograph 39 – Dampness noted to the east end of the soleplate (middle range)

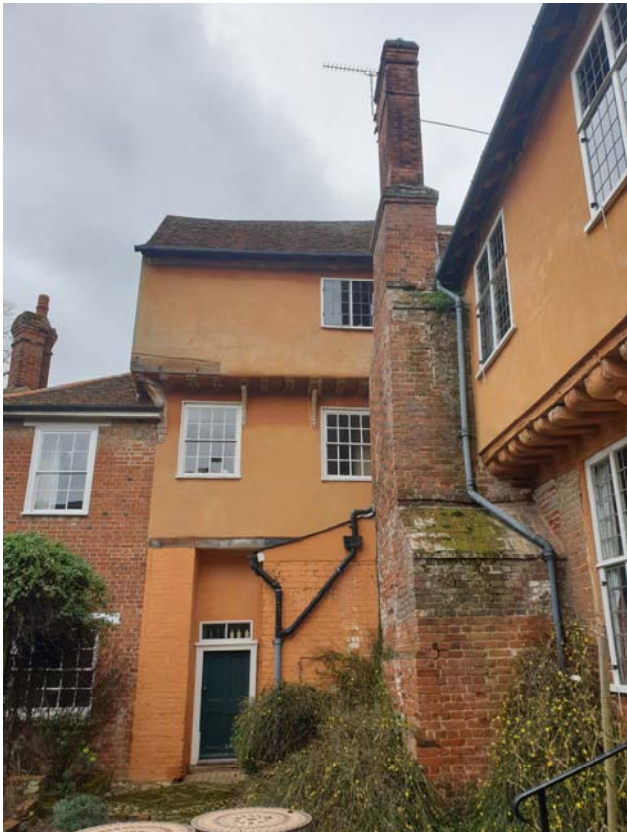
Photograph 40 – Part of the south elevation of the middle range, as seen from the courtyard

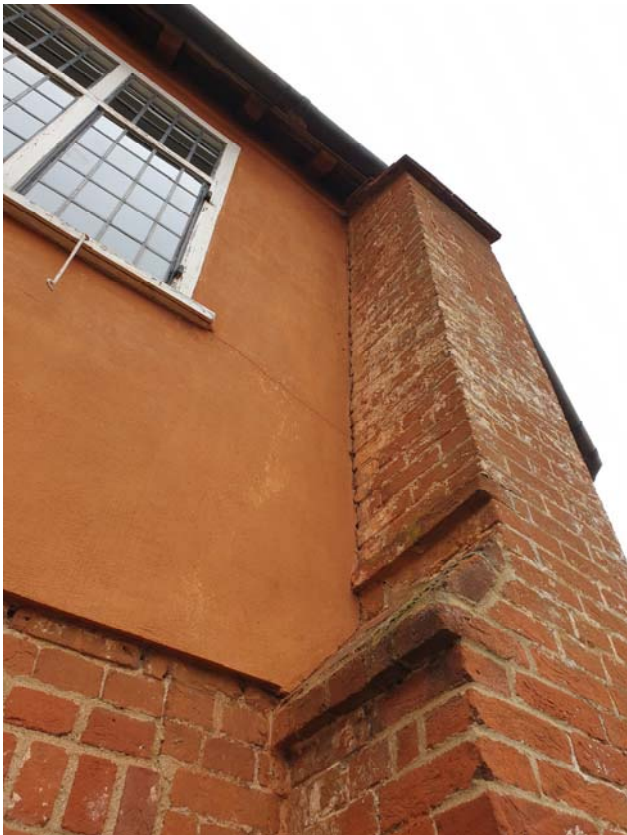
Photograph 46 – Movement noted to the buttress to the south elevation of the east wing

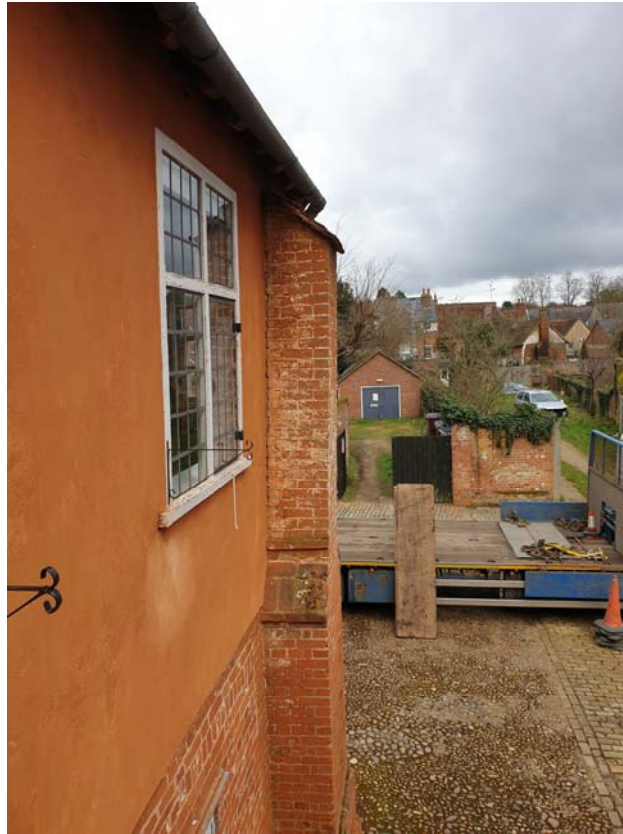
Photograph 47 – Out of plumb brickwork buttress to the south elevation of the east wing

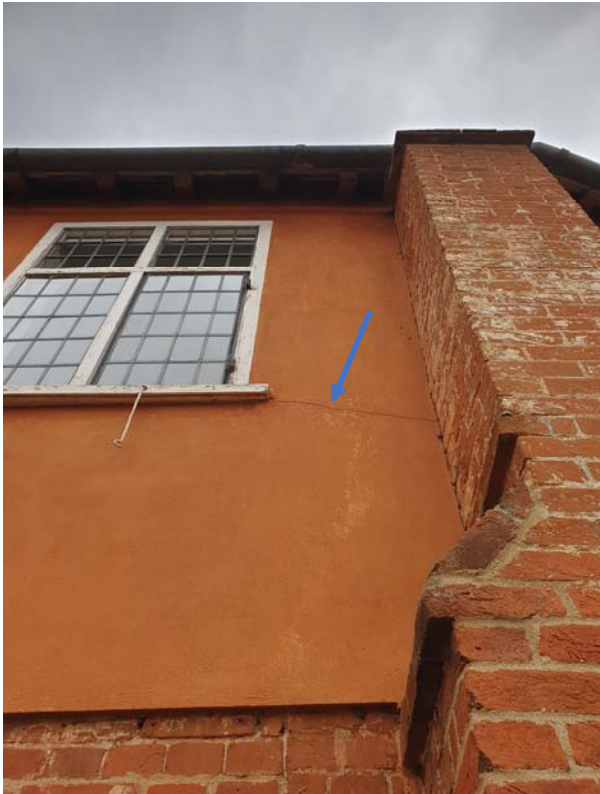
Photograph 49 – Diagonal cracking noted to the 1st-floor windows (south elevation of Market Hall's east wing)

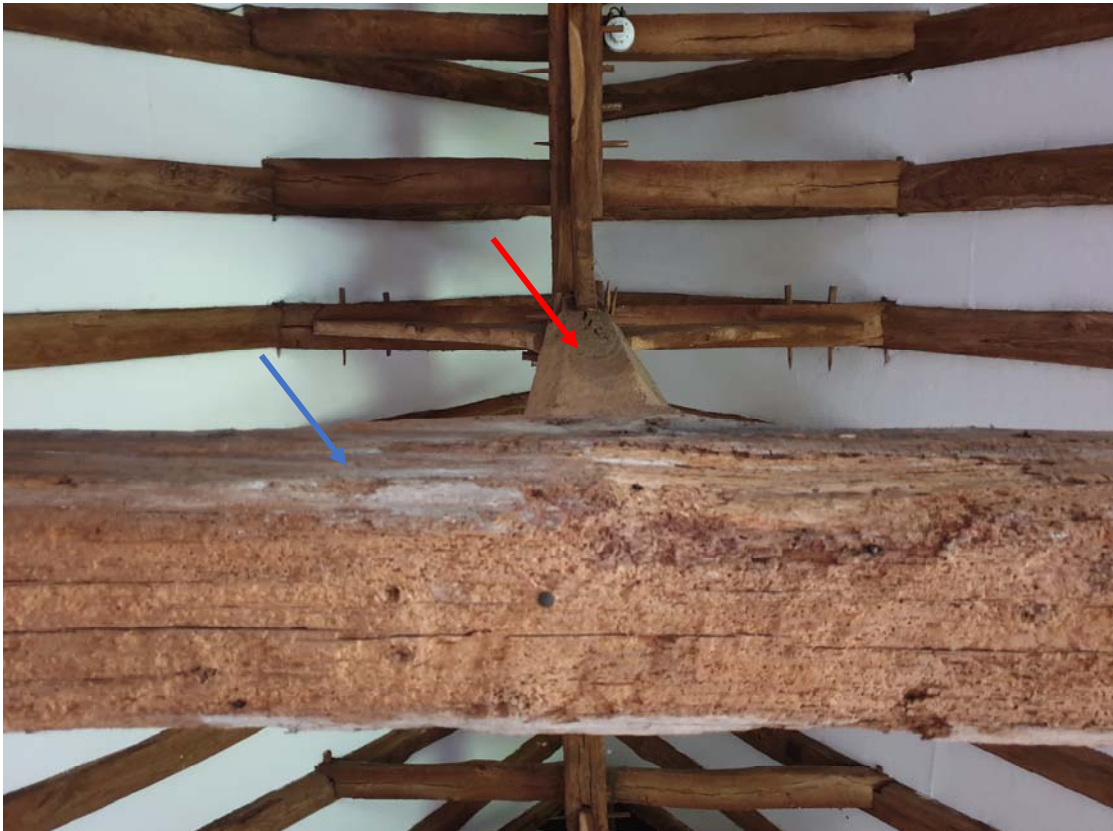
Photograph 50 – Crown-post (red) on timber tie-beam (blue) supporting the roof over Market Hall's middle range

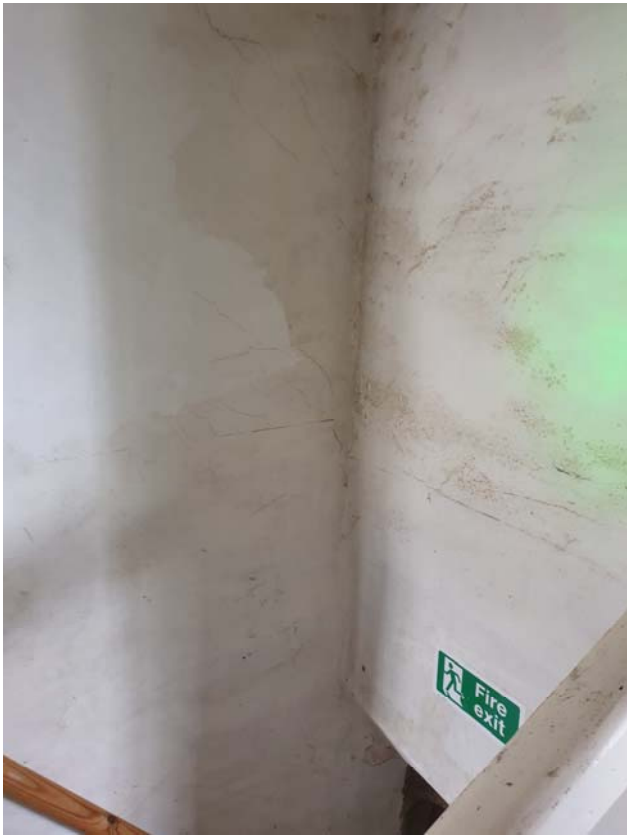
Photograph 54 – Live plaster noted in room 'C2'

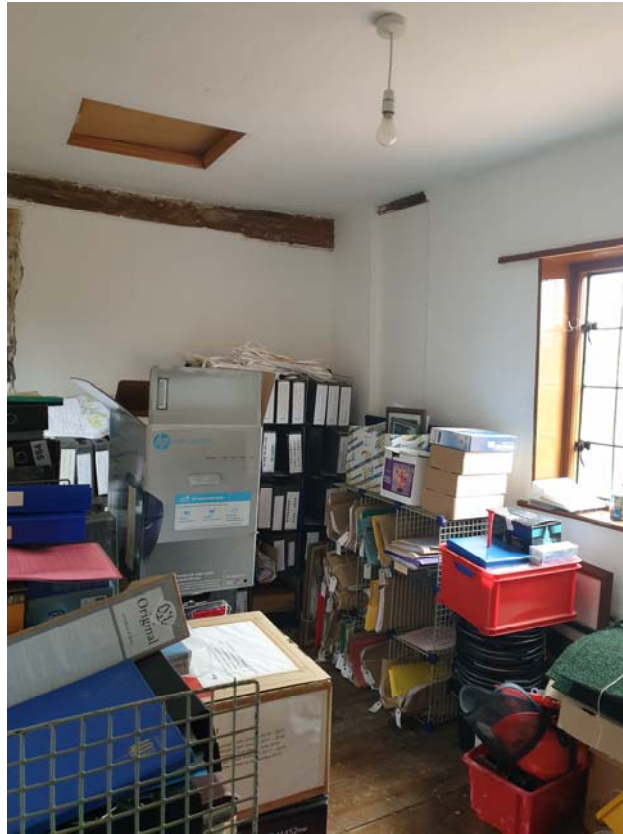
Photograph 55 – Storage area at the 2nd floor of Market Hall's middle range

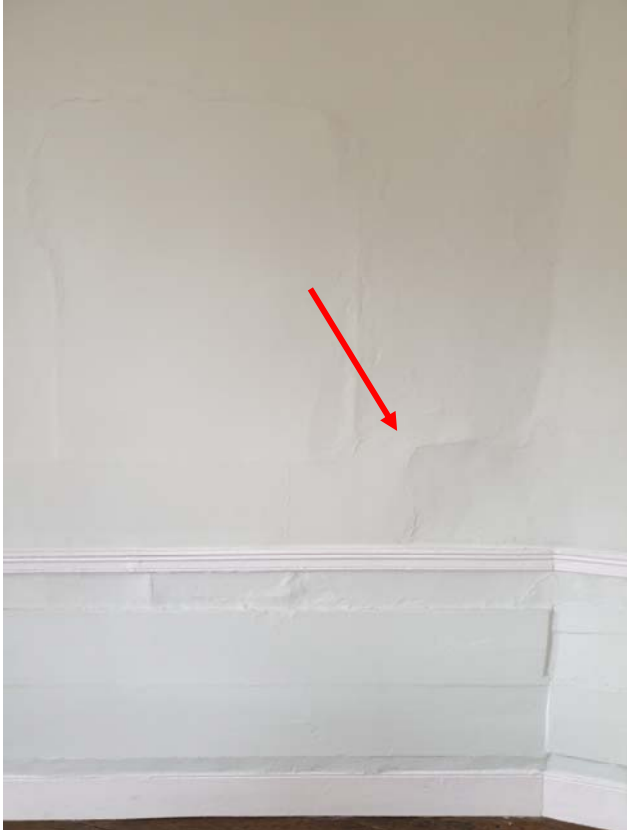
Photograph 65 – Live plaster to the walls noted in 'R1'

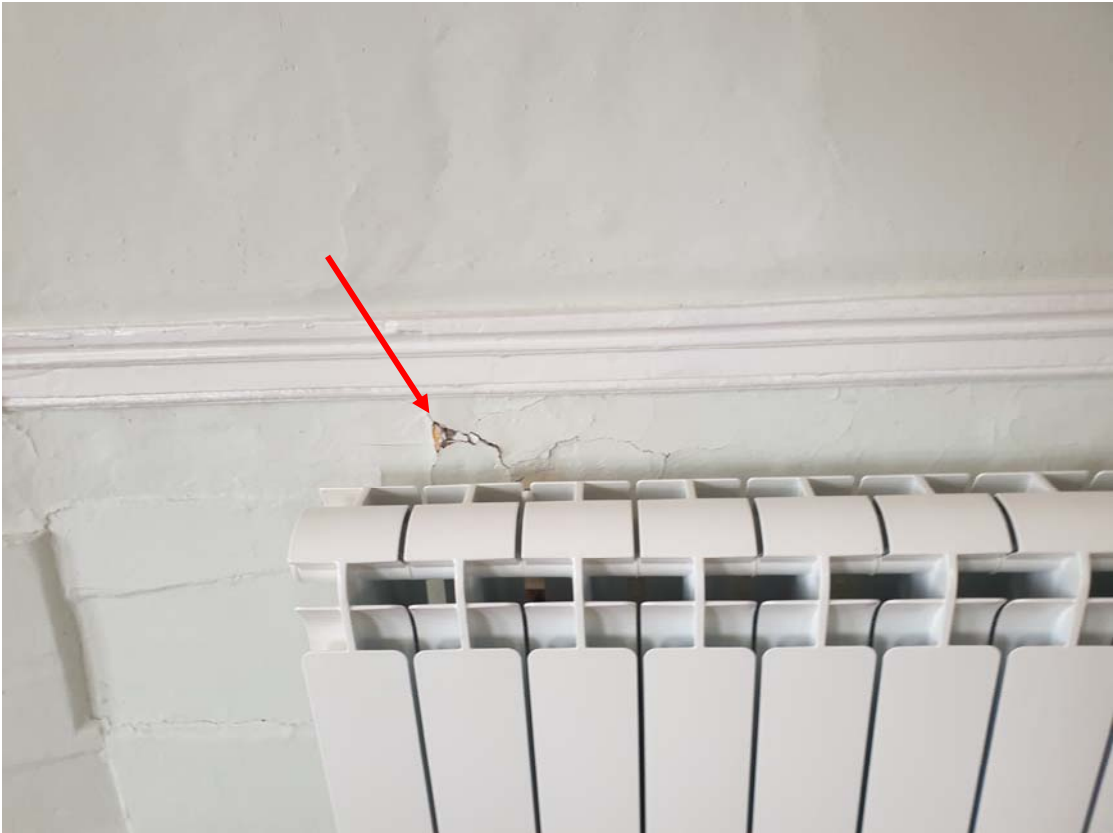
Photograph 66 - Live plaster to the walls noted in 'R1'
