**CONDITION ASSESSMENT REPORT
OF
HADLEIGH GUILDHALL
HADLEIGH
SUFFOLK**

Client: Hadleigh Town Council
The Guildhall
Hadleigh
Suffolk IP7 5DN

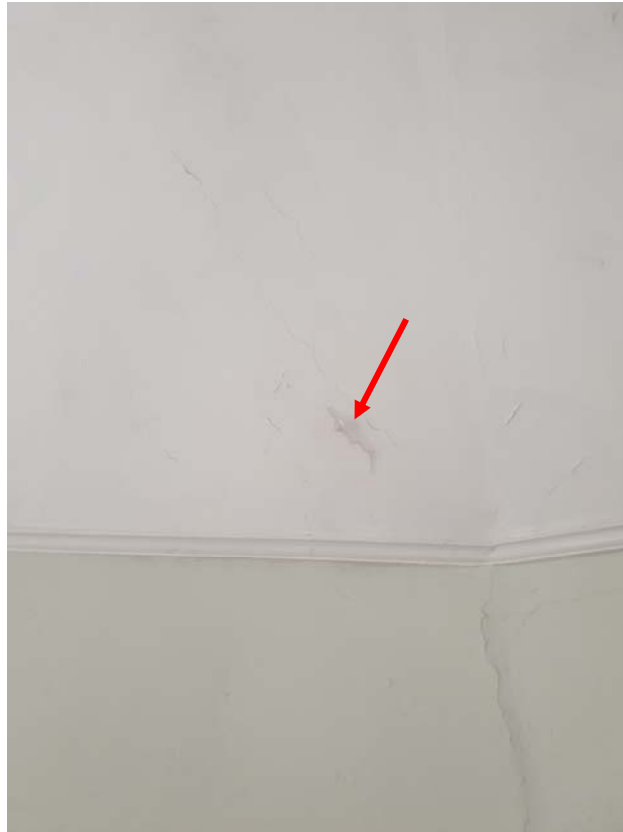
Photograph 67 – Paint flaking off at ceiling level noted in 'R1' (east end)

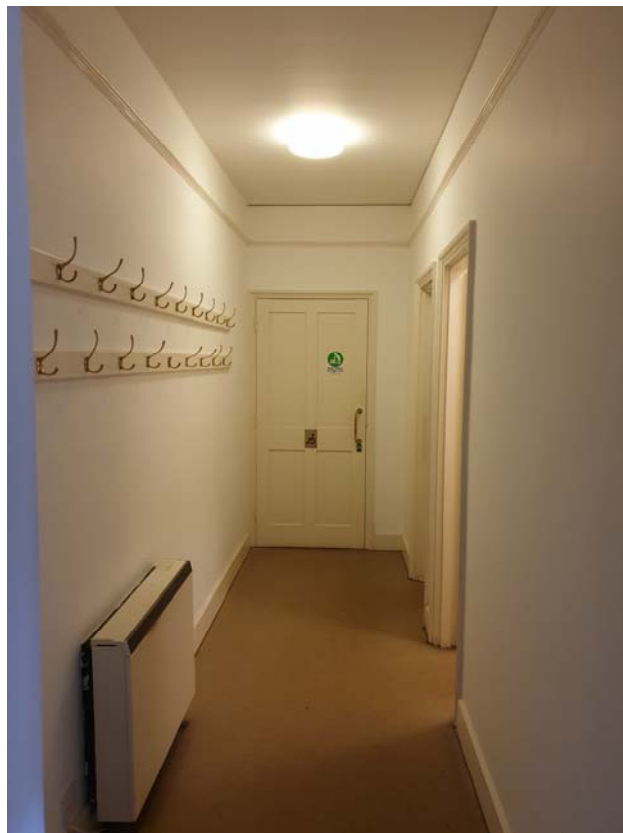
Photograph 68 – Recently re-decorated hallway ('C16')

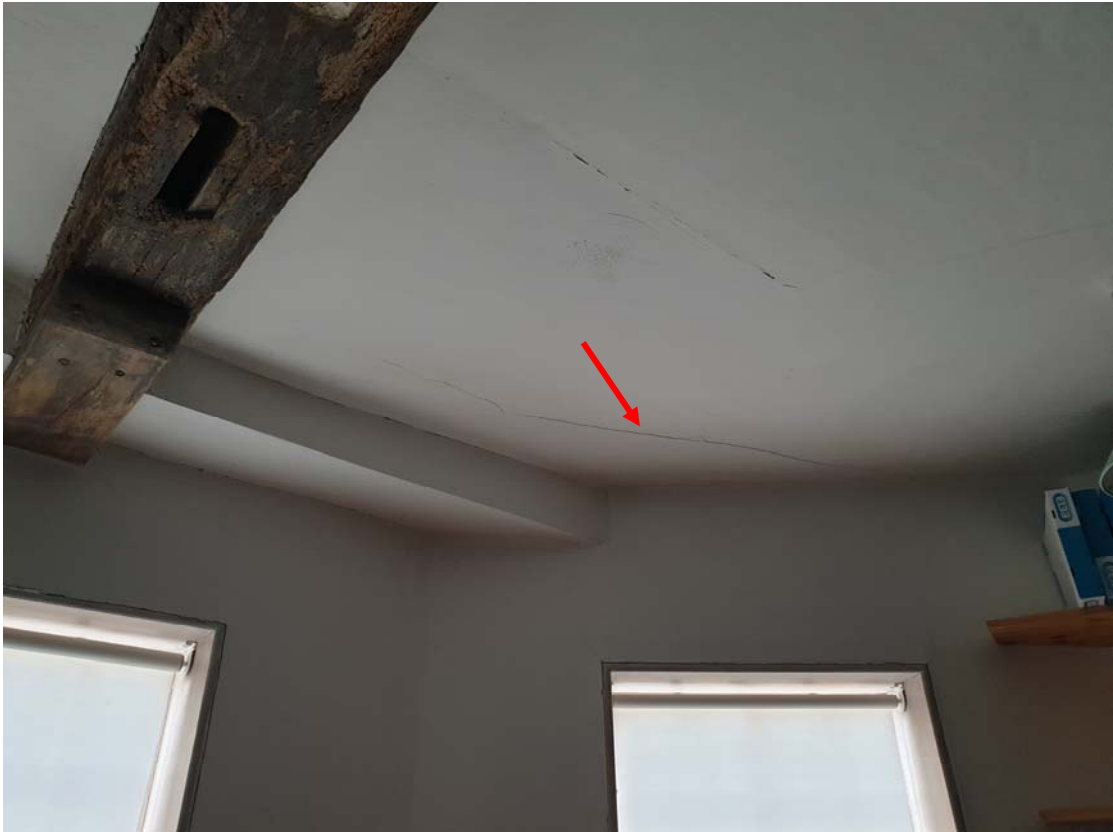
Photograph 73 – Cracks in the ceiling over 'R6' (east end)

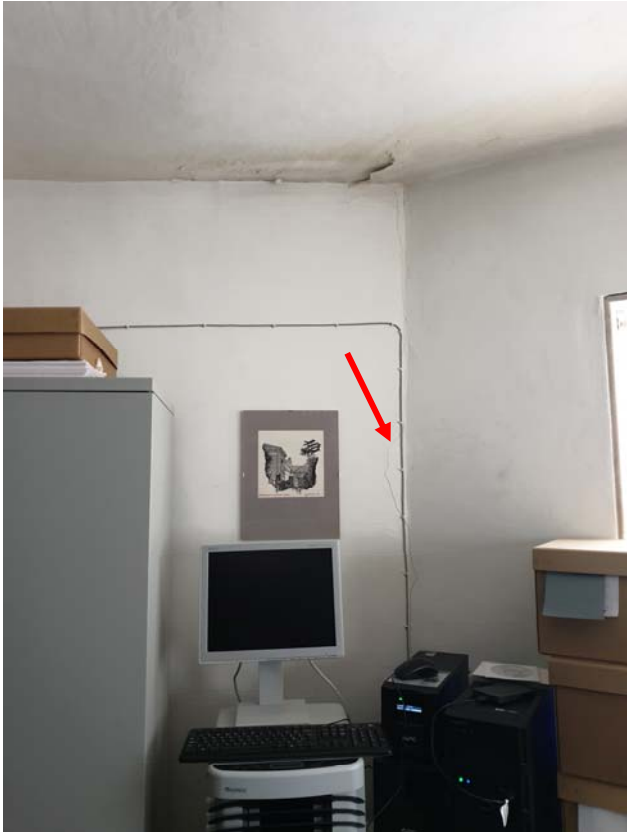
Photograph 74 – Fine crack to the junction of two faces of the brick apse within 'R6' (north side)

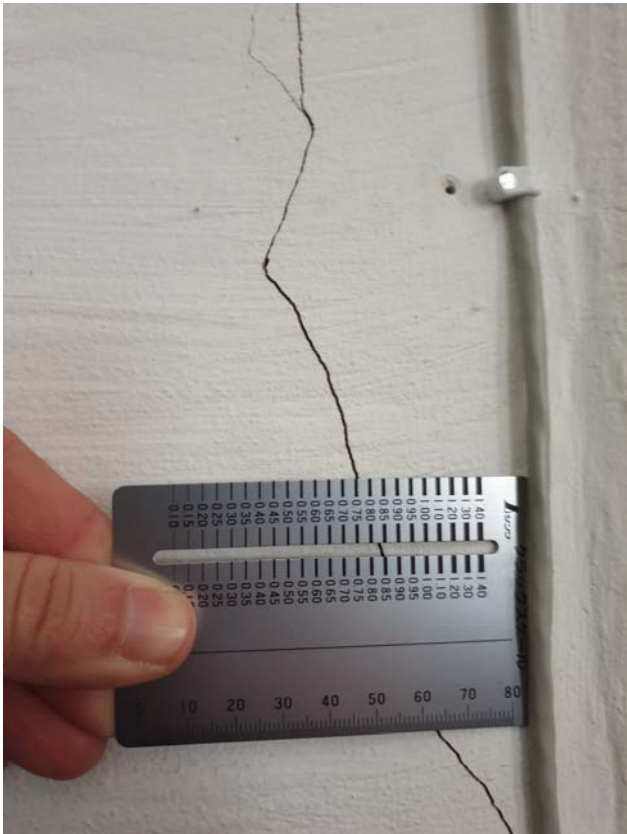
Photograph 75 - Fine crack to the junction of two faces of the brick apse within 'R6' (north side)

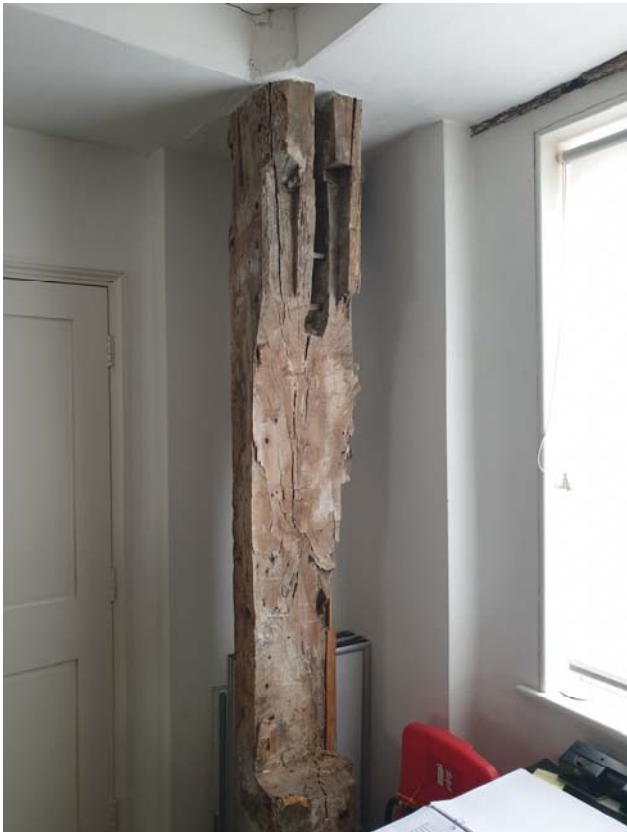
Photograph 76 – Original timber-frame post in 'R7'

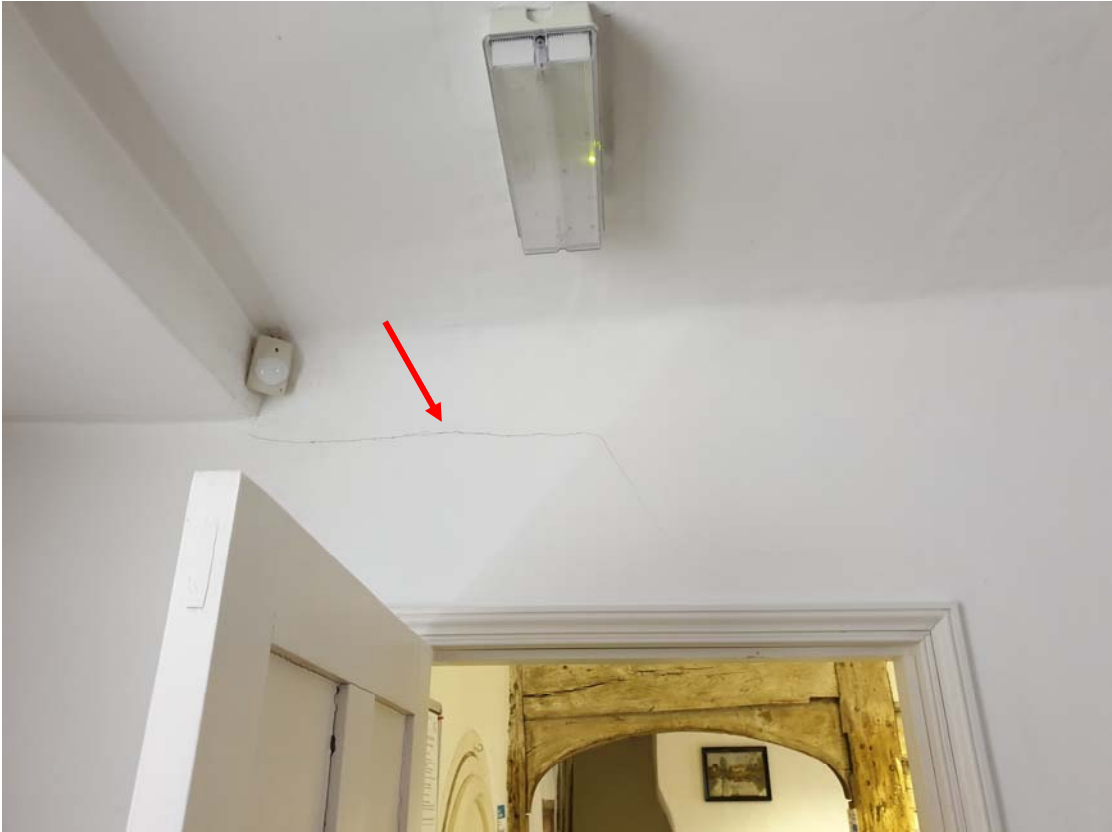
Photograph 77 – Horizontal hair-line crack noted in 'R7', above the door leading to 'R8'

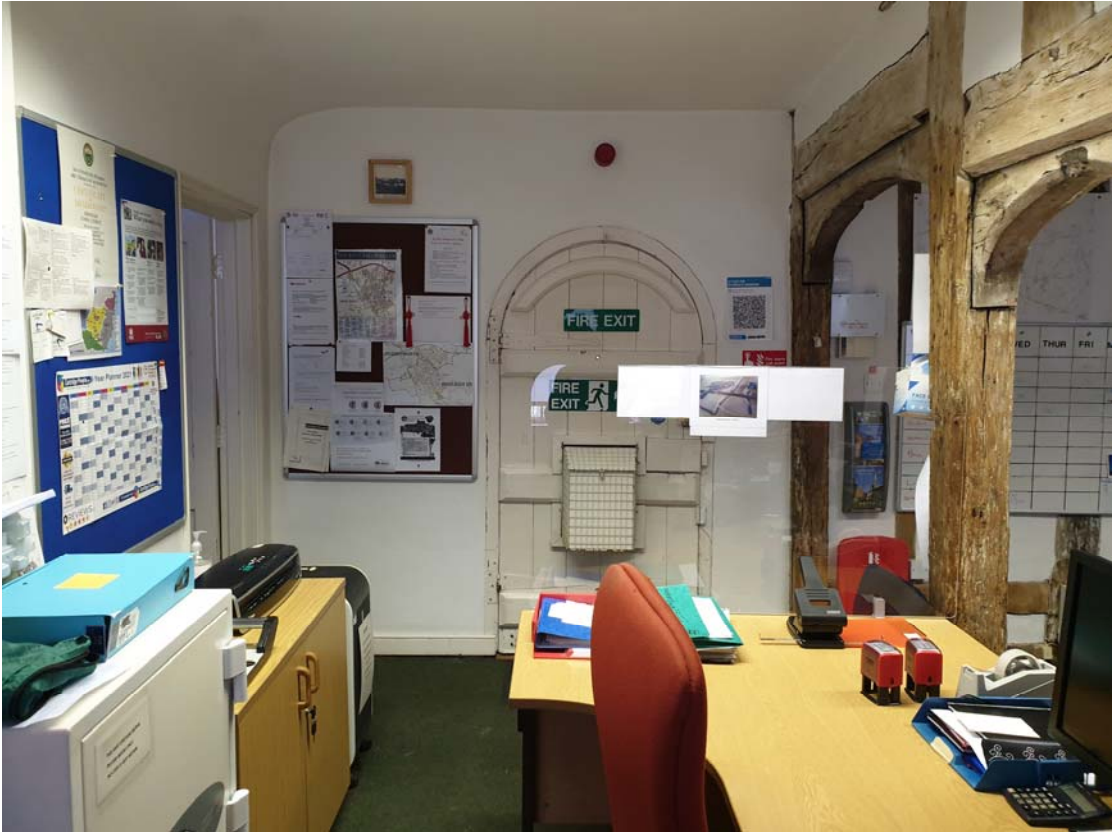
Photograph 78 – Room 'R8' looking south

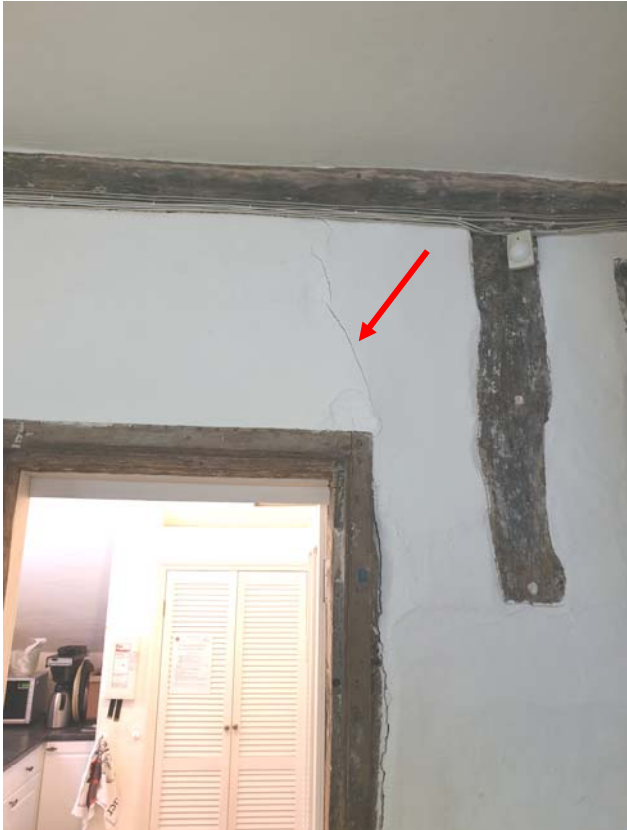
Photograph 80 – Live plaster and cracking noted above the door leading to 'R10'

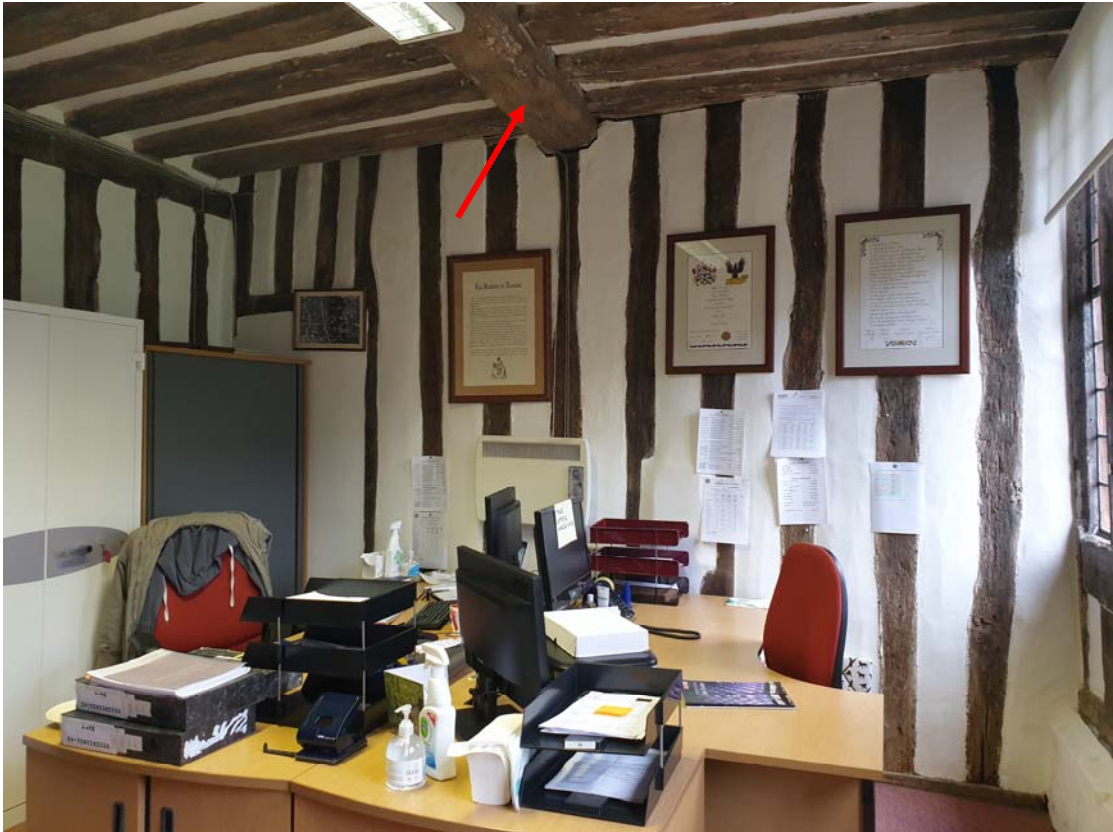
Photograph 81 – Room 'R11' and beam over

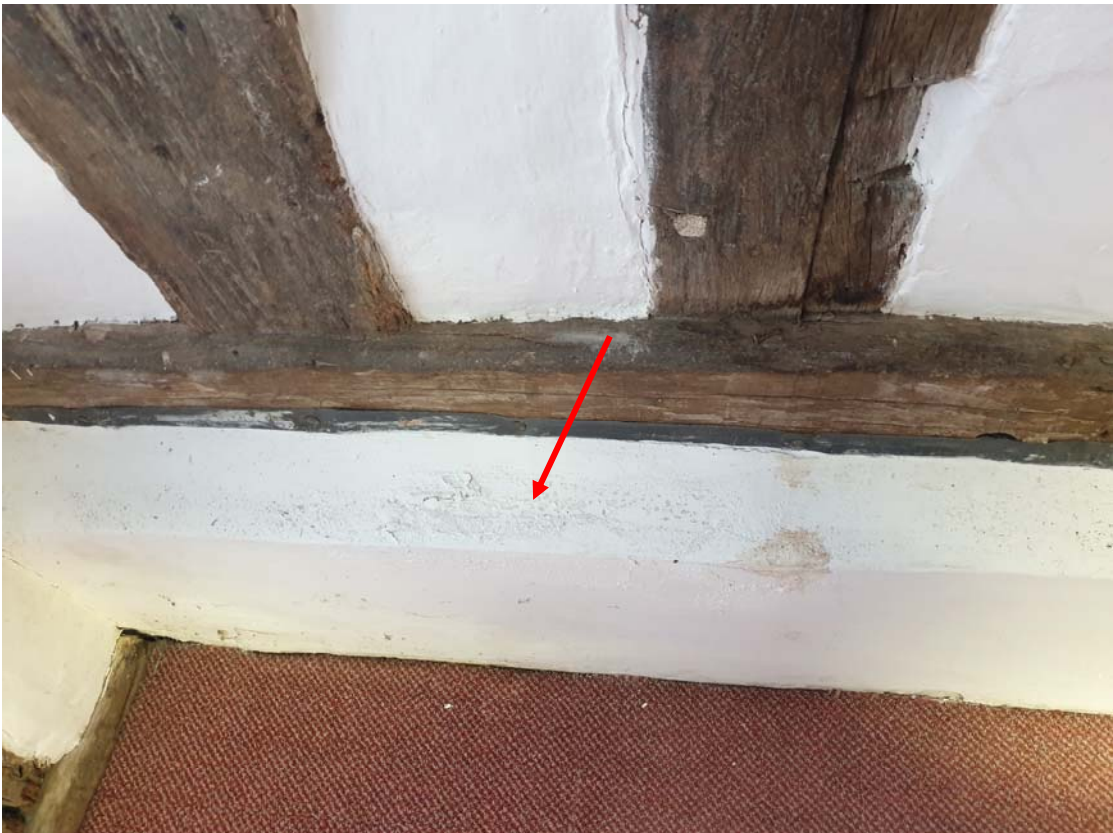
Photograph 82 – Dampness noted to the soleplate within room 'R11'

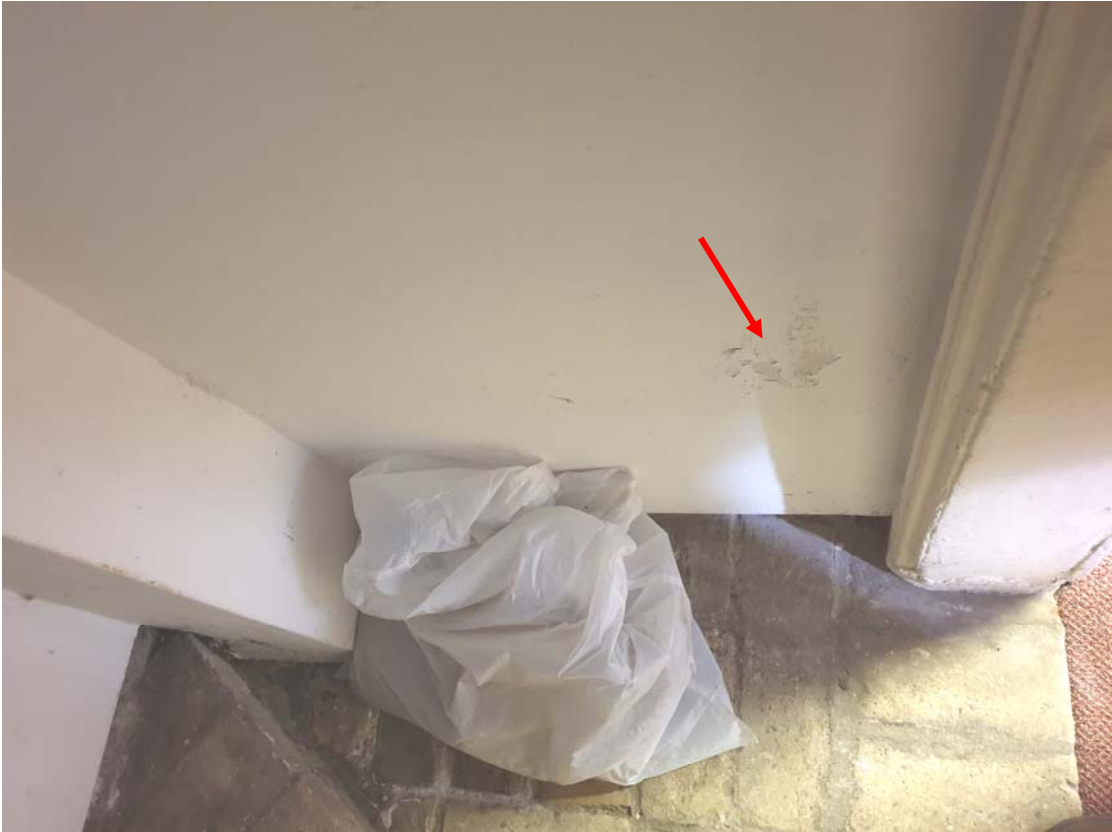
Photograph 83 – Poor decoration noted in the hallway leading to St. Mary’s Church

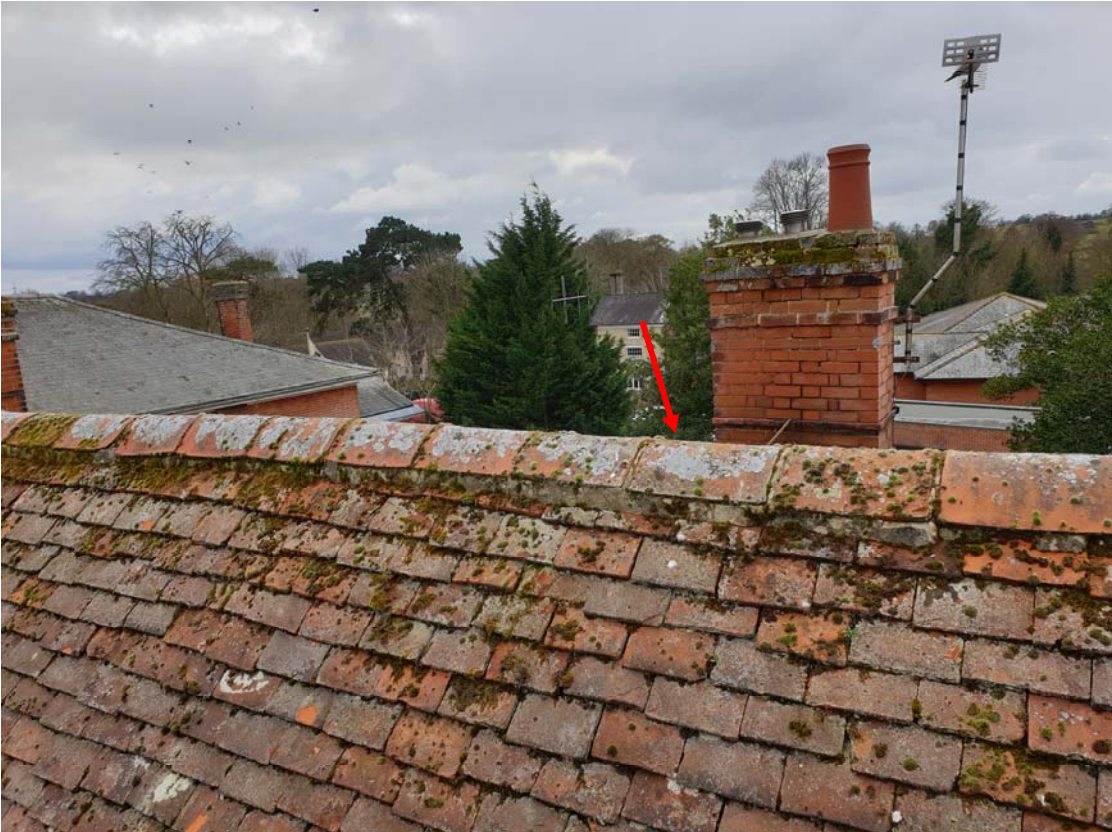
Photograph 84 – Undulations noted to the ridge beam over the Old Town Hall

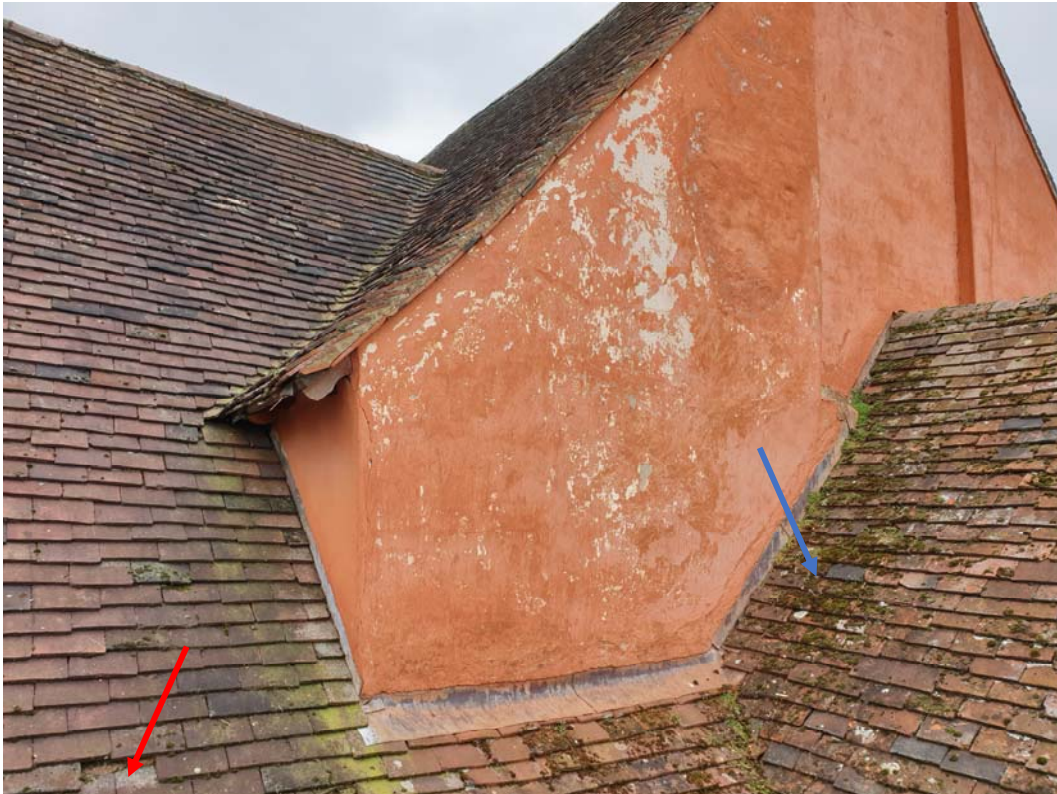
Photograph 85 – Moss vegetation (blue) and broken tiles (red) noted to the roof over the Old Town Hall

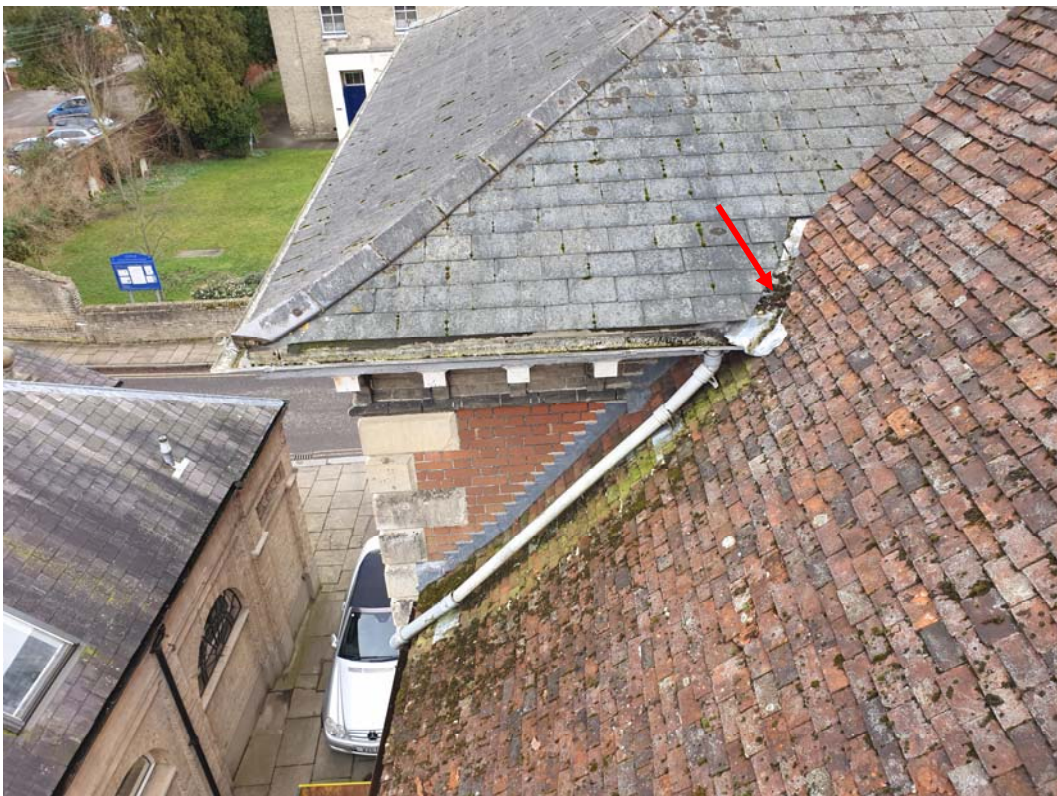
Photograph 86 – Moss build-up partially blocking the valley gutter at the junction between the Old Town Hall and New Town Hall

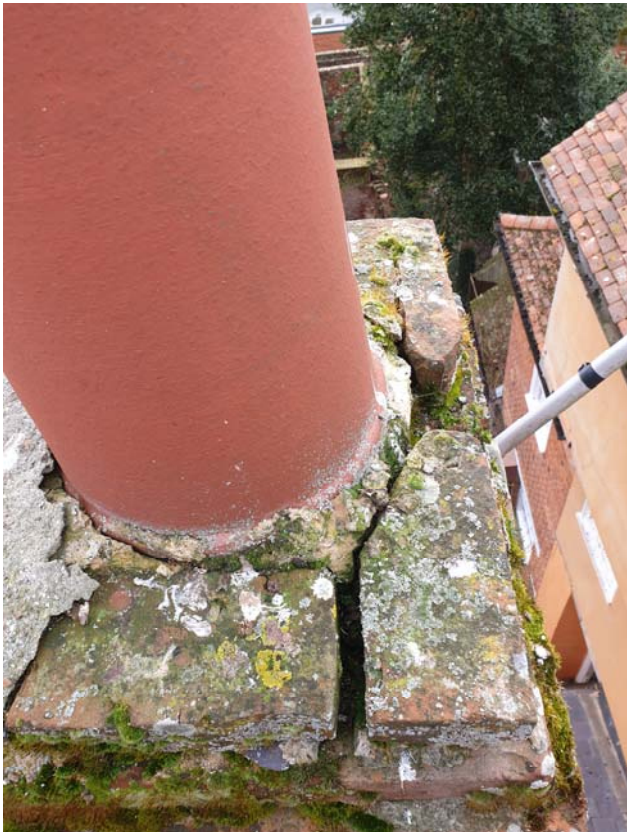
Photograph 88 – Damaged / missing flaunching to the north chimney of the Old Town Hall

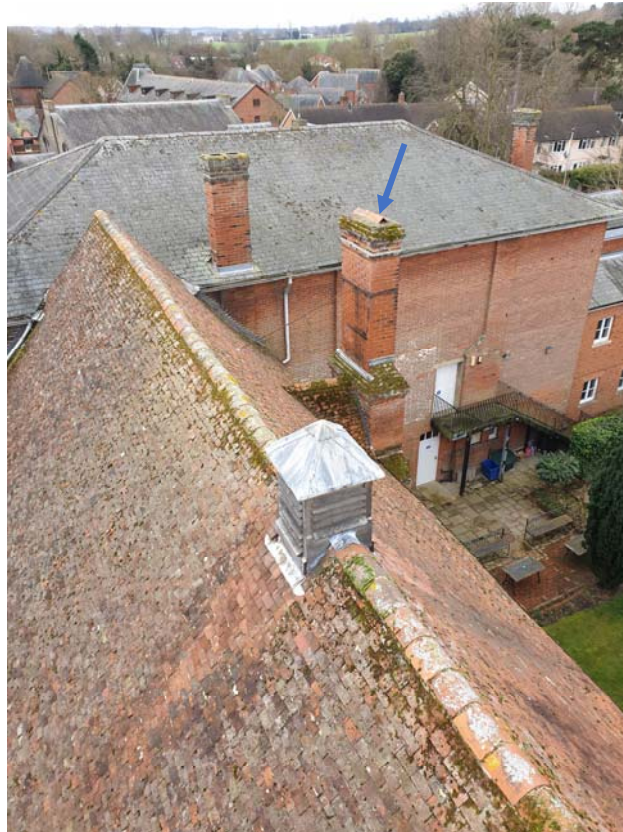
Photograph 89 - South chimney of the Old Town Hall

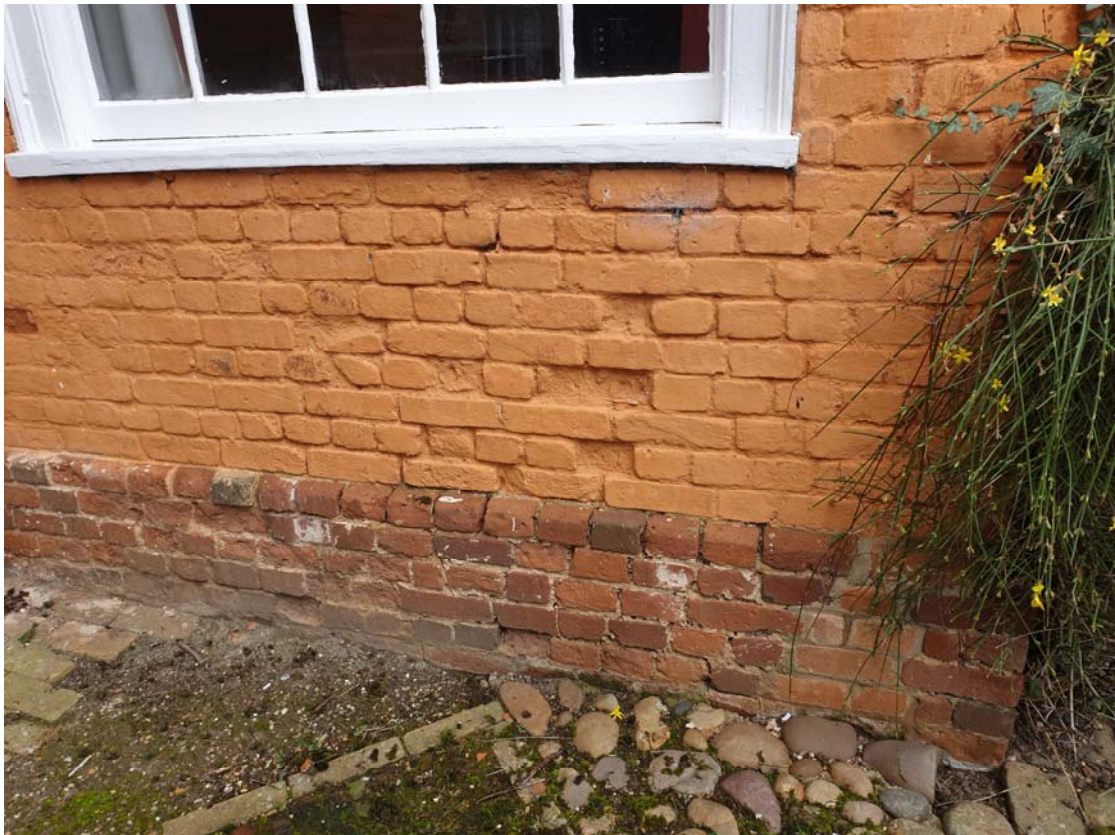
Photograph 92 – Delaminated bricks and eroded mortar joints noted to the north end of Old Town Hall's west elevation

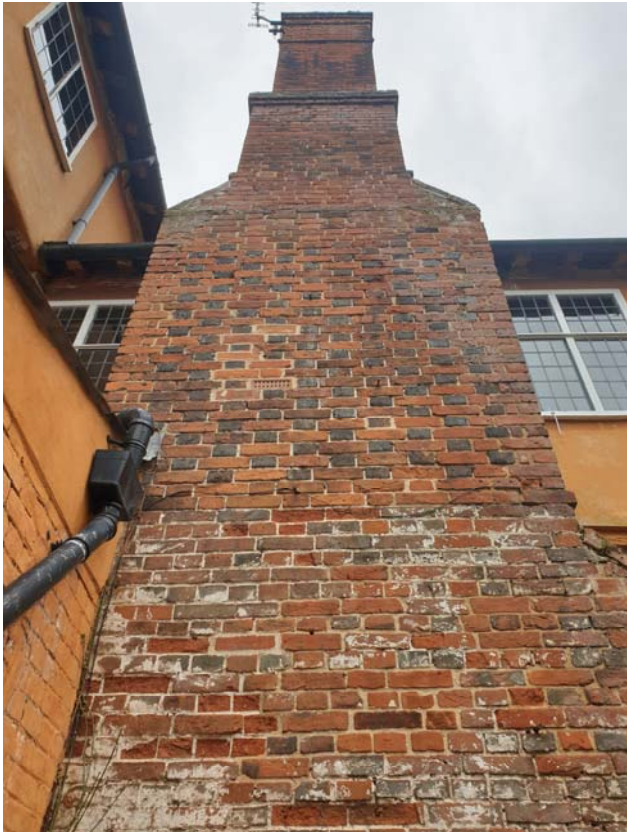
Photograph 93 – West elevation of the Old Town Hall's north chimney

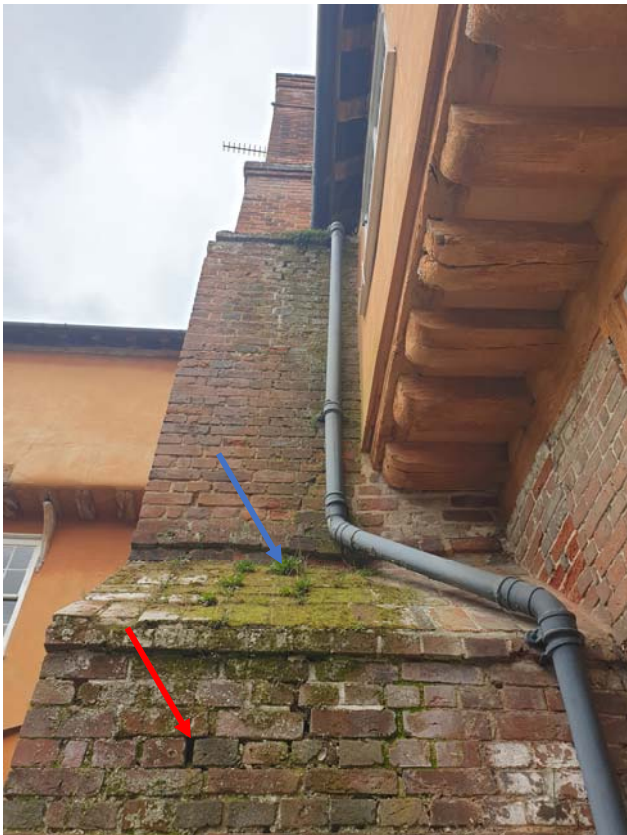
Photograph 94 – Moss vegetation (blue) and eroded mortar joints (red) noted to the Old Town Hall's North chimney (south elevation)

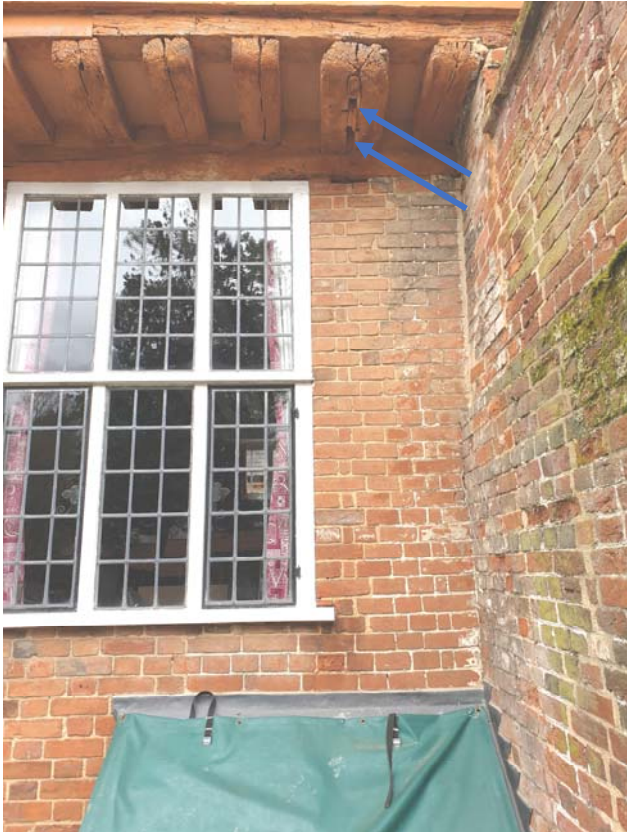
Photograph 95 – Historic mortices indicating a different structural arrangement

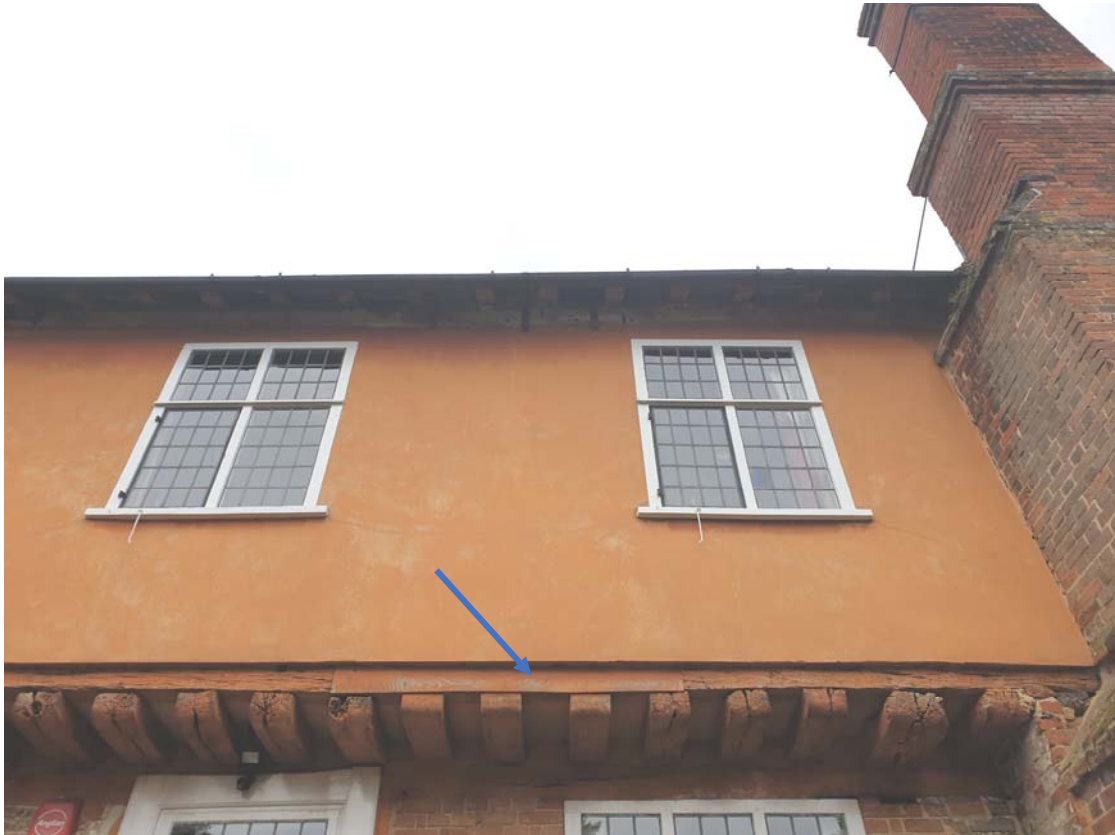
Photograph 96 – Repair to the soleplate of the Old Town Hall's 1st-floor wall (west elevation)

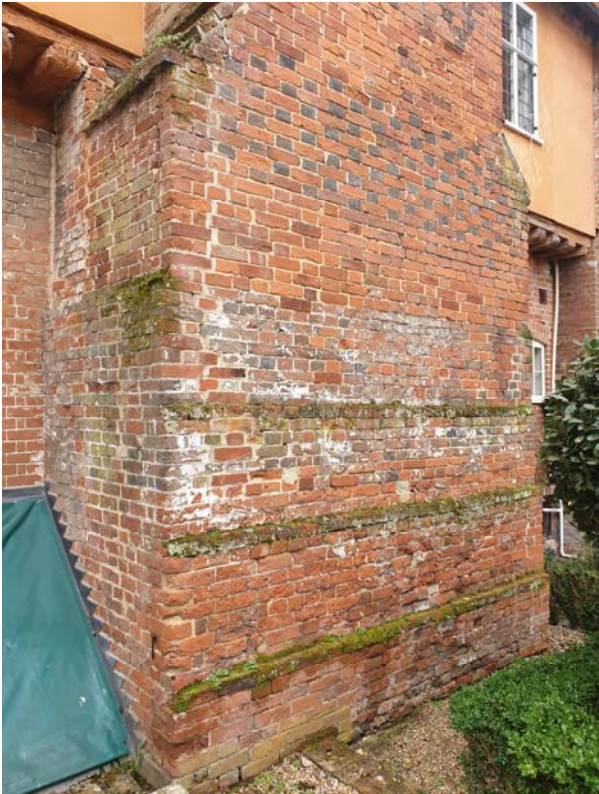
Photograph 97 – Few spalling bricks and moss vegetation noted to the base of the south chimney (Old Town Hall)

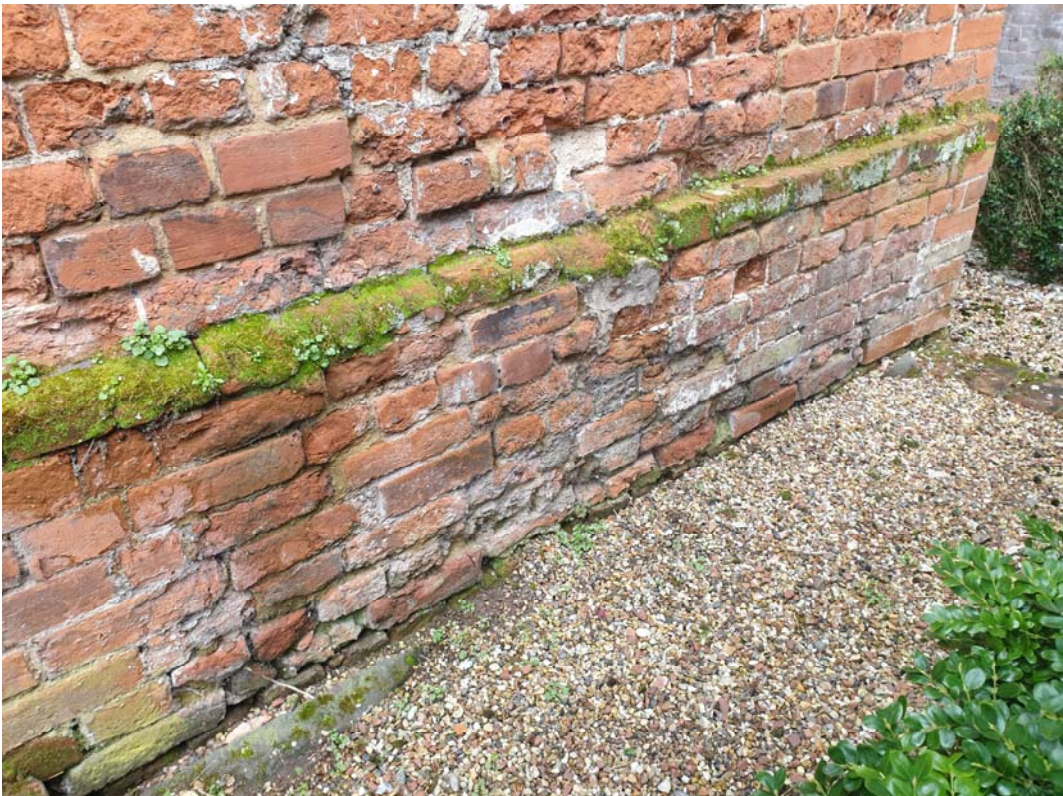
Photograph 98 - Few spalling bricks and moss vegetation noted to the base of the south chimney (Old Town Hall)

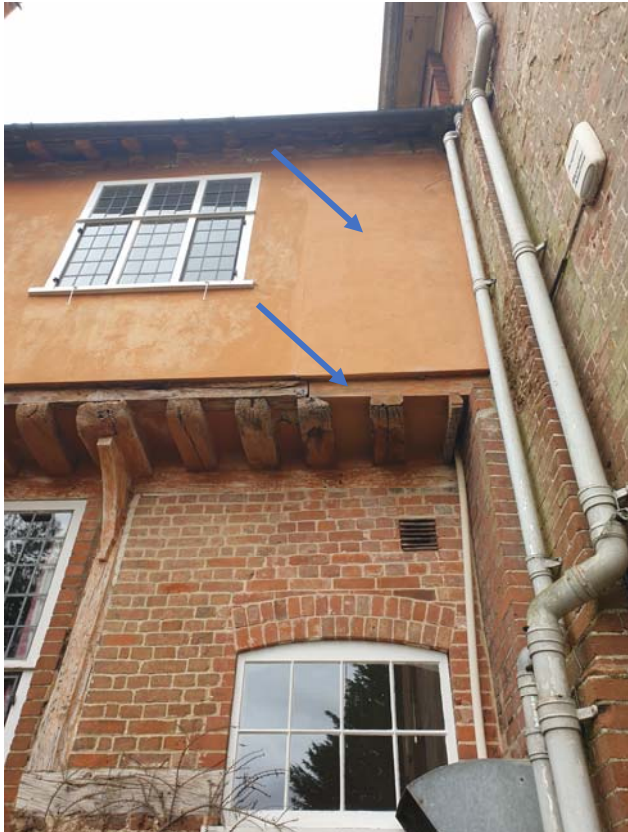
Photograph 99 – Sole plate repair and different nuance in the render to the south end of Old Town Hall’s west elevation

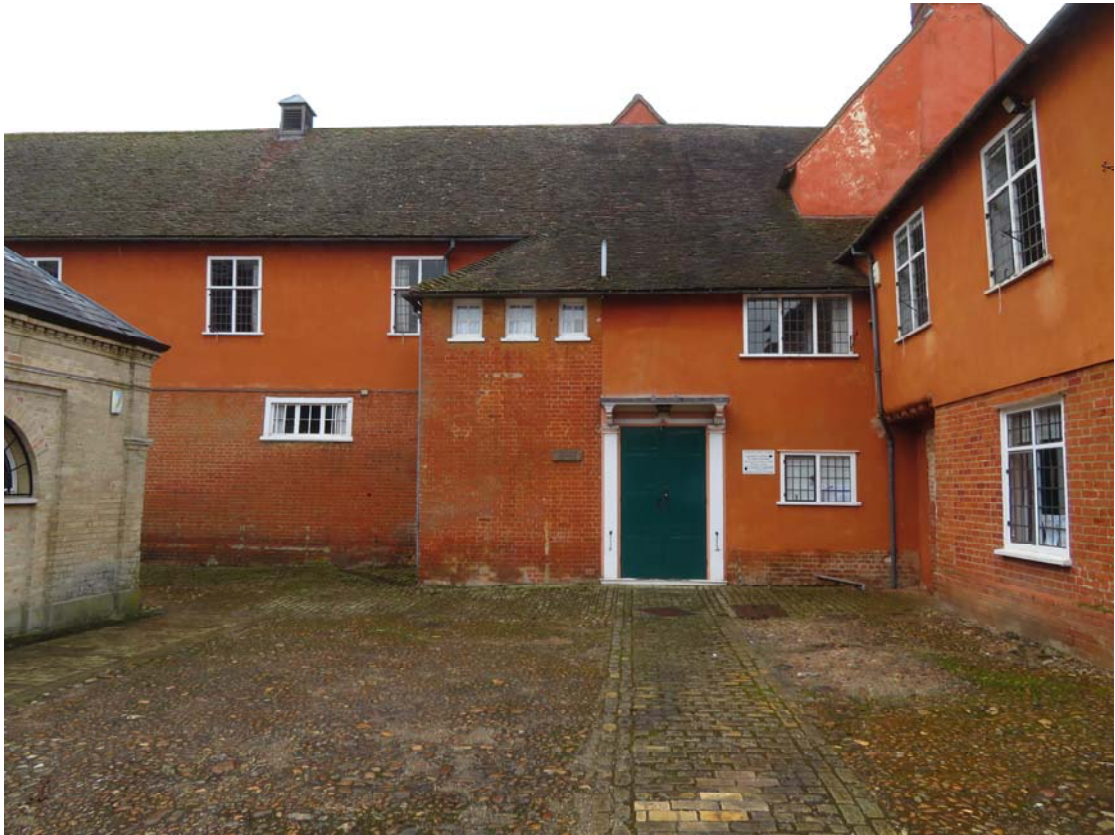
Photograph 100 – Main access into the Guildhall (east elevation)

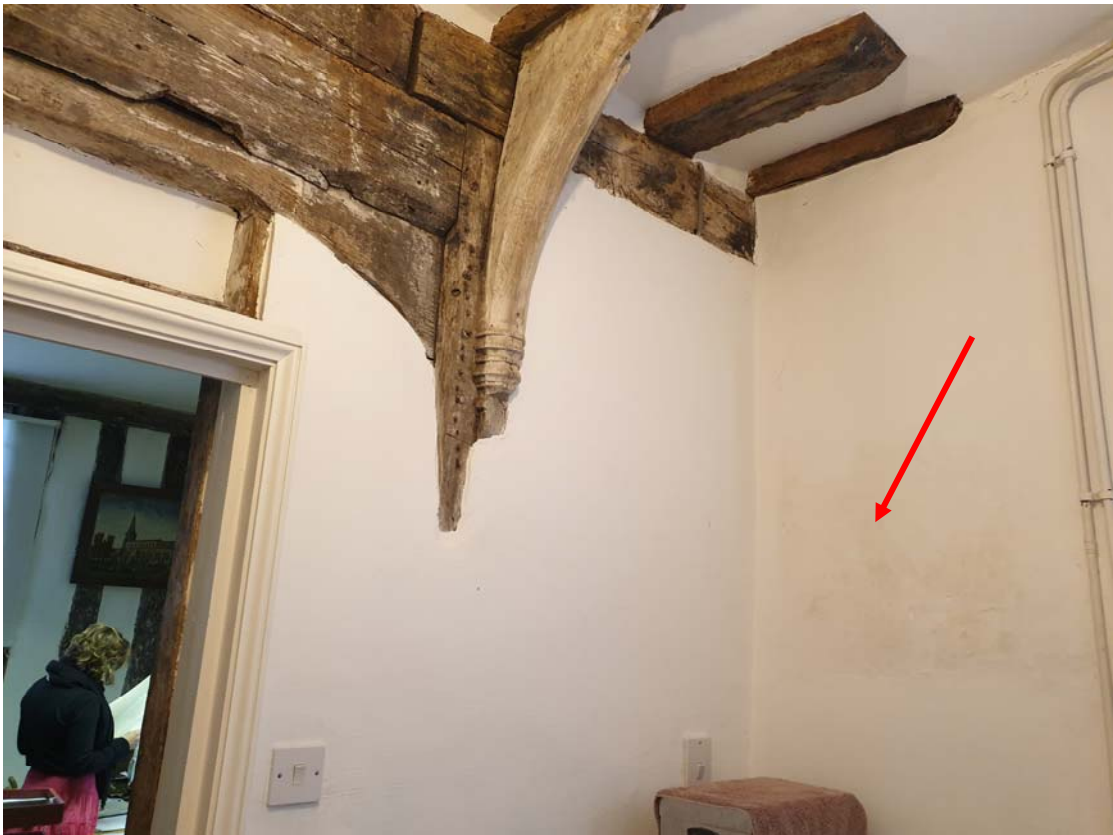
Photograph 104 – Historic damp stains noted in 'R10'

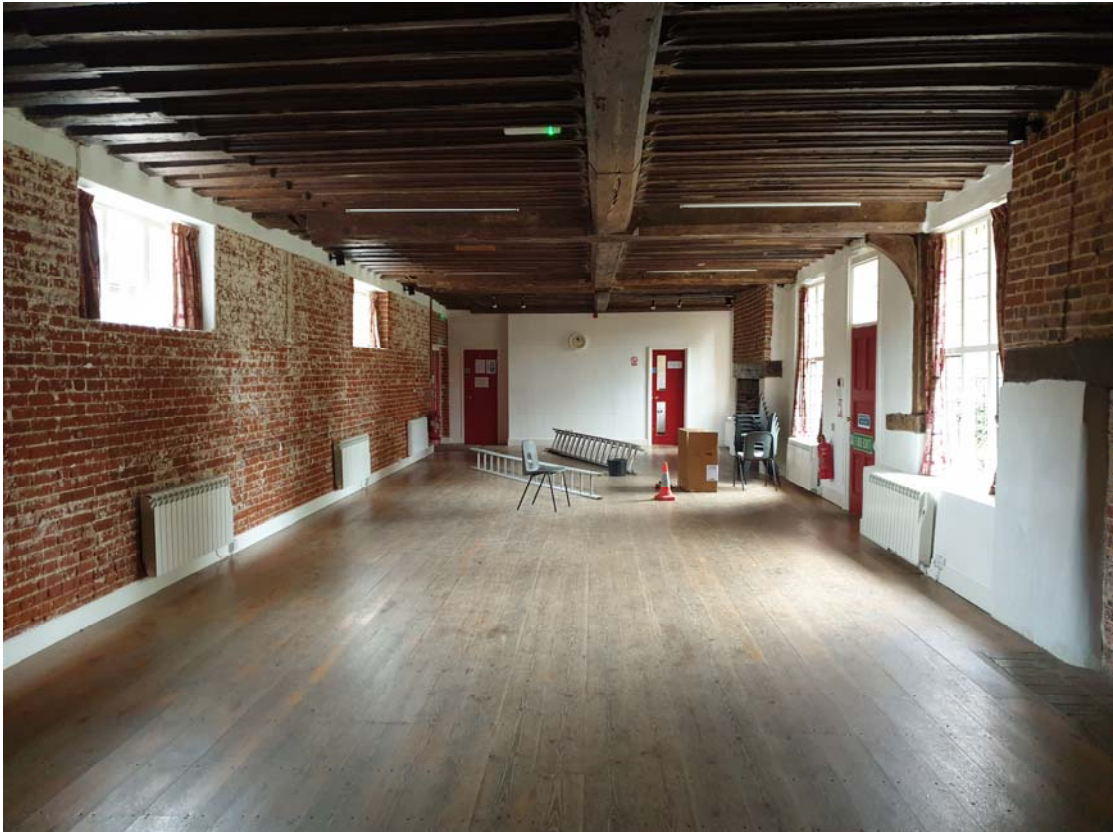
Photograph 105 – Room 'L4' looking south

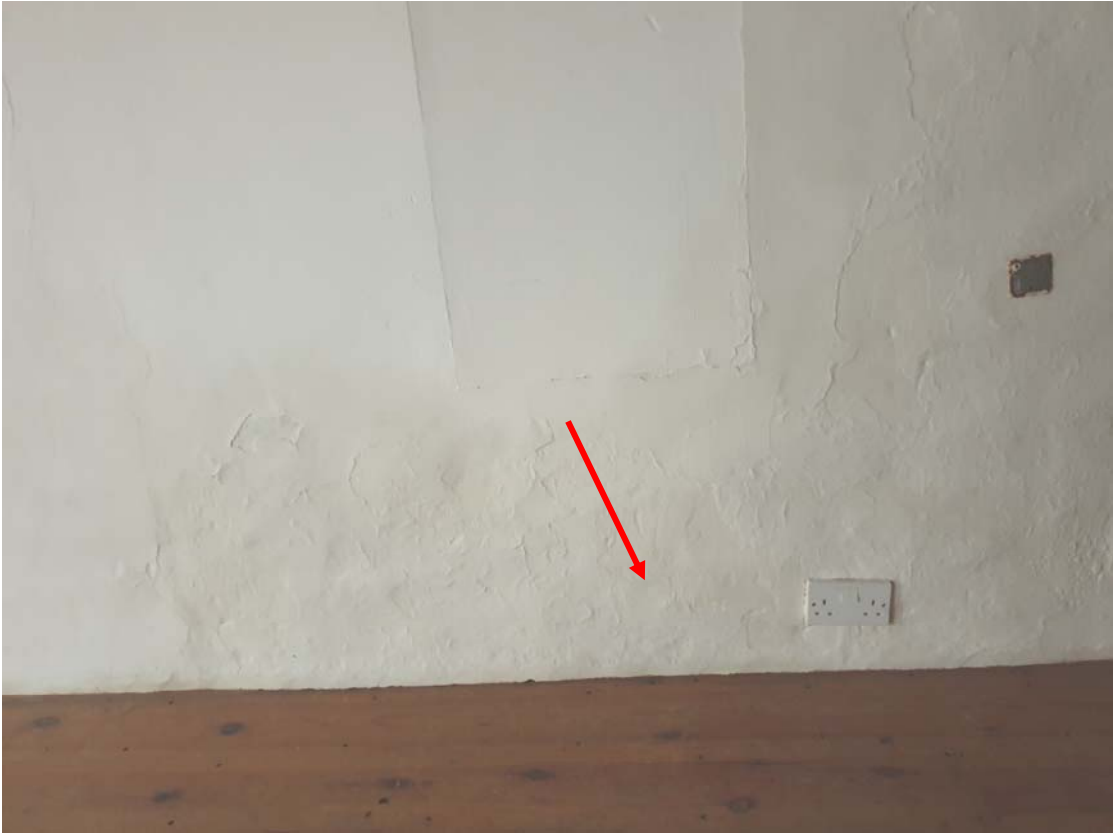
Photograph 108 – Historic dampness noted adjacent to the north fireplace in 'L4'

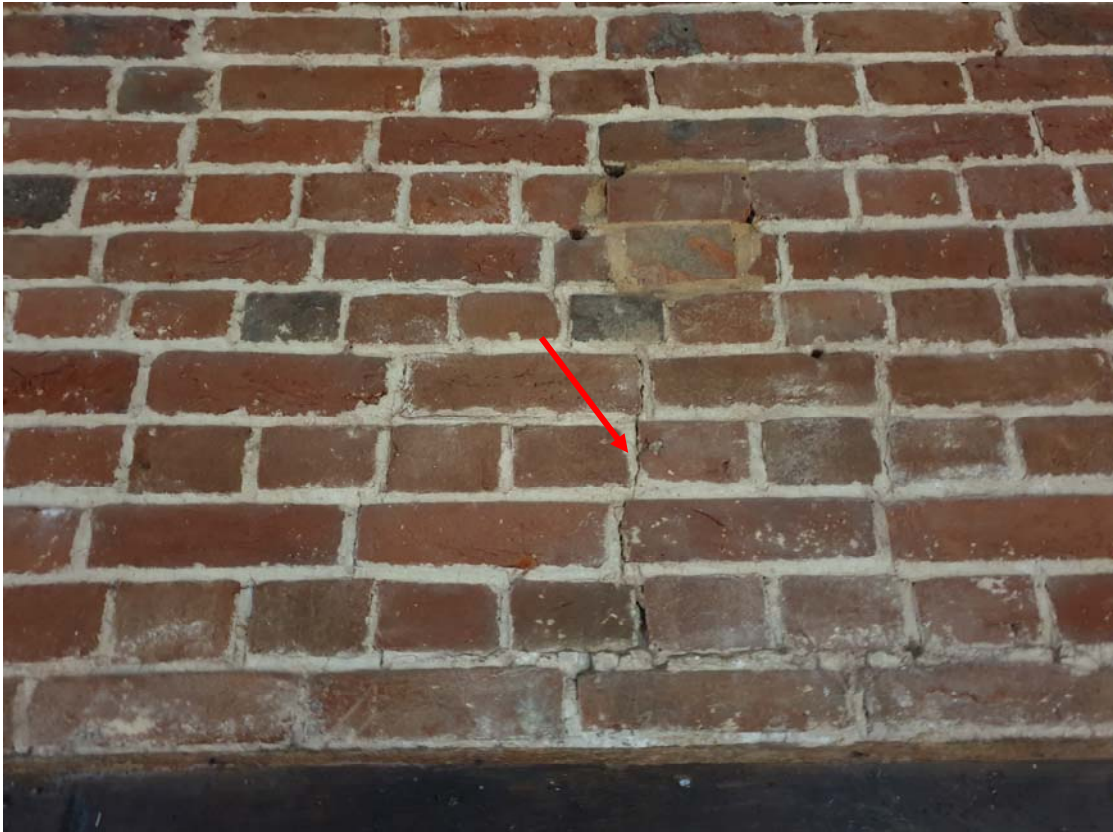
Photograph 109 – Minor cracking noted above the lintel of the south fireplace, in 'L4'
