**CONDITION ASSESSMENT REPORT
OF
HADLEIGH GUILDHALL
HADLEIGH
SUFFOLK**

Client: Hadleigh Town Council
The Guildhall
Hadleigh
Suffolk IP7 5DN

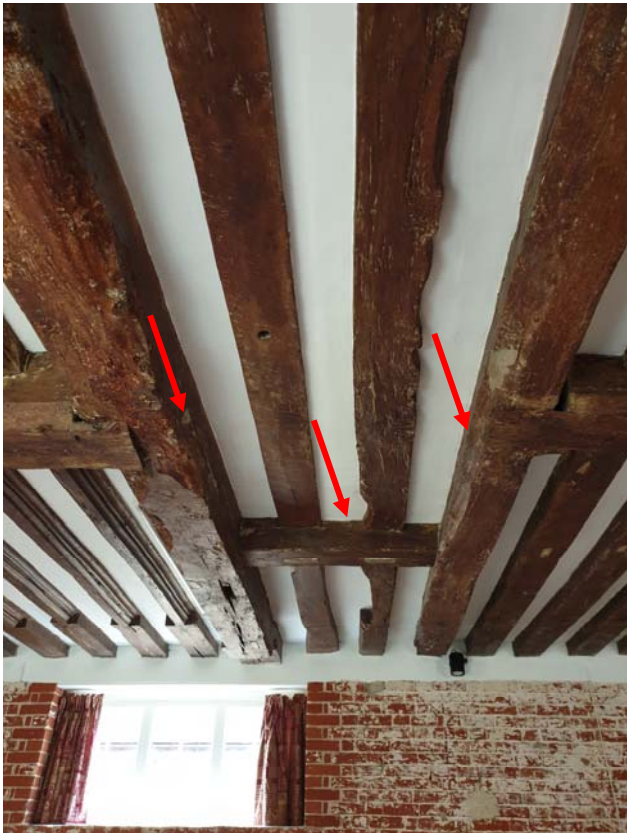
Photograph 110 – Historic trimmer beam arrangement indicating original staircase leading to the room above 'L4'

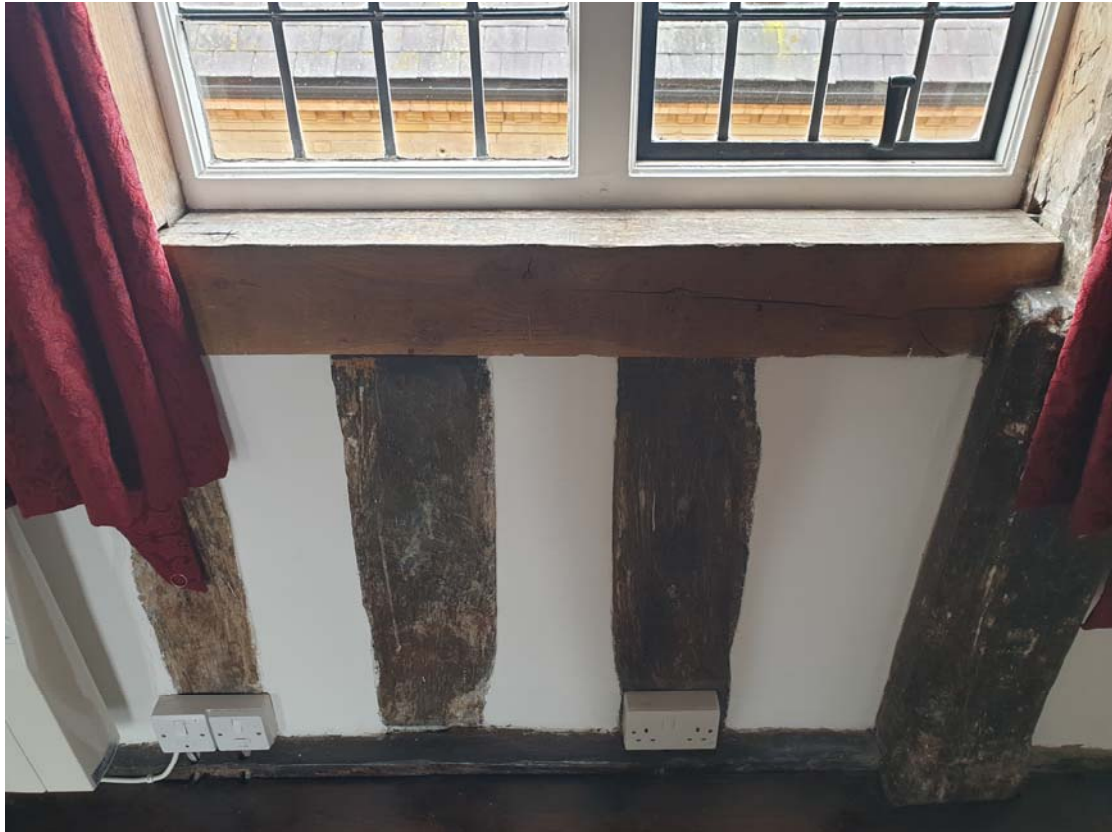
Photograph 115 – Timber sill replacement noted to most of the windows in 'L1'

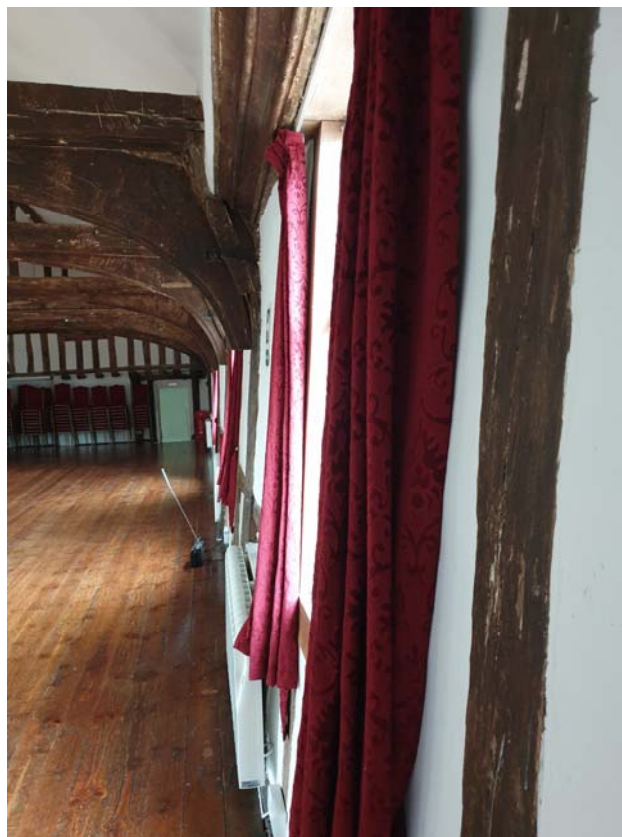
Photograph 116 – East wall bulging out, as seen from 'L1'

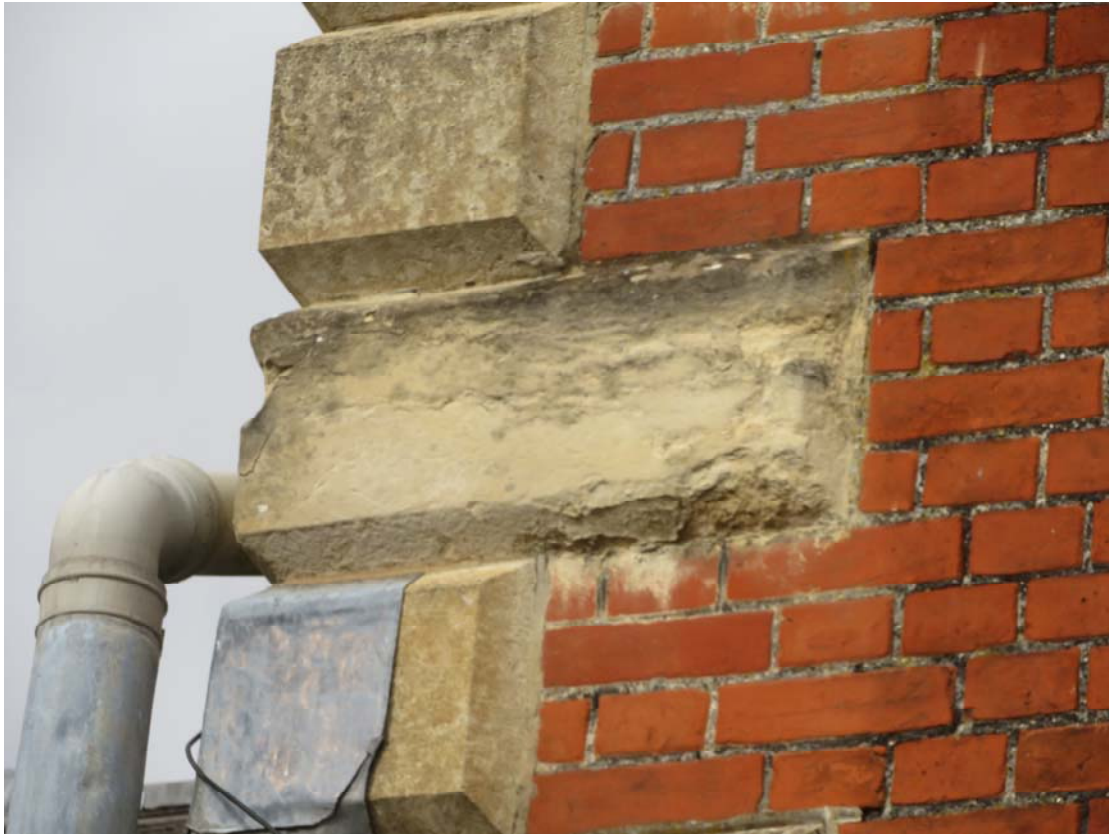
Photograph 119 – Detritus and pollution stains to the stone quoins of New Town Hall

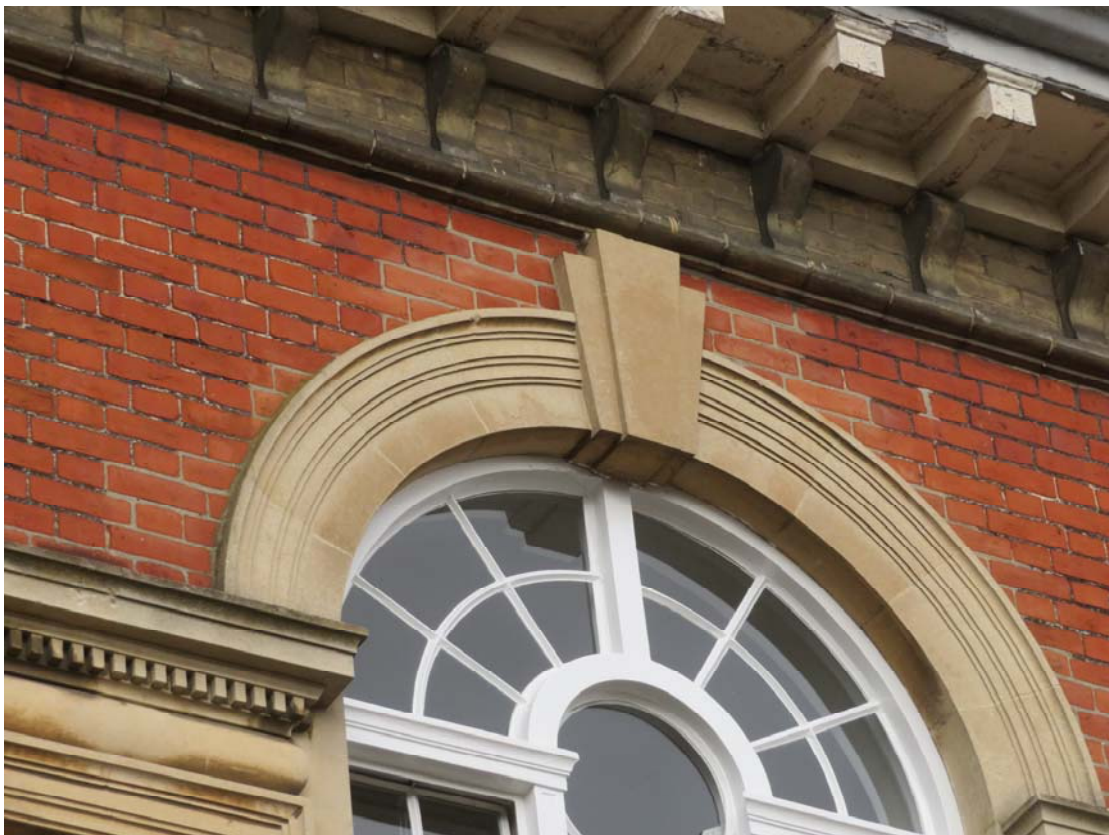
Photograph 120 – Different colour pointing noted to the front elevation

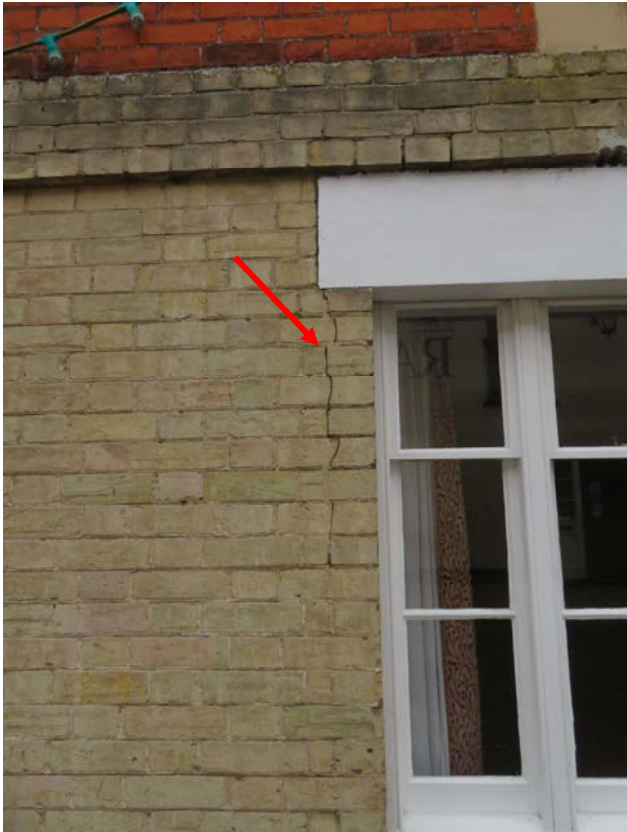
Photograph 121 – Cracking noted in line with the lintel to the centre window to the front elevation of the New Town Hall

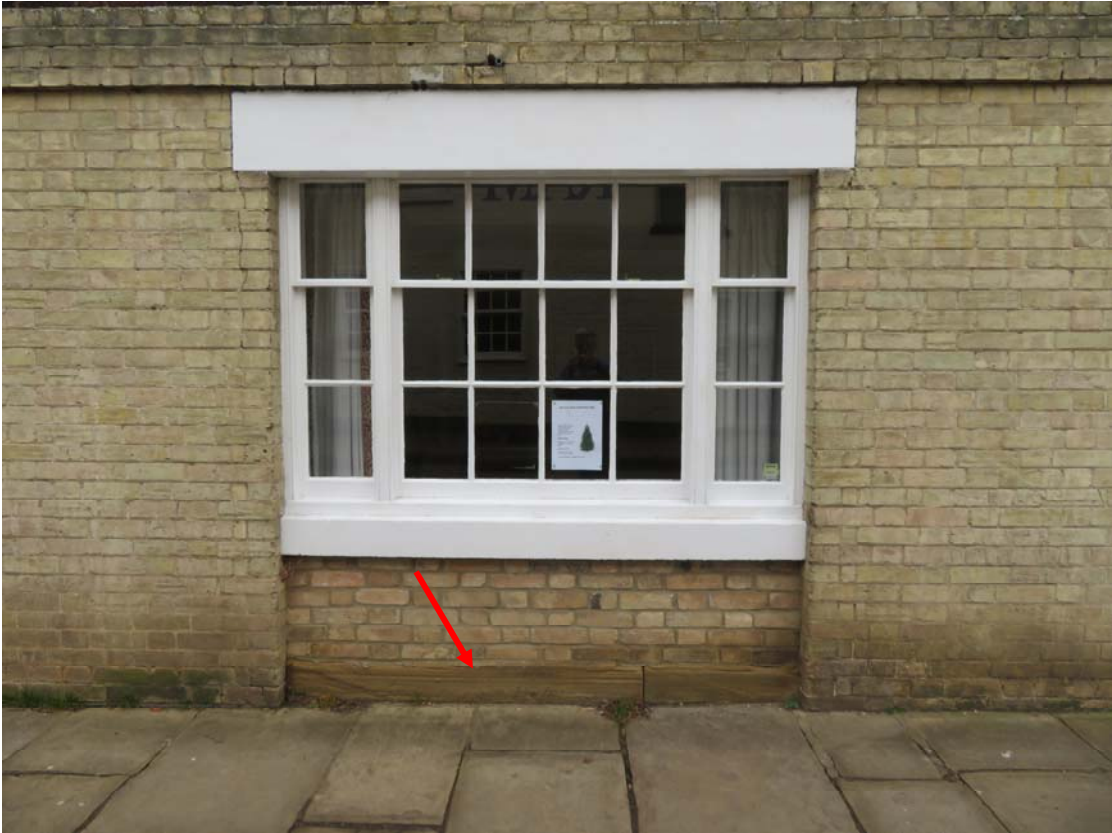
Photograph 122 – York stone paving extending out to the kerb line

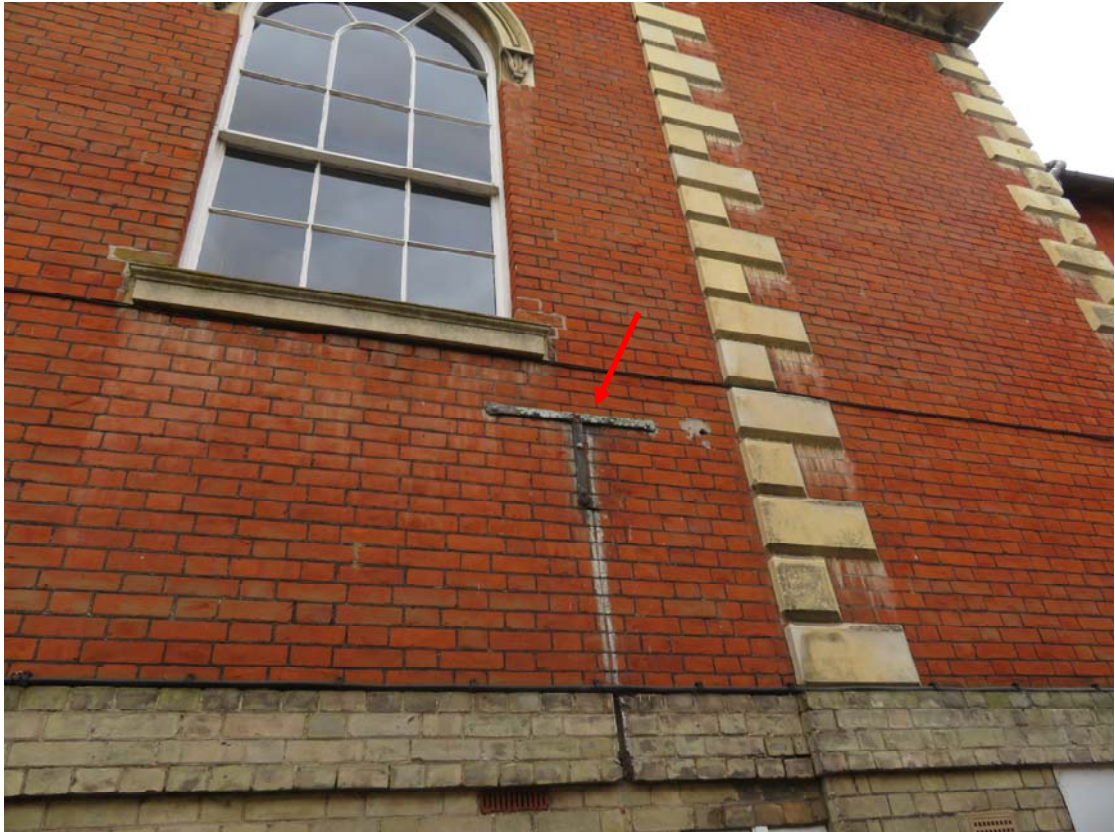
Photograph 123 – Iron bracket noted to the east elevation of the New Town Hall

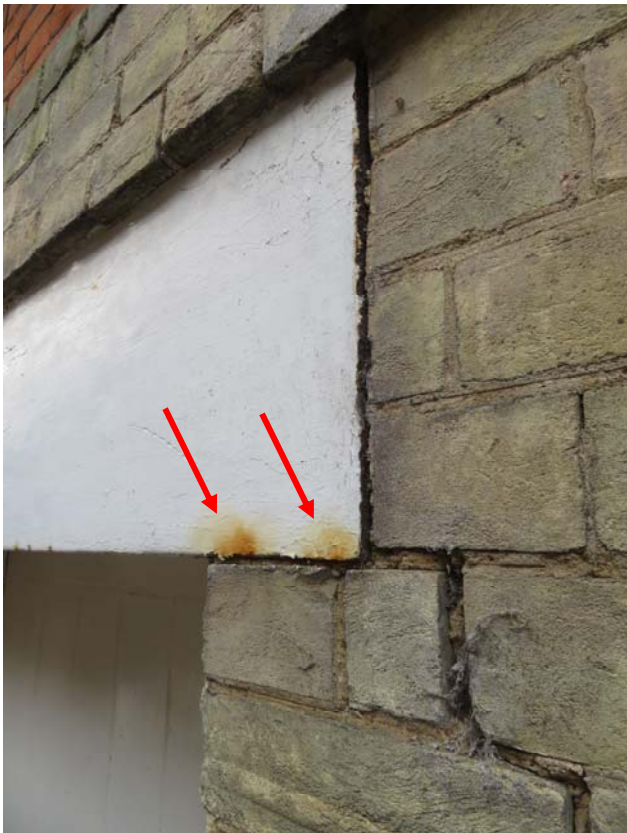
Photograph 124 – Corrosion to the base of the lintel, to the east elevation of the New Town Hall

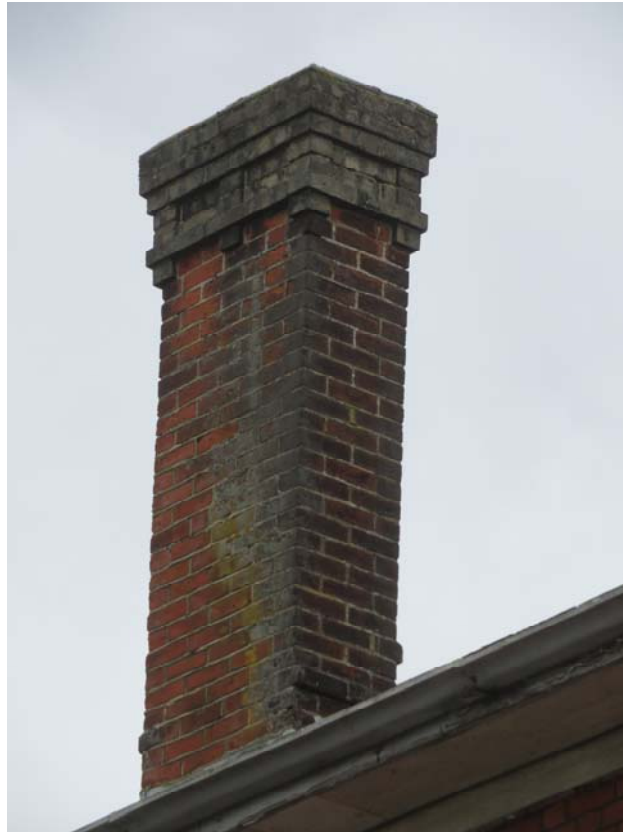
Photograph 125 – Central chimney that appears to be leaning slightly eastward

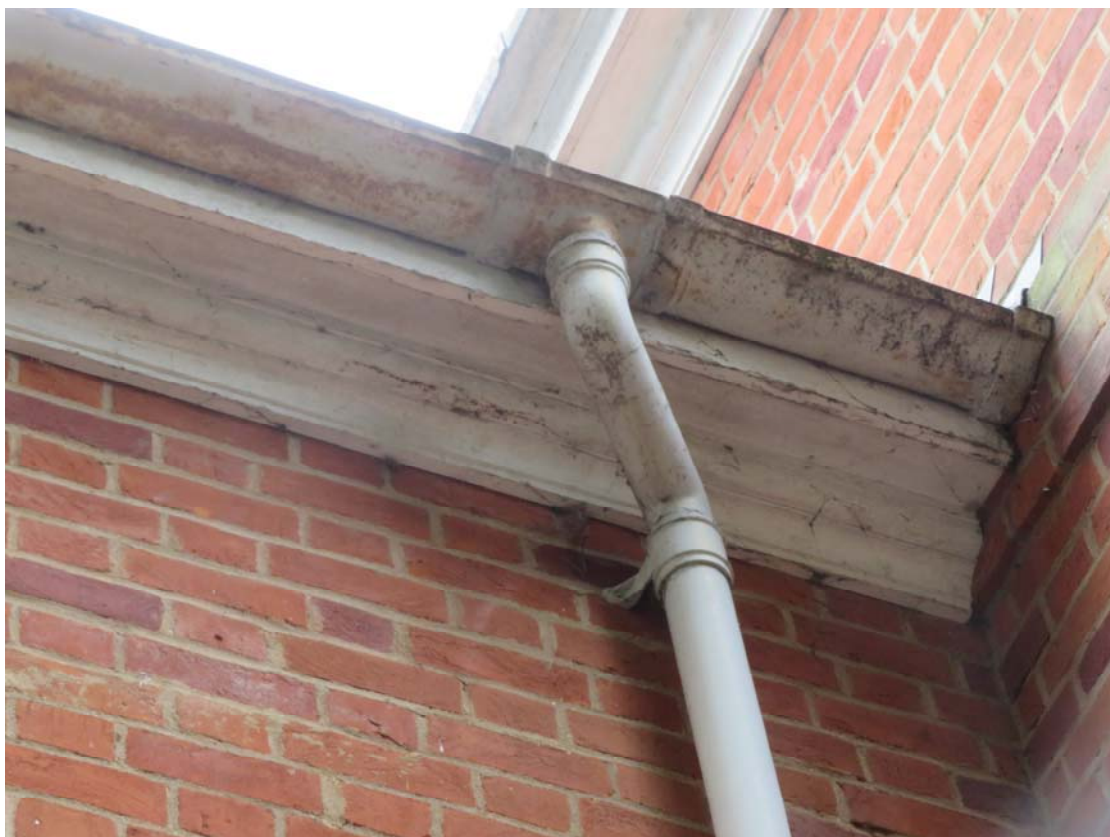
Photograph 126 – Corroding gutters noted to the west elevation of the New Town Hall

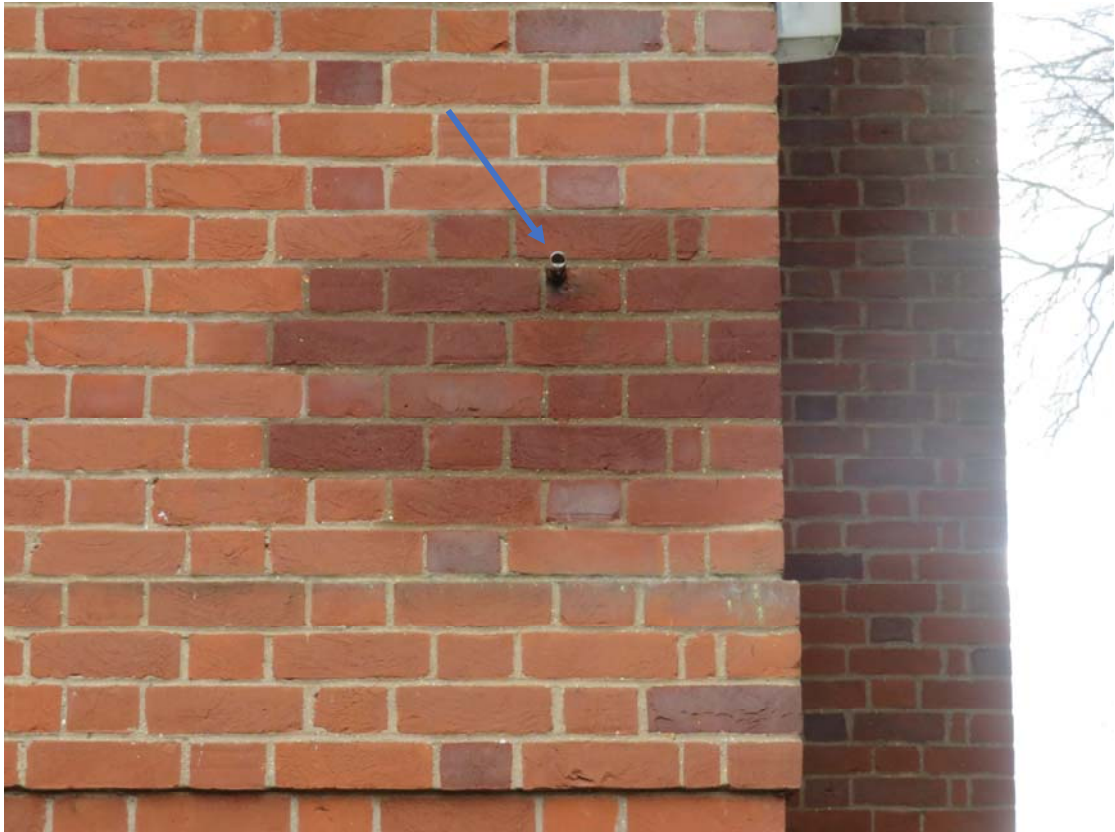
Photograph 127 – Dripping overflow pipe and saturated brickwork noted to the north elevation of the New Town Hall

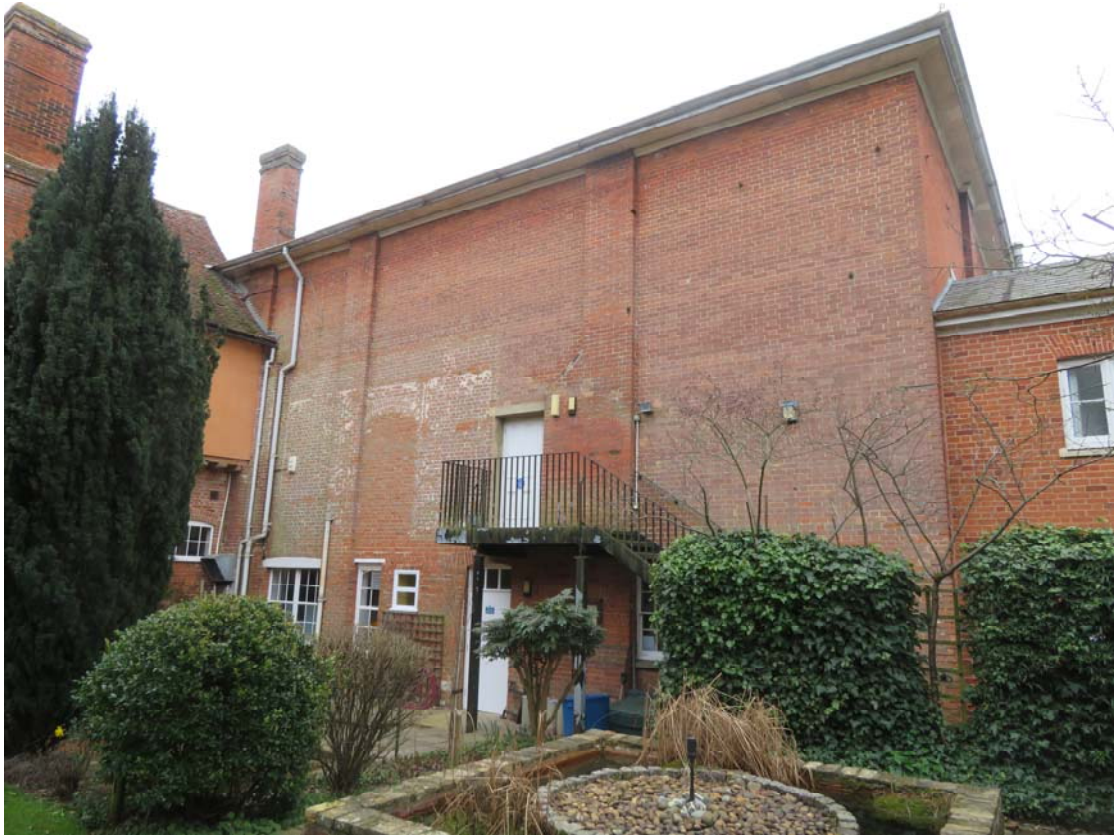
Photograph 128 – North elevation of the New Town Hall

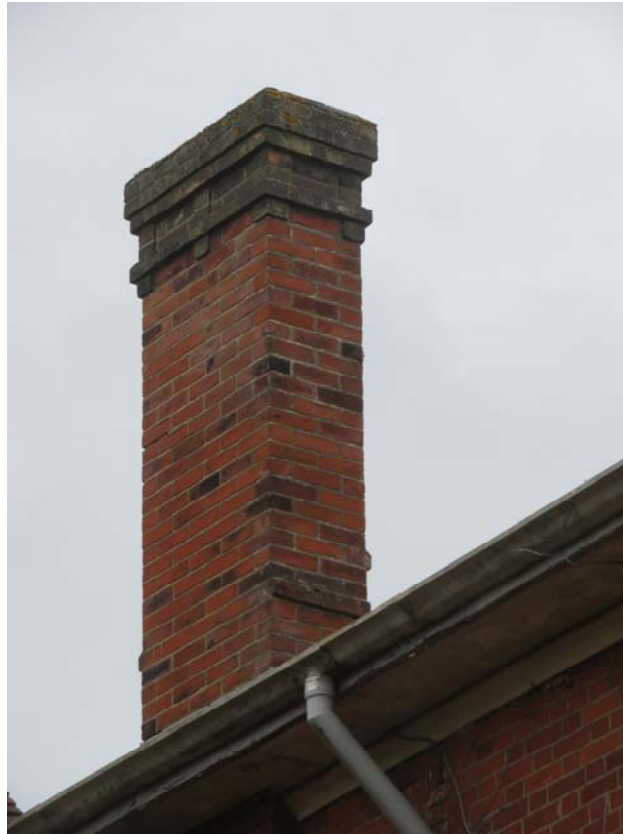
Photograph 129 – Cement-based mortar noted to the east chimney of the New Town Hall, as seen from the back courtyard

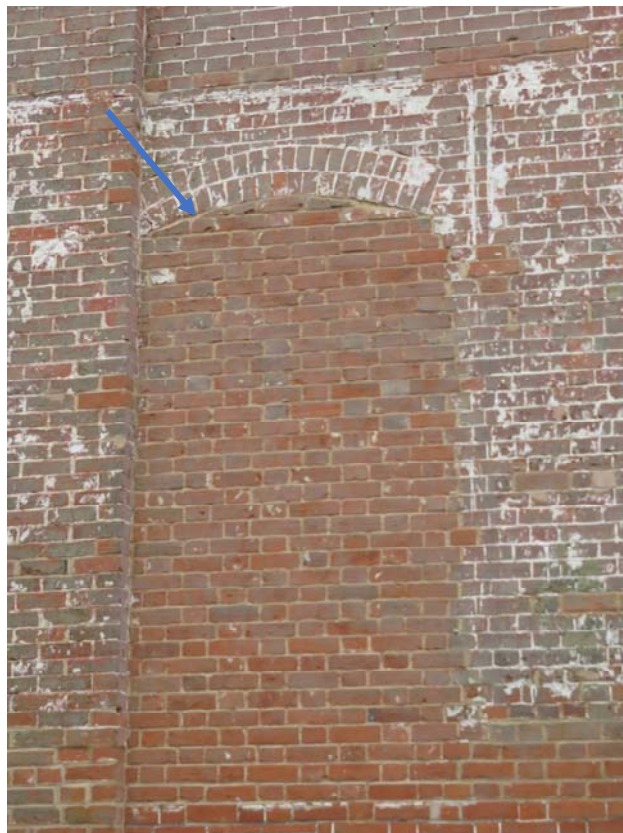
Photograph 130 – Evidence of historic door opening to the north elevation of the New Town Hall

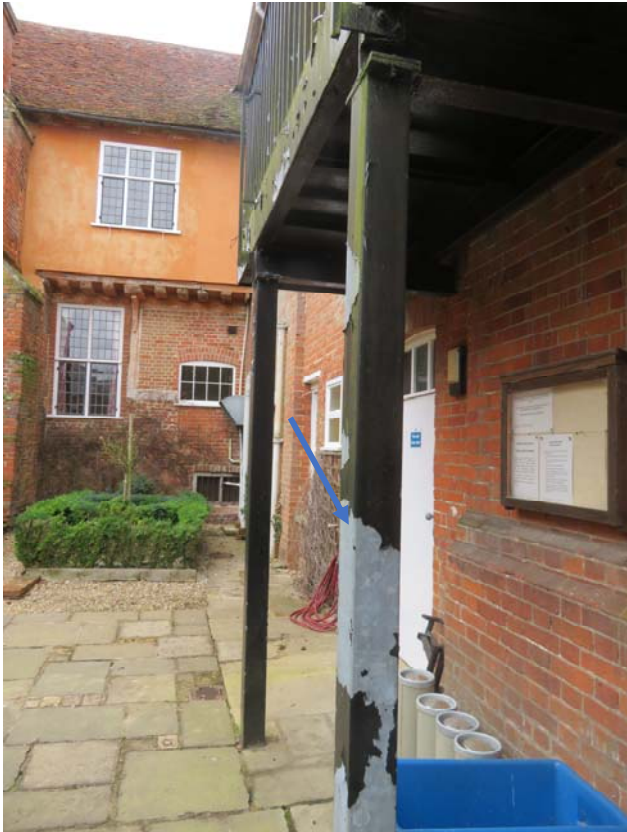
Photograph 131 – Galvanised steel escape stair showing signs of failing finishes

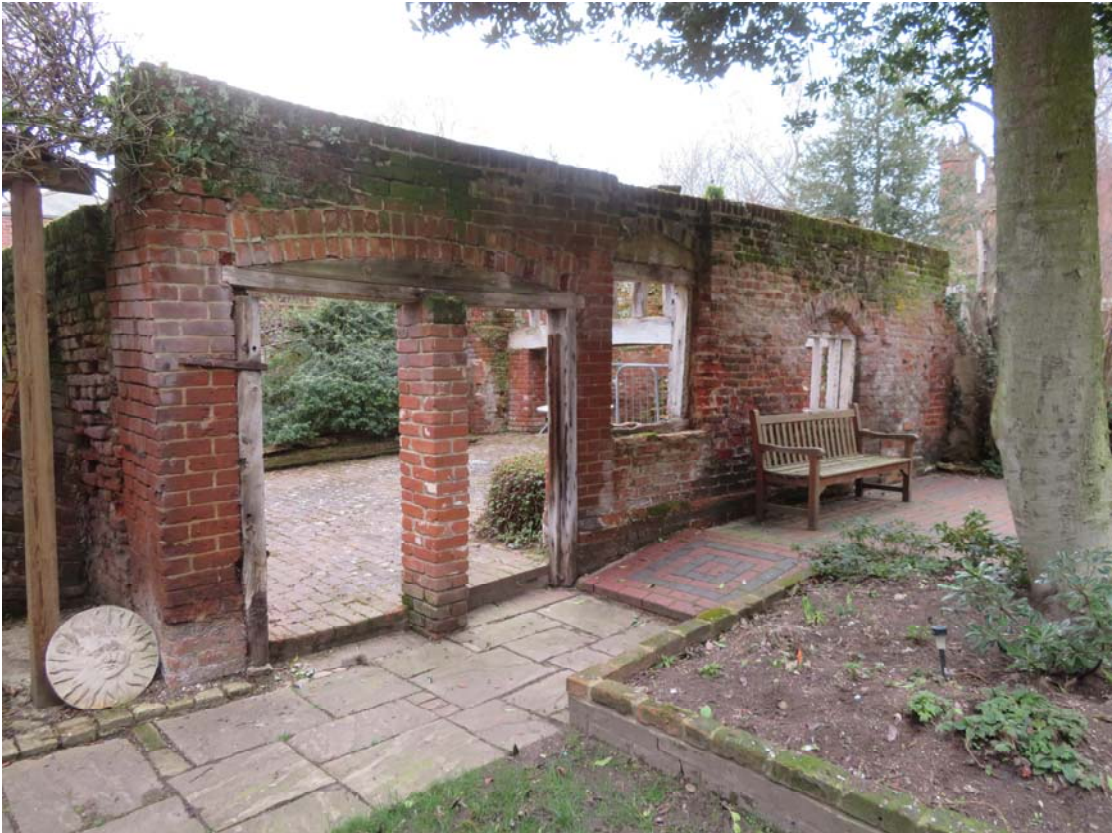
Photograph 132 – The old Tudor kitchen, as seen from the back courtyard

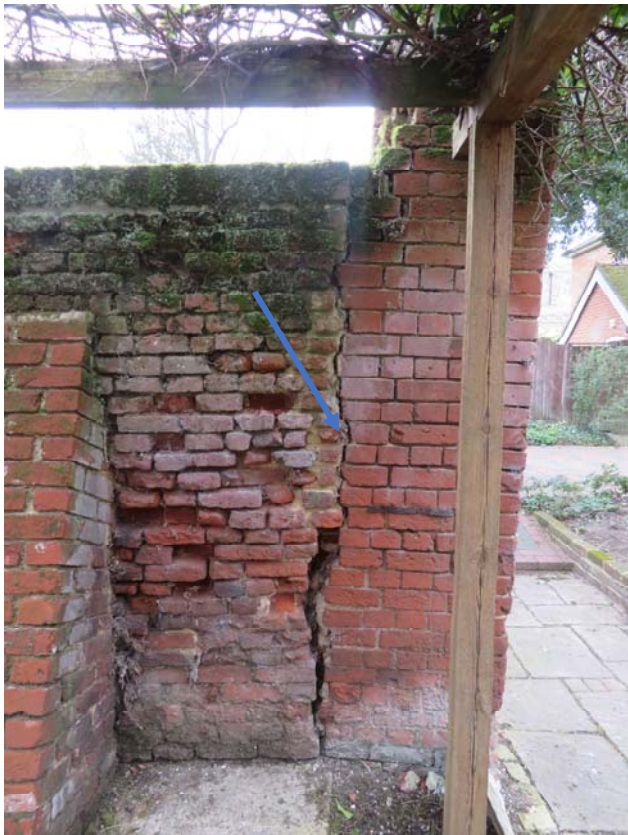
Photograph 134 – Movement noted to the south-east corner of the old Tudor kitchen

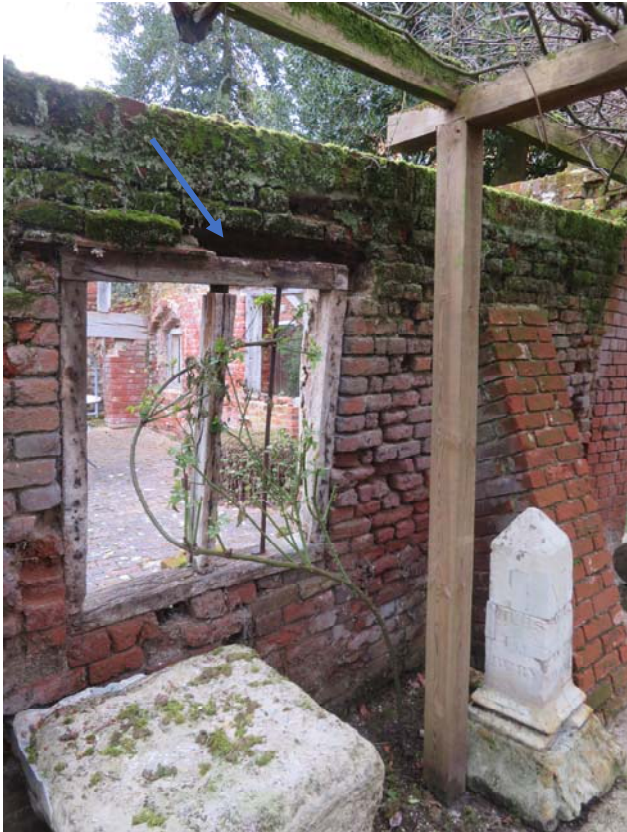
Photograph 135 – Areas requiring local rebuilding to the old Tudor kitchen

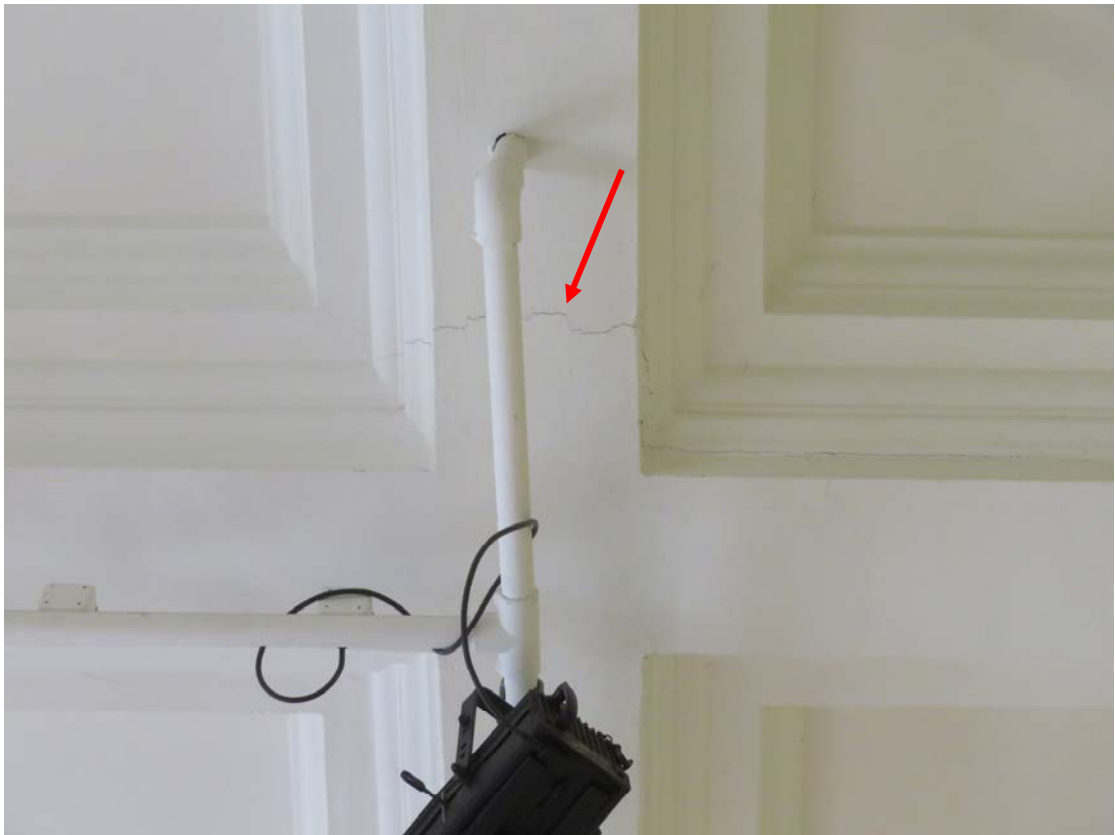
Photograph 136 – Cracks noted to the coffered beams noted in the Grand Hall

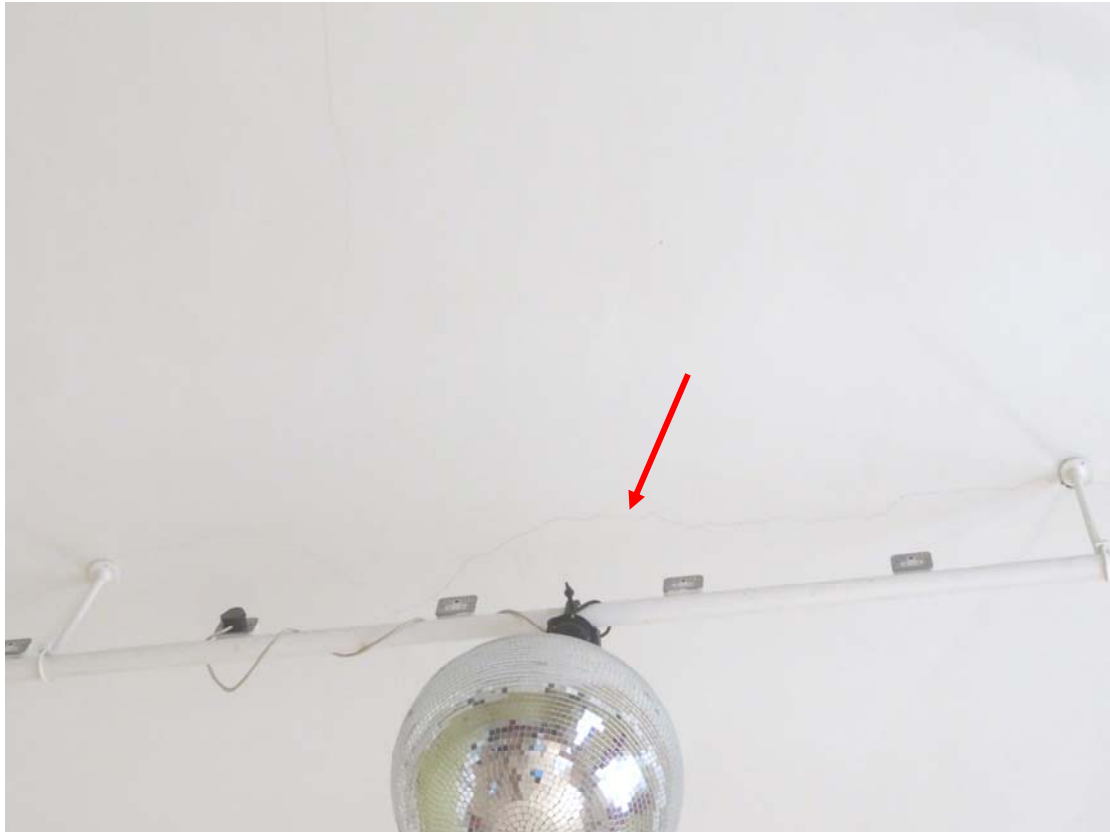
Photograph 137 – Crack to the flat ceiling, in line with the lighting rig, noted in the Grand Hall

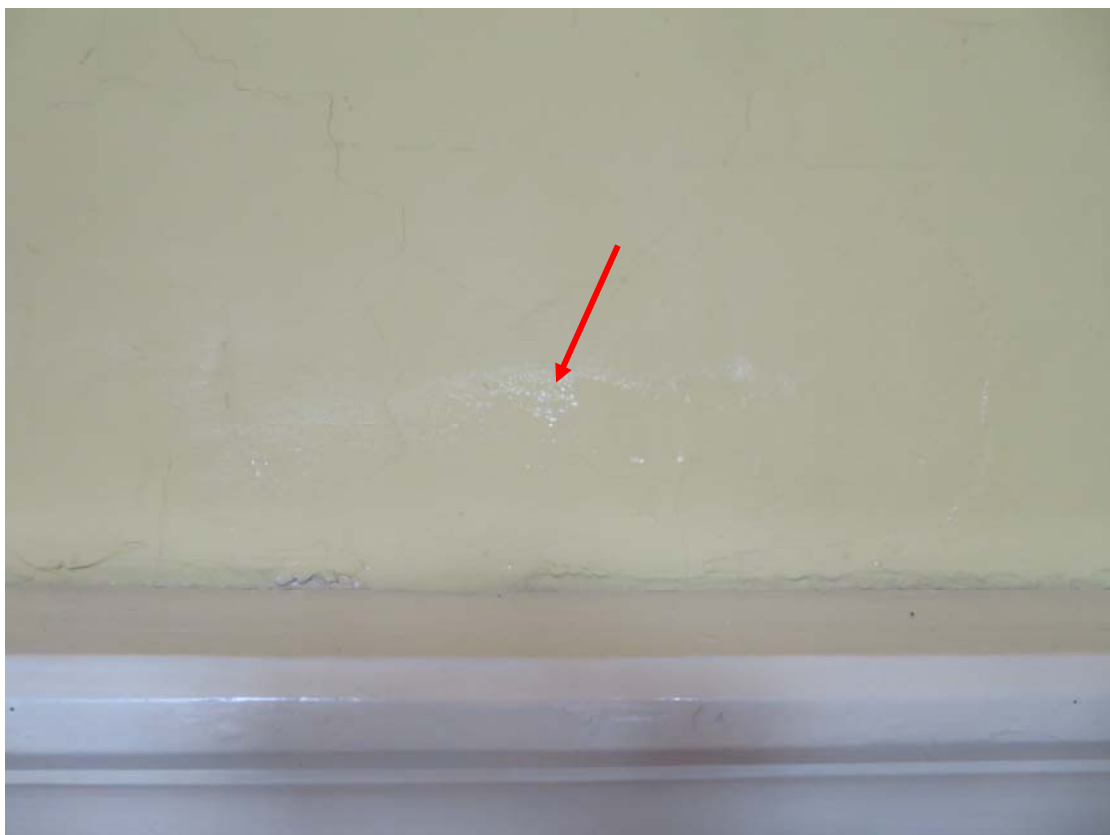
Photograph 138 – Condensation noted to the external wall within the New Town Hall

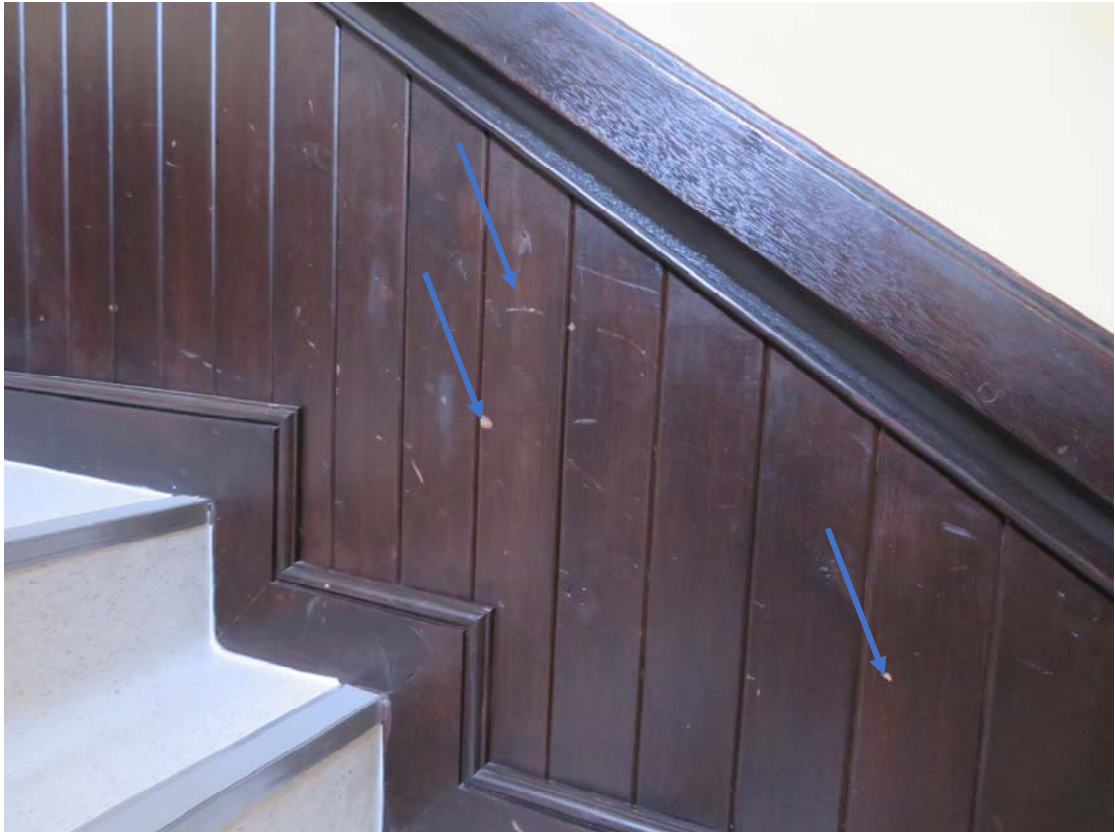
Photograph 139 – Timber joinery in need of redecoration noted to the stairs within New Town Hall

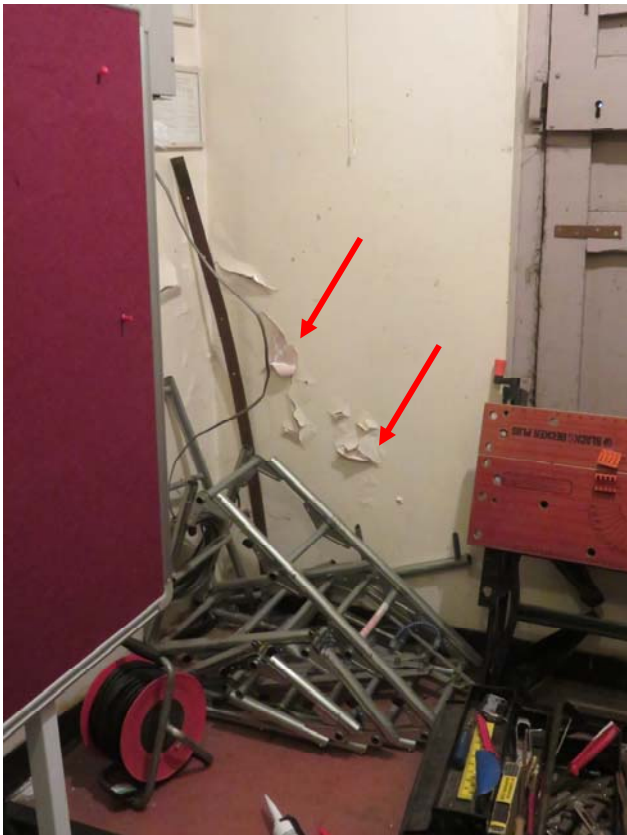
Photograph 140 – Signs of water ingress noted in the service rooms (New Town Hall)

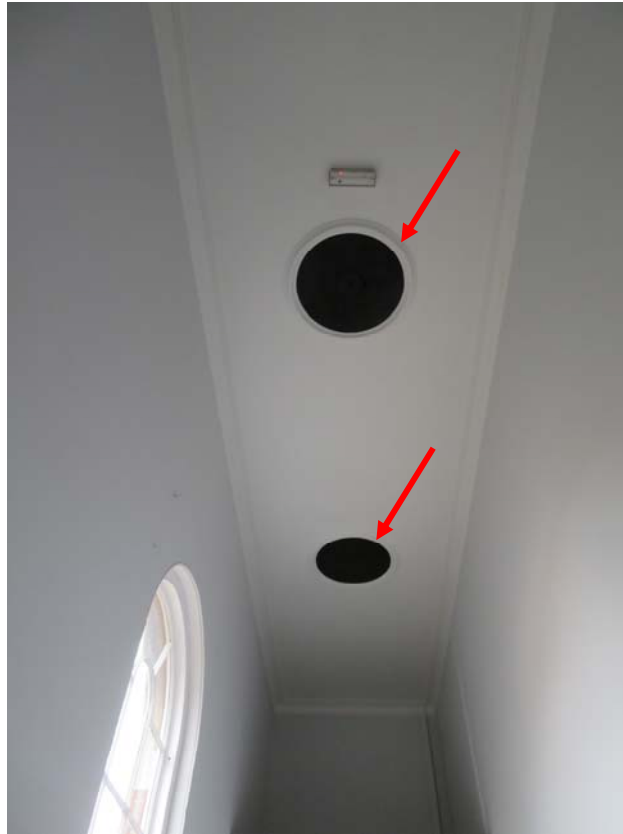
Photograph 141 – Existing grills in the ceiling noted to the stair lobby within the New Town Hall
