Hadleigh Guildhall Conservation Management Plan

©Caroe Architecture Ltd 2023.

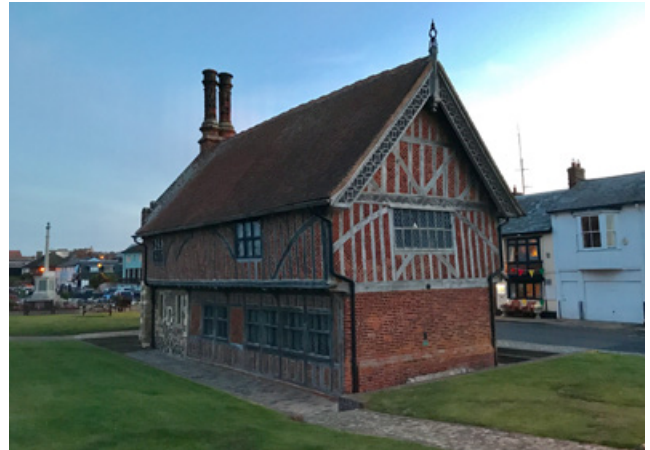
Figure 1: Moot Hall, Aldeburgh, Suffolk (Historic England).

5. Aldeburgh's guildhall, known as Moot Hall (figure 1), is estimated to have been built in the mid-sixteenth century around the time of the town's incorporation in 1547.³ It was referred to both as a guildhall and as a town house, and was used

both for religious and civic administration. It is two storeys in height, with a jettied first floor. Its first-floor hall measures 59m².⁴ Timber-framed, the ground floor was once open for market stalls and also held prison cells. Today, much like Hadleigh, it is still in use by the local town council but with a museum sited on the ground floor.⁵

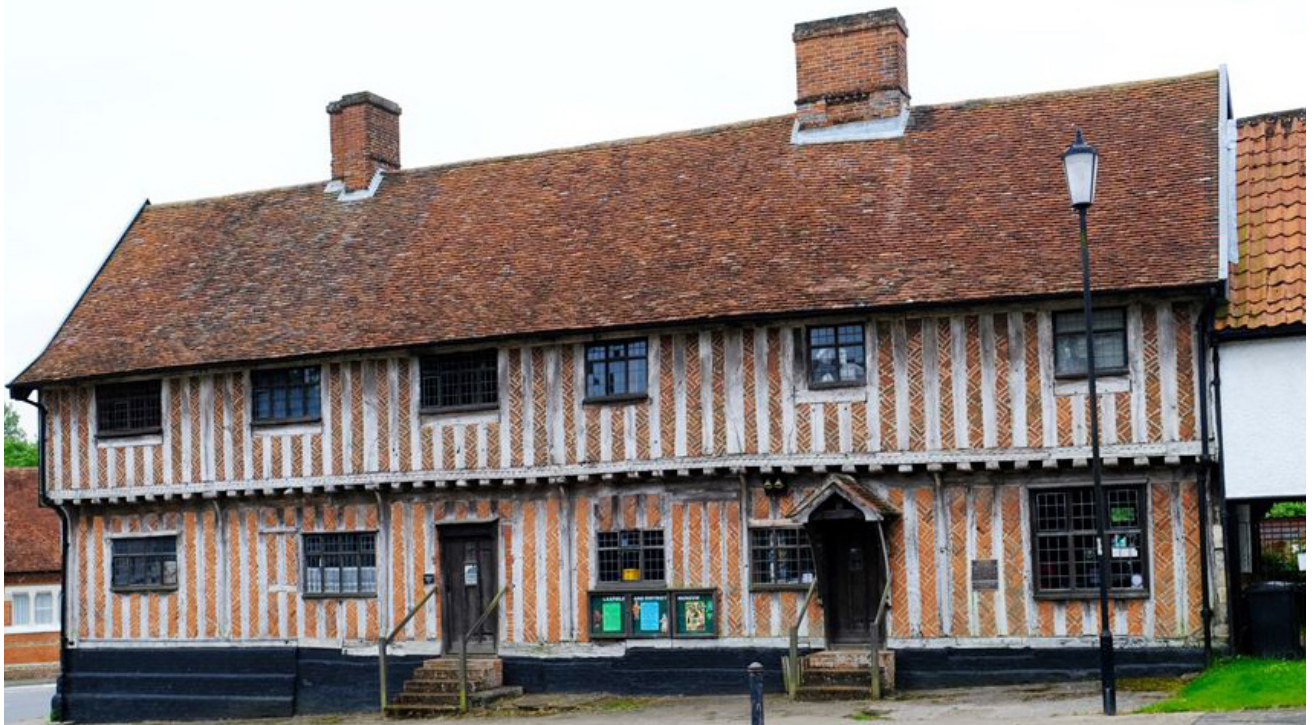
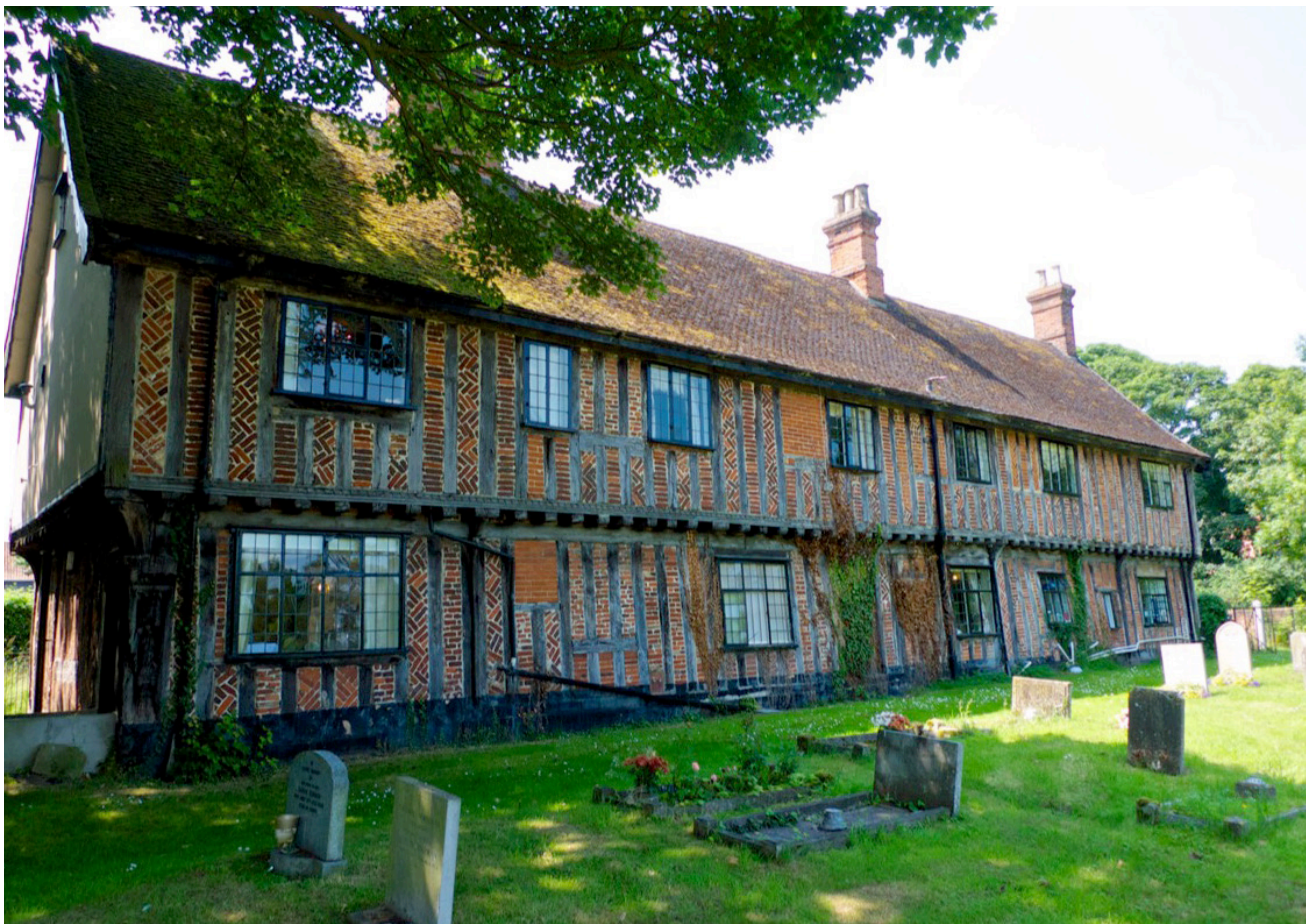
Figure 2 (above): Laxfield's Old Guildhall, Suffolk (Historic England).
Figure 3 (below): Fressingfield Guildhall (Suffolk Guildhalls website).

6. Laxfield's Old Guildhall (figure 2) is situated on the south side of the marketplace, just 45m from the church, and was constructed around 1520 for the Guild of St Mary.⁶ It is thought the current building may have replaced an earlier guild building known as 'Le Cherchehouse'. It is also timber-framed, with two storeys, the first being jettied and a queen-post roof. The first-floor hall measured 84m².⁷ Today, the first floor is in use as a museum, whilst the ground floor is let for commercial ventures.

7. Fressingfield's Old Guildhall (now known as the Fox and Goose Inn) is located just 30m from the church of St Peter and Paul (figure 3). It was built around 1508/9, timber-framed with two-storeys, a jettied first floor to the north and east, and a brick-nogged frontage. The first-floor hall measured 103m².⁸ It seems to have been used predominantly for church events. By 1615, it became referred to as the 'Town House' and by the late nineteenth century it was known as the Fox and Goose.

8. Of these four Suffolk examples, Weir observed that two (Fressingfield and Hadleigh) are similarly located on the edge of churchyards, each with one long elevation facing the churchyard and (formerly) one elevation facing an open space.⁹ Each have nearly the same size halls on both ground and first floor levels, and both ground floor halls were likely accessed by cross-passages.¹⁰ They also both provided first floor access via an external staircase.

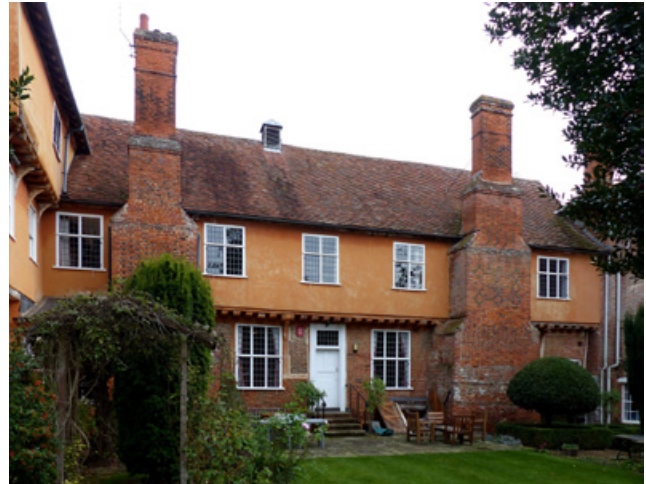
Figure 8: Guildhall from W, stair block to left (CAL).

33. The extensively surviving, close-studded first-floor framing is concealed externally. Ground-floor framing is exposed on the west elevation and is discussed in connection with internal arrangements, below (figure 8). Plain curved brackets rise to the first-floor jetty. The frame is significantly less ornamented than that of the Market Hall, with no evidence for wall-shafts associated with the jetty brackets. The windows, however, had similar traceried heads.

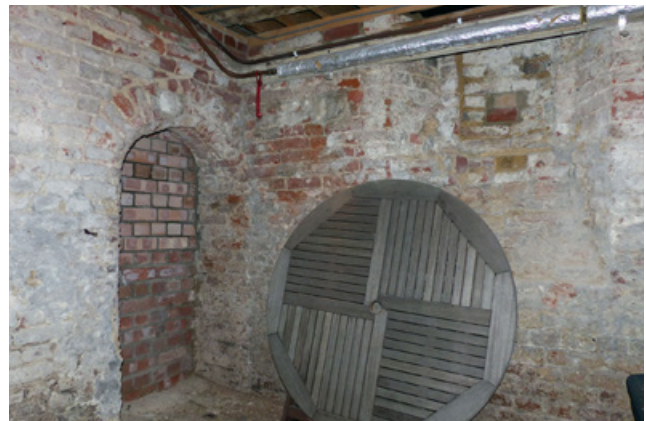
Figure 9: Cellar doorway and window (CAL).

35. The northwards extent of the cellar has not been established. The present north wall is short of the original north end of the Guildhall as postulated by John Walker; at its east end there is an original doorway with a four-centred arched head (figure 9). This has been blocked from the north side in twentieth-century brick. The absence of rebates for a door suggest that this was an internal doorway and that the cellar therefore extended further to the north. It is possible that there was a stair descending from

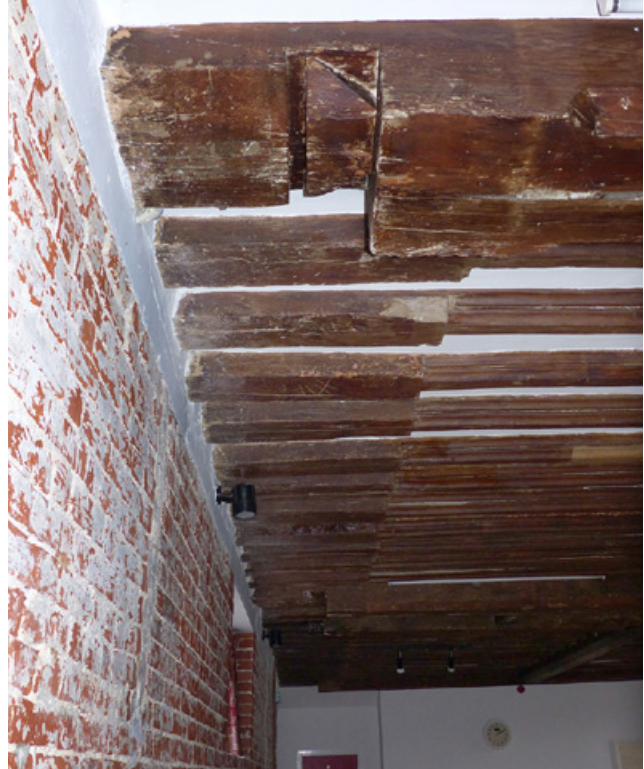
Figure 10: Guildhall GF- east jetty evidence (CAL).

38. The former jetty on the east elevation is strikingly apparent within the ground floor. Moulded or chamfered beams and joists are stopped in association with the original east wall, well short of the present brick wall, and lap-dovetail seatings are exposed on the ends of the beams where they formerly rested on the jetty plate (figure 10). The existence of mortices for brackets up to the first-floor jetty suggests that the original east wall, though substantially of brick and two bricks thick (judging by shadows left on the soffits), incorporated some posts and studs into which the lower ends of the brackets were tenoned. Some of the timbers exhibit scribed numerical carpenters' marks on their soffits.

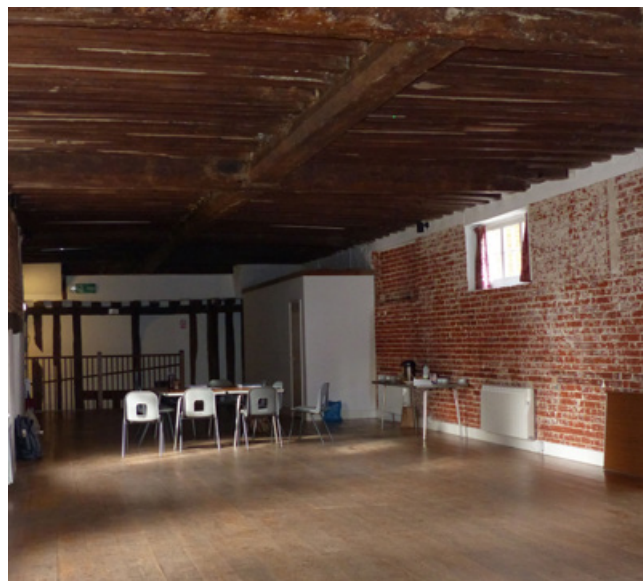
Figure 11: Guildhall GF from S (CAL).

39. Most of the evidence for the original internal form of the ground floor comes from variations in the bay lengths and decoration of the ceiling timbers. The ground floor is bridged by a series of chamfered transverse beams (figure 11). All but one interval between these beams is filled by a central, axial beam.

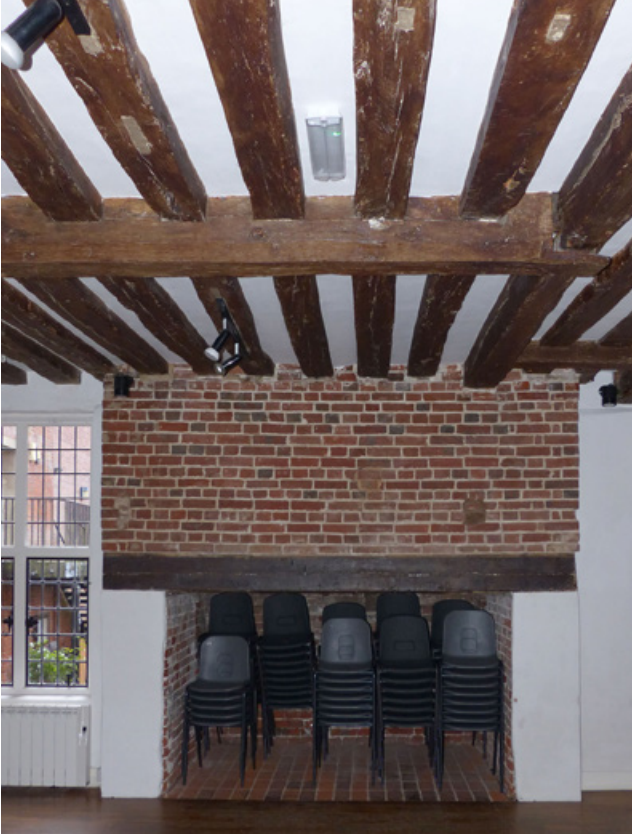
Figure 12: Guildhall GF- cross passage evidence from E, stair trap to right (CAL).

41. The presumed doorways at each end of the cross-passage are no longer identifiable, but a close-studded partition on the south side of the passage is indicated by empty mortices (figure 12) and a wide doorway is indicated by an interval in the mortices at the east end.
42. The stair corresponds to a very short bay which omits the axial beam, and it is further indicated by two trimmers defining the stair trap, one of which (to the east) has mortices in its soffit forming a bulkhead between the stair and a short passage linking the cross-passage with the principal room to the north (figure 13). Perhaps surprisingly, there is no evidence for studs closing off the stair on the north and south sides; it may be that it was enclosed within brick walls.

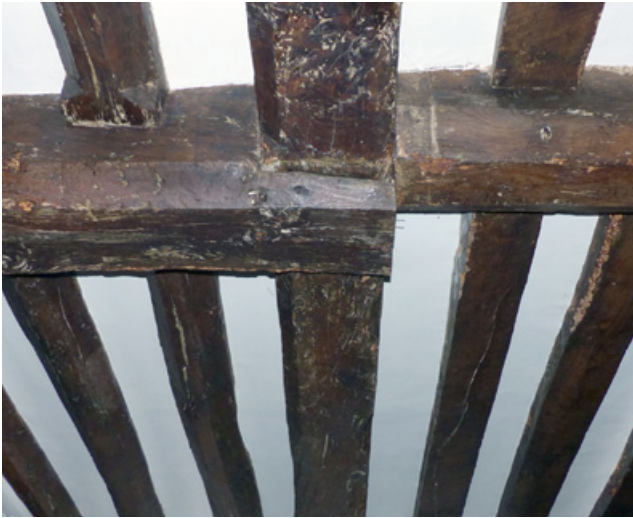
Figure 14: Guildhall GF- original N end, extension to R (CAL).

44. The principal room, north of the stair, consisted of two long ceiling bays with east-west moulded joists. The north end of the room is marked by a pair of unchamfered joists which appear to have overlain a brick partition as there are no stud mortices in the soffits. This partition, in turn, would have overlain the present north wall at cellar level, also in brick. The axial beam spanning the north bay of the principal room continues north of the partition to a transverse beam a short distance to the north, under which there appears to have been another brick wall forming the original end of the building (figure 14). This passage-like space corresponds to the closed-off cellar bay mentioned above and must have contained a stair descending to the cellar. This would account for the change in the treatment of the ceiling joists, which here have a large chamfer rather than a more elaborate moulding.

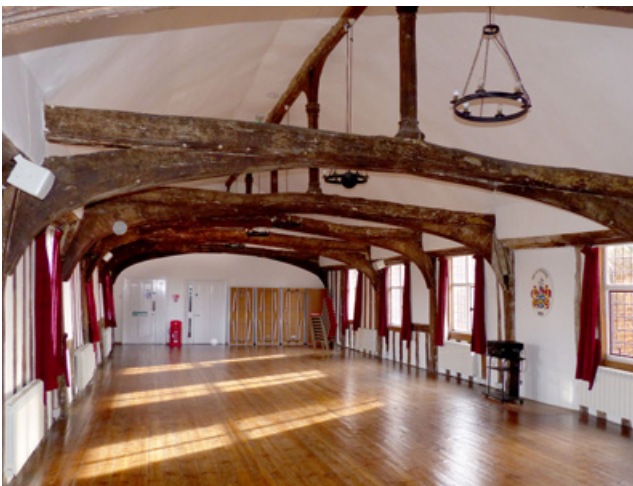
Figure 15: Guildhall 1F crown-post roof from NE (CAL).

46. The first-floor rooms were probably open to the roof, which originally consisted of six bays, later extended to eight (figure 15). The six bays include one long bay (third from the south), which includes the internal stair. The roof is of crown-post form, with octagonal crown-posts rising from arch-braced tie-beams and two-way braced to the collar-purlin. The tie-beams have a reverse-ogee moulding and the more slender arch-braces have a cavetto and soffit-roll.

47. Though these forms are stylistically credible for the likely date of the Guildhall, there is evidence that this roof and the accompanying cornice replace an earlier arrangement. Peg evidence on the upper edge of the transverse ceiling beam of Walker's cross-frame F indicates close-

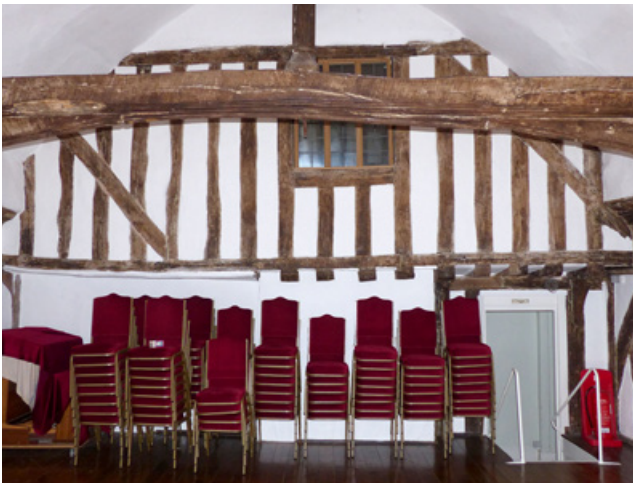
Figure 16: Guildhall 1F showing south elevation of Market Hall (2F) (CAL).

53. On the ground floor, a single axial beam bridges the whole length of the extension as far as the first-floor jetty bressummer of the Market Hall (figure 16). The beam is chamfered and morticed into the beam forming the original north end; the joists are laid flat and plain. The absence of a decorative treatment of the ceiling joists, in contrast to the chamfered and moulded joists in the next bays to the south, suggests that the brick end wall was retained and that the extension provided a single additional room. This was lit from the east, possibly by a large roughly central window between two joists with mortices for jetty brackets in their soffits.

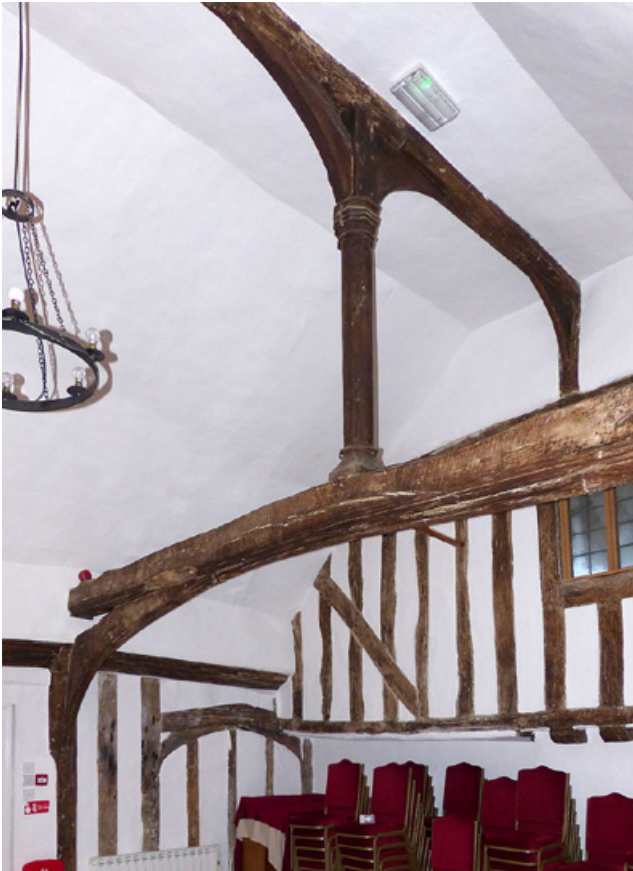
Figure 18: Guildhall 1F showing jetty and stair doorway (CAL).

56. On the first floor the walls were of timber to both east and west. Access to the first floor was via the stair block, entering through a wide doorway with a cranked lintel and arch-braces composing a depressed four-centred arch (figure 18). The east and west walls are otherwise close-studded. Light was not available from the west, owing to the adjoining stair block; instead, three windows occupied much of the east wall. One of these retains vestiges of tracery, a stylistic similarity suggesting a date not far distant from those of the Guildhall and Market Hall.

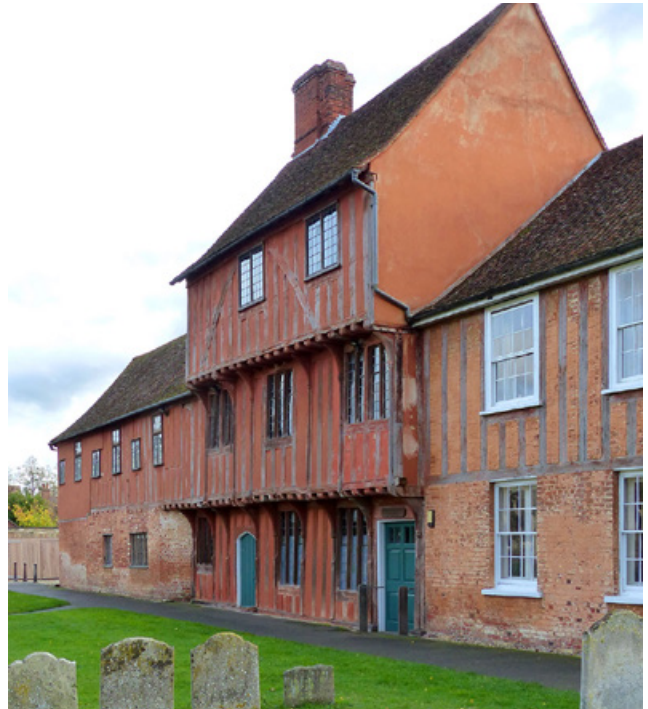
Figure 19: Market Hall from NW (CAL).

57. The present Market Hall has been linked to a 1451 document and is understood to have been built abutting the east end of the earlier market house and almshouses. The ground floor of the Market Hall was described in 1496 as containing two butchers' shops, priests' chambers and a wool house.²⁹
58. The Market Hall (figure 19) is a timber-framed building of three storeys, the eastern portion now reduced to two storeys. It was jettied on the first and second floors to north and south, though on the south side the jetties are now mostly concealed externally by later additions.

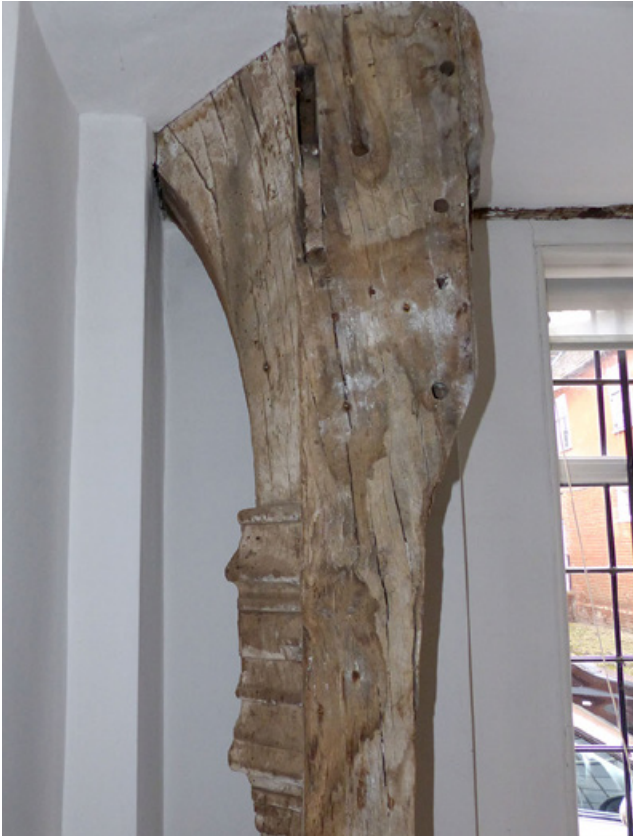
Figure 20: Market Hall GF- SE dragon post (CAL).

on the south. Bracing is confined to long, down-swinging stud-braces on the second floor.

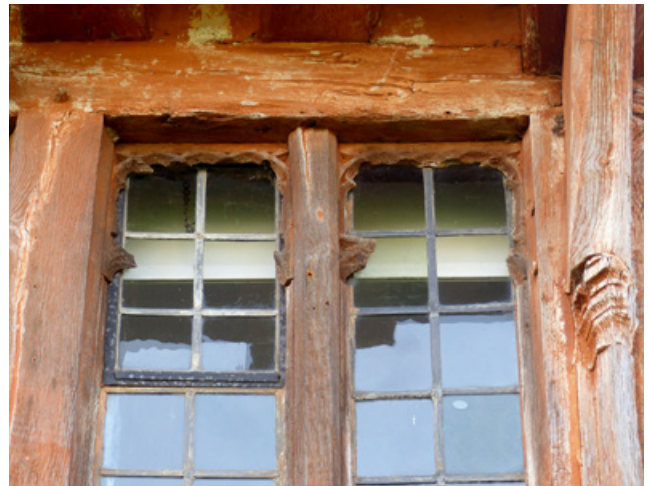
Figure 21: Market Hall 1F tracery (CAL).

61. The westernmost principal post on the second floor incorporates a downstand at the jetty plate, indicating that the building terminated here; the absence of closure under the first-floor transverse beam at this end, with the exception of a central post supporting one end of a long axial ceiling beam, confirms that the Market Hall was built abutting an existing building (the earlier Market House).
62. On the ground and first floors of both elevations the principal posts and the studs framing doorways and windows have attached shafts, carved capitals, and curved brackets rising to the underside of the jetties above (figure 21).³²
63. On the ground and second floors of the north elevation, the original fenestration consisted of three-light mullioned windows, the heads of which retain vestiges of carved tracery, and

the sills of which were double-pegged at the adjacent studs; the remaining second-floor windows have been altered to contain two lights. Within that part of the south elevation that was later enclosed by the Guildhall extension, there were two ground-floor windows forming a pair and a single three-light second-floor window has been reinstated since 1990 as a borrowed light (mullions renewed).

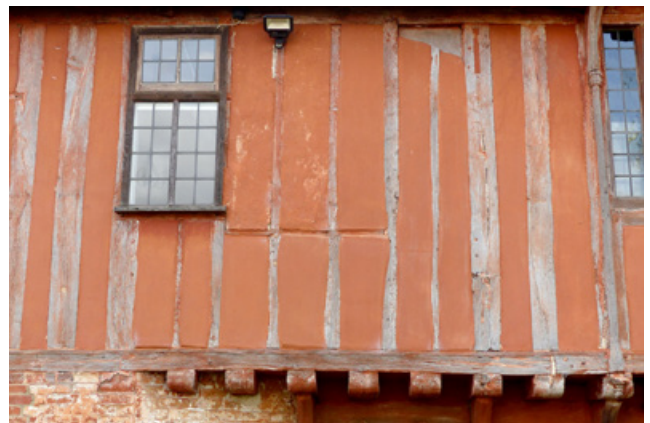
Figure 22: Market Hall 1F former oriel from N

64. On the first floor, facing north, similarly traceried two-light windows (grouped in pairs with a central dividing stud) alternated with larger oriel windows, evidenced by the deep, triple-pegged sills and the absence of pegs in the jetty plate for intervening studs (figure 22). These large openings have since been narrowed to contain replica three-light windows. The south-facing fenestration of the first floor is overlaid by plaster.

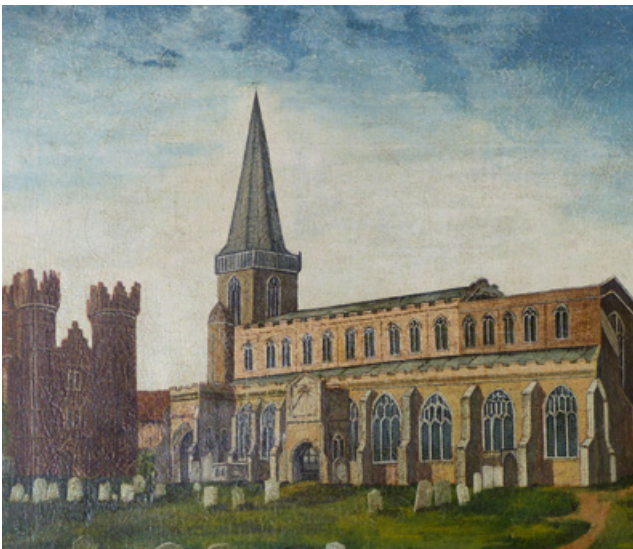
Figure 23: Eighteenth-century view of church showing gild porch - hung in Market Hall.

66. The eastern half of the ground floor provided two shops facing each other across the passage linking the marketplace with the churchyard, as discussed above. A path proceeded northwards from the passage to a former porch, awkwardly placed against the fifth and sixth bays from the east on the south aisle of the church, used for gild processions (figure 23). The passage front of the west shop survives intact. The openings are chamfered to the passage face and plain internally, and they consist of a central doorway with a four-centred arched head and flanking wide windows uninterrupted by mullions (a type generally diagnostic of shop use) beneath heads which are roughly three-centred (figure 24). These windows were supplemented by a pair facing south into the marketplace. The smaller east shop seems to have been similarly lit from the south and from the passage. No windows in these two rooms overlooked the churchyard to the north.

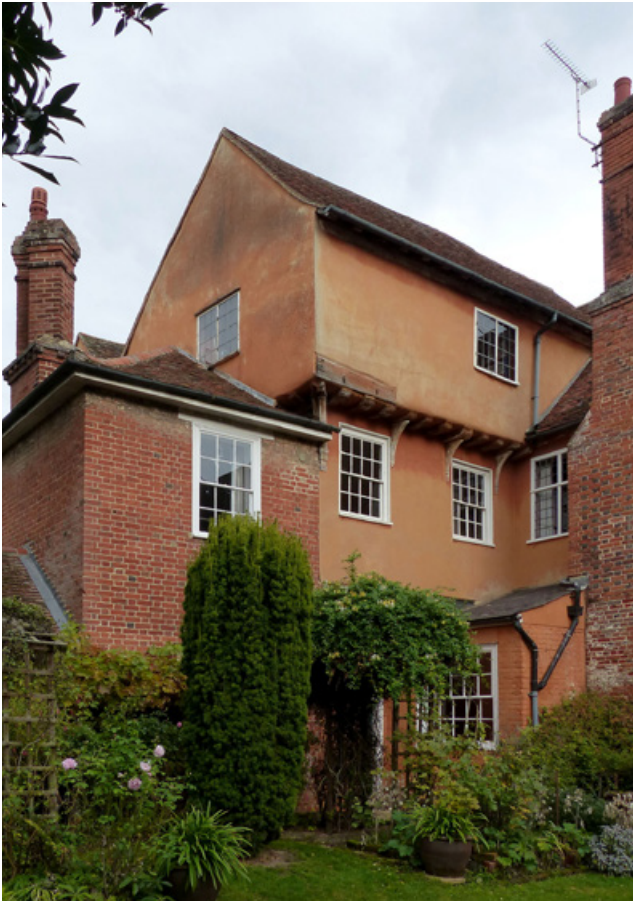
Figure 27: Stair block from SW (CAL).

74. The roughly square-plan stair block occupies the re-entrant angle on the west side of the Guildhall extension where it meets the Market Hall (figure 27). The placing of the stair at the south-west corner of the Market Hall, extending west of it, suggests that it was designed to serve the Market House as well, and that the use of the two buildings was therefore integrated. The position of its east wall appears to be defined by the 1449 grant of land (see Guildhall above).

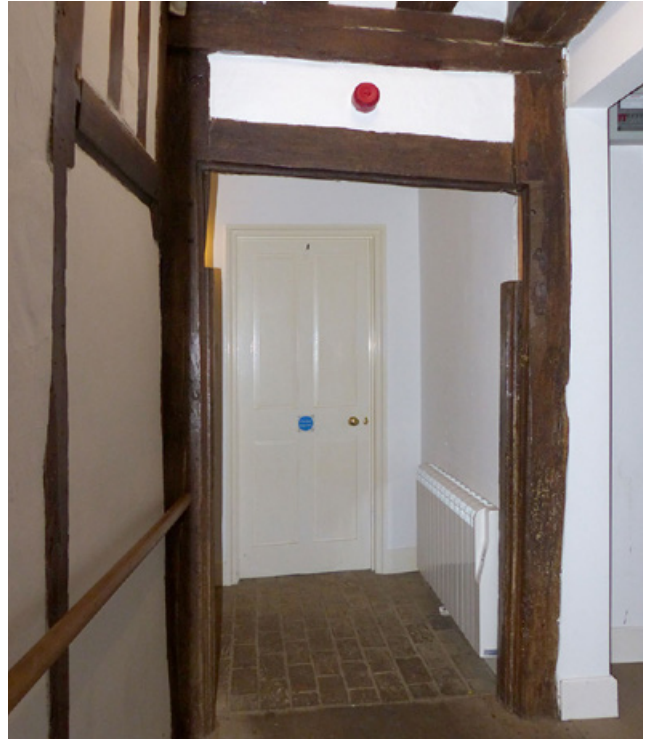
Figure 28: Market Hall GF- original S door to stair block (CAL).

beam is visible in the first floor and another is concealed in the floor above.

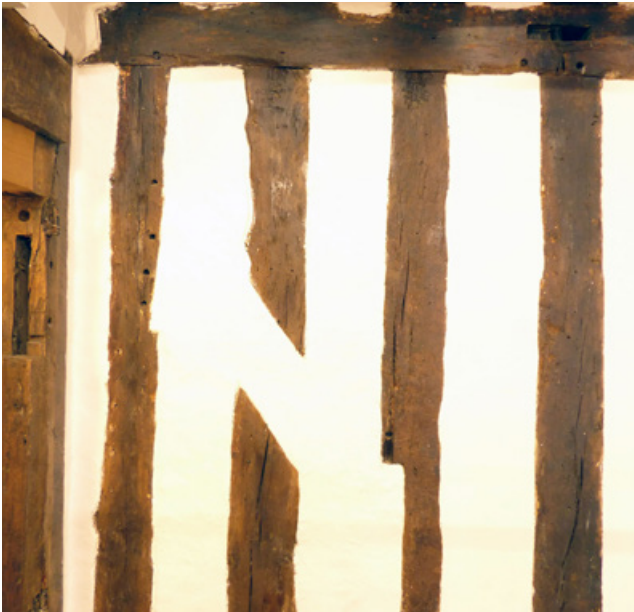
Figure 29: Market Hall GF- blocked doorway, possible evidence for porch (CAL).

judging by a mortice in the south side of the jetty plate. The provision of a second ground-floor doorway immediately alongside the first indicates that a wall dividing the stair block from the Guildhall extension was in existence when the Market Hall was built.

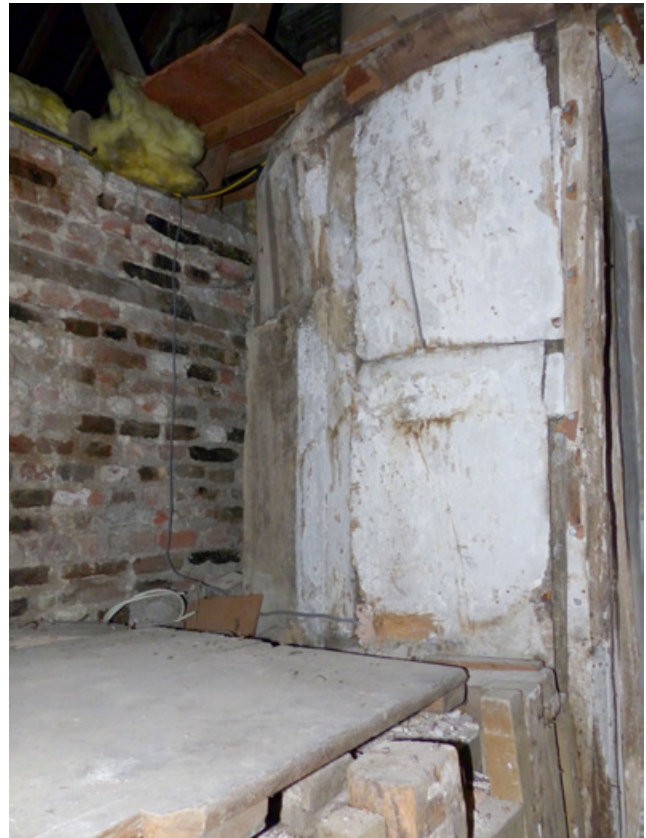
Figure 30: Stair block- perimeter of stair (CAL).

the northern third of the range. Within this compartment the stair is placed off-centre towards the east. The stair block also provided a room on each floor lit from the south and west.

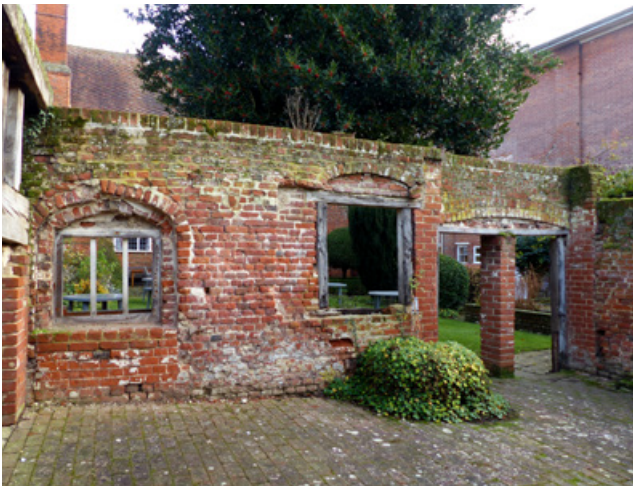
Figure 31: Kitchen interior from W (CAL).

84. Listed since 1972 as the Old Bakehouse, this is a detached, brick-built kitchen standing about 15m west of the Guildhall (figure 31).³⁴ It is now a consolidated ruin within the Guildhall garden, the north, south and east walls standing to a height of about 2.5m, roughly corresponding to the original eaves level. The east wall has been rebuilt towards its south end and the leaning south wall is restrained by two later buttresses; the west wall, bordering a public footpath, survives only at its north end.

85. The kitchen was recorded in 1977, when the remains of an arch and evidence for an associated four-light, diamond-mullioned window at the north end of the east wall were noted as evidence for a contemporary continuation. This interpretation is corroborated by the 1884 Ordnance Survey map, which shows the building extending further towards the north. A rebuilt north gable was still standing in 1977 and parts of a roof had only recently collapsed; the structure appears to have been consolidated shortly afterwards (figure 32).³⁵

86. Detached kitchens reduced the fire risk associated with cooking hearths. The 1977 report calls it a 'feast kitchen', reflecting the custom of annual gild feasts which it may have been built to serve.

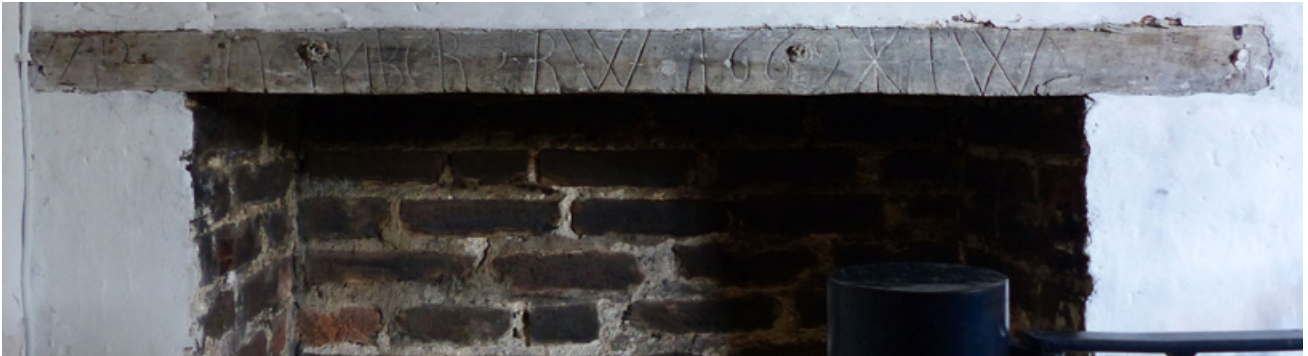
Figure 33: Market Hall 2F- dated fireplace lintel (CAL).

95. The third chimney occupies a short bay in the Market Hall. It serves back-to-back fireplaces on the ground and first floors and another in its north face on the second floor. On the ground floor both fireplaces have chamfered timber lintels similar to those in the Guildhall. On the first floor the original openings are concealed by eighteenth-century timber chimneypieces. On the second floor, the plain, awkwardly sited fireplace has a slender timber lintel, the inscription on which appears to read: 'noMBeR 2 RW 1669 * IW'. 'Nomber' may be for a contraction of November; RW and IW are clearly personal initials, perhaps of the same family; 1669 is plausibly the date of the stack (figure 33).³⁷ No references have come to light to works in 1669, but the Governor of the workhouse between 1664 and 1673 is recorded as Robert Whale, and it is possible that the inscription commemorates his work.³⁸

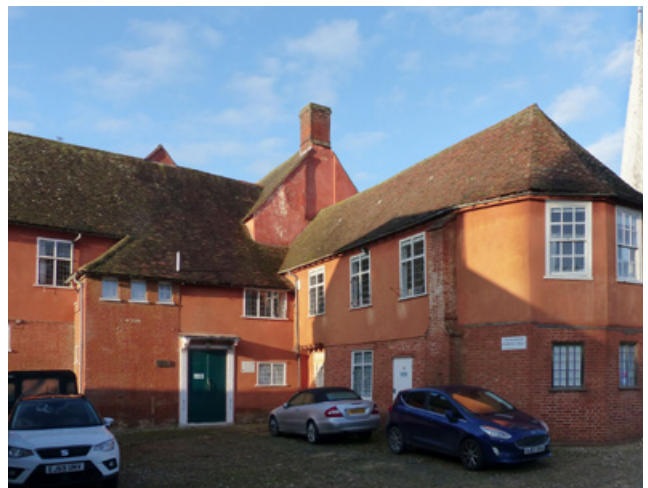
Figure 34: Assembly Room and stair outshot from SE (CAL).

98. The east half of the Market Hall was radically altered to create an assembly room in 1792 (figure 34).⁴⁰ The top storey was removed, the

east end extended in brick and parts of the first-floor jetty underbuilt, to create an assembly room of the desired length, with a tall, covered ceiling so that the atmosphere did not become oppressive during heated dances.

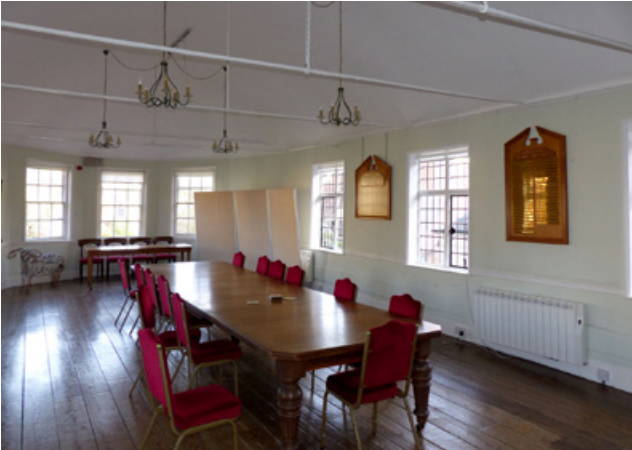
Figure 35: Assembly Room from NW (CAL).

100. Much of the interior of the assembly room survives (figure 35). The extension provided a five-sided apsidal end. The room was lit mainly by a series of mullion-and-transom casements and heated by a fireplace in the seventeenth-century stack at the west end of the room, fitted with a lugged timber chimneypiece and set between flanking internal porches. The grate appears to survive from the 1790s. A musicians' gallery projected overhead on a plastered cove and was ornamented with a fretwork fascia and an openwork balustrade reminiscent of Chinese Chippendale patterns. All these details, with the exception of the grate, suggest a date in the third quarter of the eighteenth century rather than the

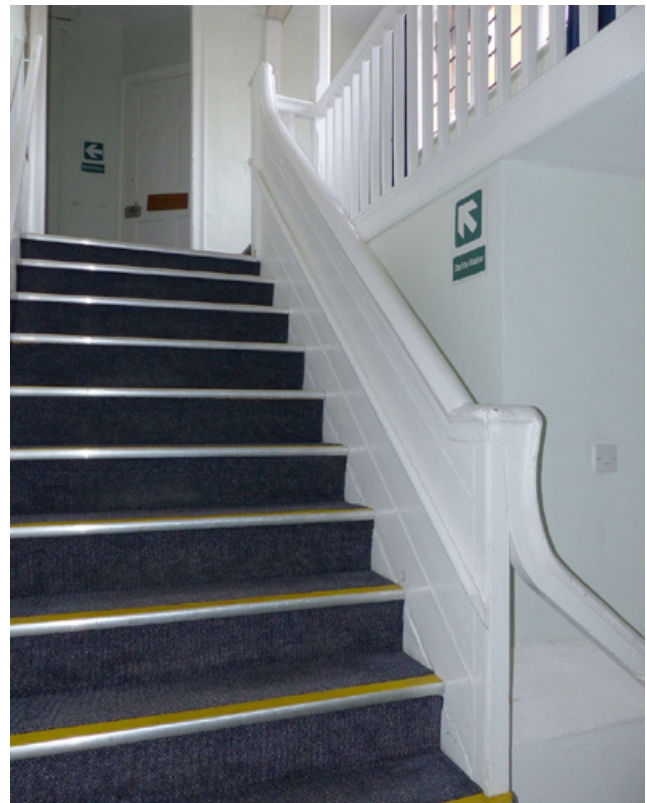
Figure 36: Assembly Room stair (CAL).

101. The assembly room was reached conveniently using a stair rising in an added timber, lath and plaster outshot in the angle where the east side of the Guildhall met the Market Hall. The addition had its own external entrance, meaning that assemblies did not disrupt other uses of the building. The stair and its landing occupy most of the interior. The stair has evidently been rebuilt, but some of the elements – a ramped handrail and a number of re-set turned column balusters – are consistent with an 18th-century date, though again, stylistic dating would favour a date before the 1790s (figure 36). It rises to a doorway with an eighteenth-century moulded architrave and is lit by a vernacular-looking three-light casement window.

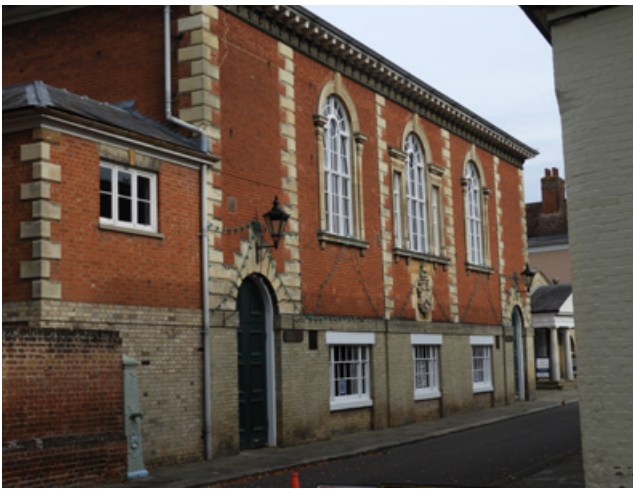
Figure 37: Photograph of the Town Hall (CAL).

3. The Town Hall of Hadleigh Guildhall is a two storey, six-bay structure. The first floor is considerably taller than the ground floor. It has rusticated stone quoins and is constructed of Suffolk white brick for the ground floor and eaves and red brick for the first floor, beneath deeply oversailing bracketed eaves.

5. Conversely, those on the ground floor are squat and rectangular, flanked by two doorways with semi-circular heads and rusticated voussoirs. The coat-of-arms of Hadleigh is displayed in the centre of this elevation. A dentilled cornice extends around the eaves, running below a roof of Welsh slate.

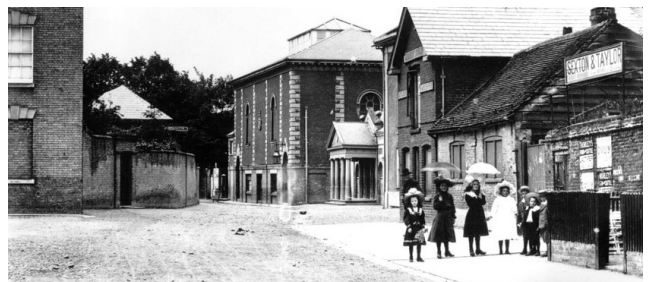
Figure 38: Photograph of the Town Hall from the late nineteenth century (Hadleigh Archives).

10. Originally, the south elevation had only two windows at first floor level, the central bay occupied with the Hadleigh coat-of-arms. Photographs from this century suggest these were blind, though it is not clear whether this was the case as-built (figure 38). These photos show a lantern lighting the first floor, since demolished. At this time, the range was shorter than at present, terminating prior to the stair block, though wider, with a ladies toilet to the northeast. This block was removed in the late twentieth century.

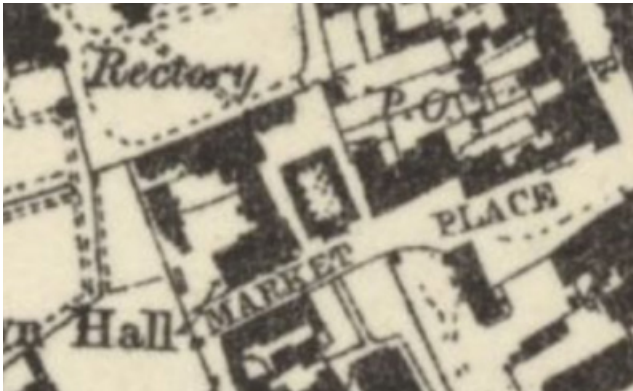
Figure 42: Detail of OS map, Suffolk Sheet LXXIV.SW. Surveyed 1884, published 1884. Without stair block (Hadleigh Archives).

13. Between 1884 and 1902 (on map evidence), a stair block was added to the west of the range (figure 42 shows the extent of the range prior to this addition). This gave independent access to the first floor from the south, separating the then-caretakers' residence and the first floor events space. Events held around this time include the Hadleigh & District Troop of Baden Powell Boy Scouts' show, recorded in May 1911.⁷

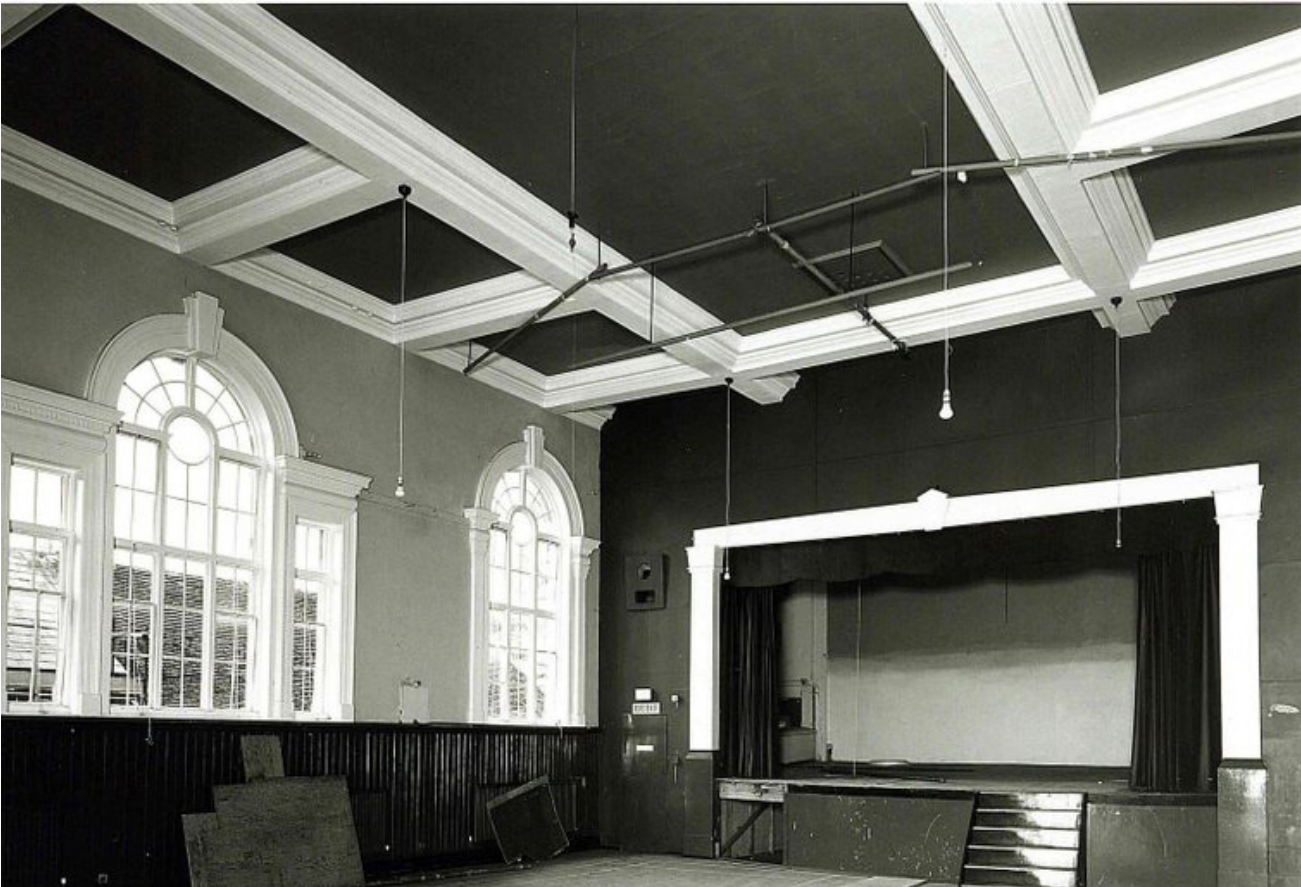
Figure 43 (above): Town Hall interior (first floor) from the mid-twentieth century. Shows ceiling prior to conservation works (HA).
Figure 44 (below): Ground floor layout plan from scheme of works for Hadleigh Guildhall by Purcell Miller Tritton and Partners (HA).

15. During World War Two, a stage was erected on this floor, where it remained until 1986 (figure 43).⁹ There was a fire here in 1942 which

22. Between 1986 and 1994 a major scheme of works was undertaken to the Town Hall. This included: the enlargement of the stair block, increasing the toilet provision of the range; the installation of a lift to the east; and conservation works on the Grand Hall ceiling. Figure 43 indicates that these conservation works preserved the prior form of the coffered ceiling. Indeed, this is likely the original form as it shows the extents of the former lantern in its detailing. The total cost of the renovation was in the region of one million pounds, with a grant of £400,000 from Babergh District Council and a loan from the Public Works Board.¹⁸

23. In addition, the ground floor was completely renovated to accommodate a dining room, bar and commercial kitchen by Purcell Miller Tritton for Hadleigh Town Council (figure 44). This space was re-opened by the Lord Lieutenant of Suffolk on 1st March 1991.

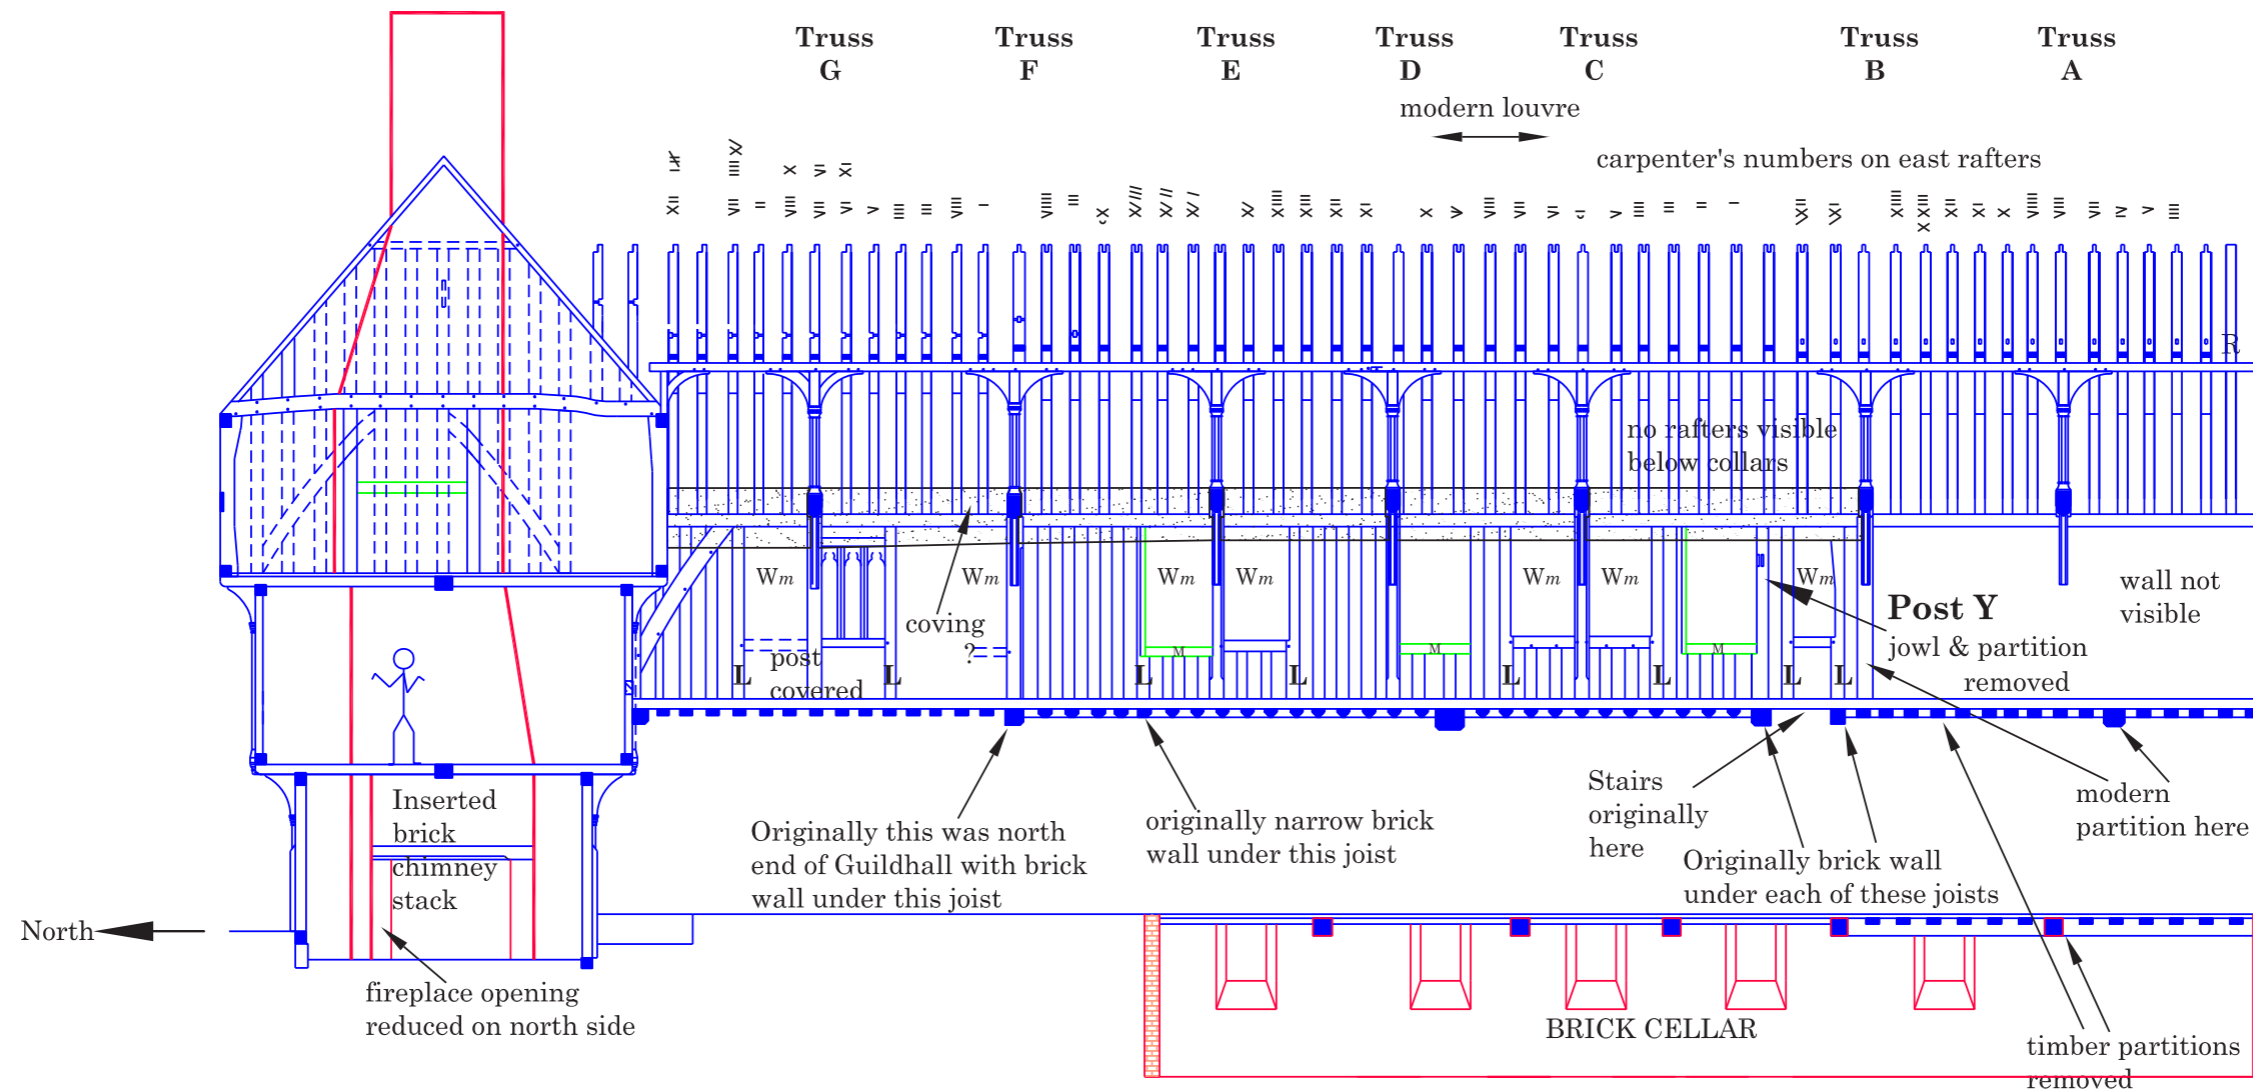
Fig 4: Section through Hadleigh Guildhall & Market Hall Looking West

The original stair tower for the Market Hall was removed when the Guildhall was extended.
