Hadleigh Guildhall Conservation Management Plan

©Caroe Architecture Ltd 2023.

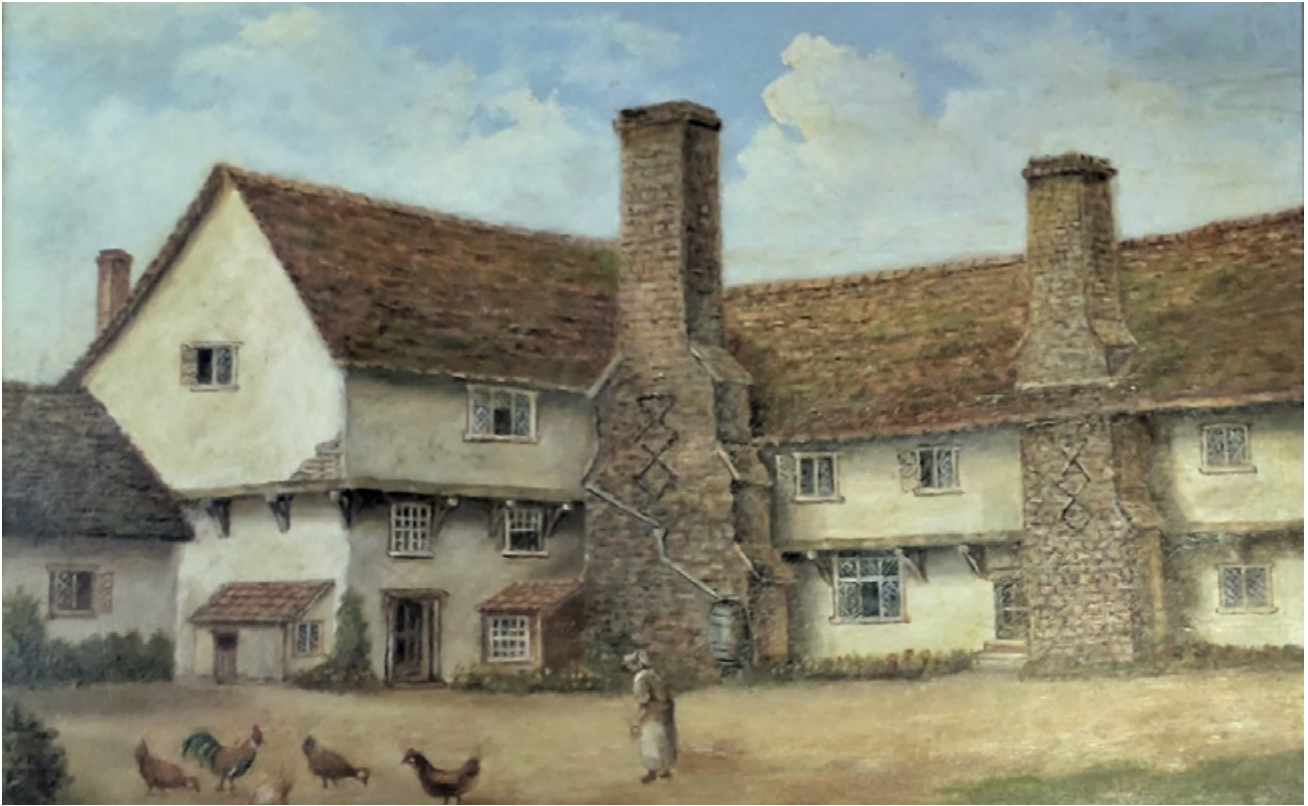
Appendix 3: George Fiske painting 1928, made from a 1880 photograph

97. A further chimney was added, based on Fiske's painting, on the north elevation of the Market Hall, towards the west end. It was later taken down, probably not long after 1880 (appendix 3).
